# OPTICAL CHARACTERIZATION OF HIGH TEMPERATURE DEFORMATION IN NOVEL STRUCTURAL MATERIALS

John Gales<sup>1</sup> & Mark Green<sup>2</sup>

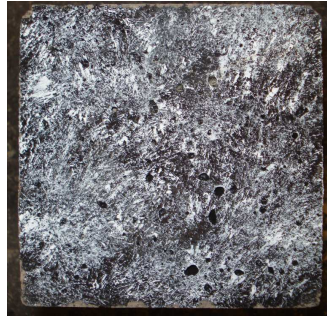
Figure 2: Typical textured paint as applied on concrete.

Typically a white base coat with black speckled paint can be applied. Though the opposite layering of paint can also be performed. The authors have found applying a black base coat with white speckled paint texture more effective for high temperature testing (Figure 2). The black paint being an available, effective, and more durable primer at high temperature. The white paint used shows faint discoloration at 500°C. There is temptation at times not to paint a material which appears to have a randomized texture in its natural state. This has advantage as material phase changes can also be considered qualitatively. This implication is considered within this paper.

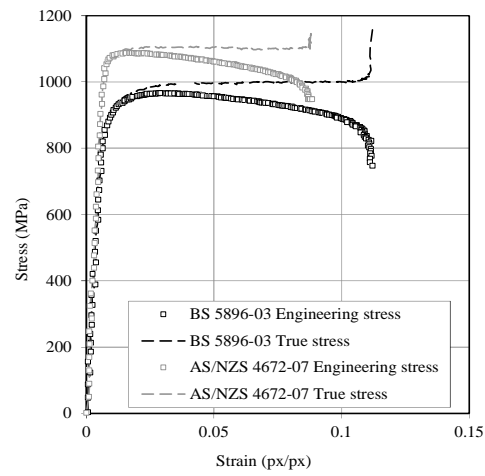
Figure 4: Steady state strength tests of HSS showing engineering and measured true stress comparison between two different manufacturers at 400°C.

Herein this paper remarks on the characteristics observed in high temperature steady state strength and creep tests using the optical measurement technology for HSS. Strength tests were conducted at target temperatures of 100°C intervals. All strength tests beyond 200°C for each HSS specimen indicated a rapid decrease in engineering stress with strain increase after peak engineering stress was observed early into the test. Just prior to failure a characteristic stress 'tail' occurs where strain no longer increases and engineering stress rapidly drops off. When area at the location of necking is measured using optical methods the true stress curve measured is almost linear though does exhibit small increases in stress as the specimen is strained. Once a localised neck clearly emerges the true stress rapidly climbs and is noticeably different than the measured engineering stress. In test repetitions the same observations were observed. This are schematically illustrated in Figure 4 and 5.

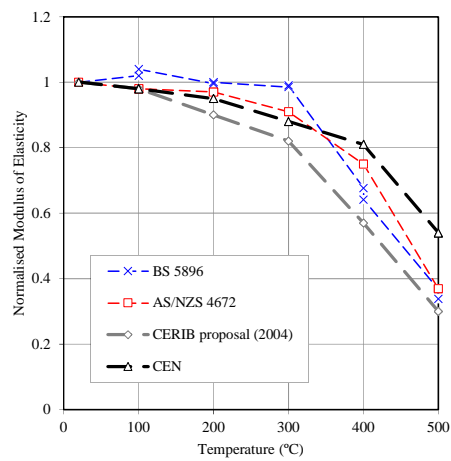
Figure 6: Normalised Modulus of Elasticity for two different HSS in comparison to the accepted Eurocode reductions and proposed reductions.

The elastic modulus at high temperature for each specimen tested was also considered. Figure 6 illustrates that in all cases measured parameters were higher than those proposed for the original Eurocode giving confidence in the existing parameters for modulus reduction. However these Elastic modulus reductions taken from the steady state strength tests inherently include an amount of plastic deformation damage. Similar observations were observed for strength. Part of the research program considering HSS was to evaluate plastic damage at high temperature and a selection of creep tests were performed to define an accurate creep model. For HSS that is highly tensioned in service, creep is important to calculate the corresponding stress relaxation and possible failure of the steel.

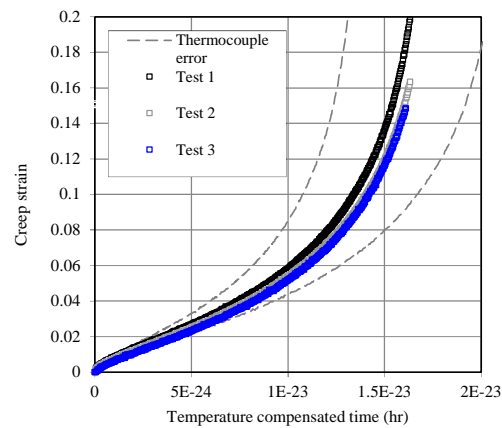
Figure 7: Repeat steady state high temperature creep tests of a HSS.

Figure 7 illustrates a selection of three repeat creep tests performed on BS 5896. There is consistent debate that creep tests have a level of randomization, in that their results are not always consistent between one test to the next. The optical equipment has a unique advantage that a strain measurement can be taken almost anywhere on a sample thereby having the capability to measure the maximum and failure strain of a piece of steel. Figure 7 was constructed by considering three creep tests conducted at the same temperature (about 440°C and loaded to a target stress of 647 MPa) while measuring strain across the location of necking using the post-processing analysis procedure as specified above. The creep strain results (after careful removal of elastic strain) are plotted against the well utilised lumped temperature and time coefficient. For simplicity this coefficient is determined through use of the Arrhenius equation. Further details of this calculation can be referred to in Harmathy's research<sup>11</sup>. Figure 7 illustrates that if proper care is considered in test analysis and control, that a creep test could be satisfactorily repeated at steady state conditions.

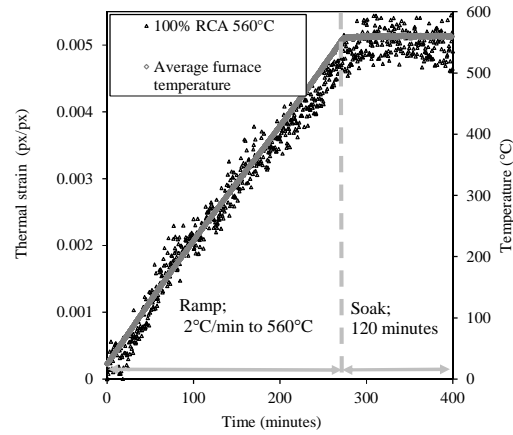
Figure 9: Thermal expansion strain of RA concrete.

Optical measurement was conducted to approximate the thermal expansion of concrete with RCA. Figure 9 illustrates this result and it can be seen that a good linear behavior can be observed during heating of the concrete as could be expected.

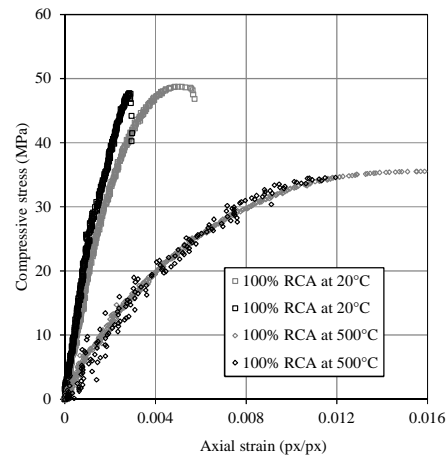
Figure 10: Concrete test repeatability.

Strength and modulus relations indicated that a distinct linear trend in reduction could be observed at elevated temperature. Figure 10 provides two repeat tests for both ambient and at high temperature tests. Even with a complete substitution of conventional aggregates with RA, the sustainable concretes still performed within Eurocode strength reduction guidance, though concrete with RA exhibited less strength retention than its conventional counterpart. Of all tests considered, the optical measurement technique was capable of assessing strain reliably in each test. Before load was applied thermal expansion strain was tracked along the surface of the specimen. Failed concrete typically illustrated higher ductility during elevated temperature tests, while lower ductility at ambient temperature. In all tests, strain at peak stress ranged below 1.5% which was in conformance with expected results as can be seen in the Eurocode.

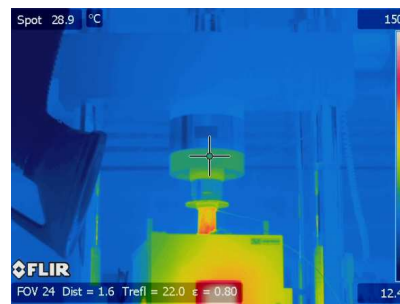
Figure 11: Thermal imaging of equipment frame at load cell showing negligible temperature rise outside furnace.

Although optical measurement was done in conjunction with the test, an additional study was performed to assess the temperature of the surrounding area of where the camera was being used and the amount of heat around the loading frame. The concern had been that although cameras are expected to self-heat which can also cause error, the proximity of a camera to the furnace may influence the camera and its lens to expand thereby corrupting the measurement of strain. The authors assessed this by using a thermal imaging camera (a FLIR A302A camera) to consider both the heat the camera had shown during the test as well as the surroundings of the loading frame. The load cell on the frame uses strain gauges to calculate strain and has a maximum operational temperature at 50°C. Therefore it was important to verify that during the test the load cell was indeed within its operational temperature, otherwise the load data could not be trusted. Figure 11 represents a thermal image of the set up with the camera. It was confirmed that these concerns were not an issue for the test configuration employed, however the authors recommend other test set ups be checked for this issue where high temperature tests are conducted.

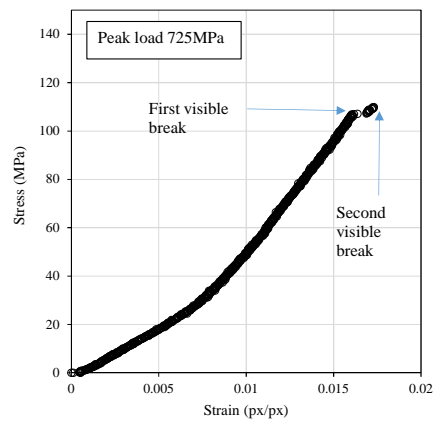
Figure 15: Stress strain of a GFRP without tracking paint coating at 400°C

elasticity with optical measurement were complicated. Figure 15 illustrates the measured stress and strain response of a GFRP sample at 400°C. The outer sand coating constantly exhibited random cracks and peeling as the load was applied. The measured elasticity was much less than what would be expected for the degradation of FRP with glass alone at 400°C. Failure of the GFRP appeared abruptly in the imaging.

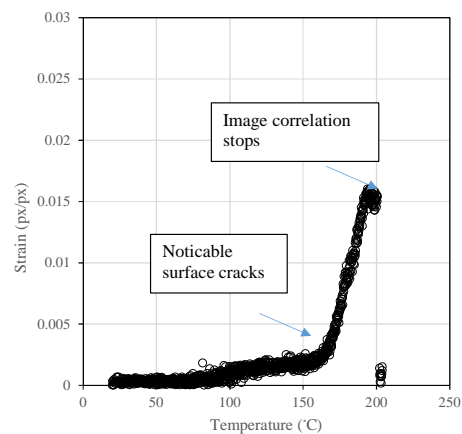
Figure 17: Measured thermal strain and actuator deformation of GFRP with applied load and no tracking paint coating on specimen.

A much different interplay mechanism was observed by studying a transient test which had direct consequence on the ability to measure optical strain. Before heating, load was applied. Using the optical measurement technology the ambient temperature elastic modulus was satisfactorily measured at 41.5 GPa. The data used to produce this value exhibited a good  $R^2$  of 0.99 (see Figure 16). Heating then began after reaching a target load level. The load level was maintained for the test duration. Almost instantaneously near the glass transition point, the glass fibres tended to rupture along the outer coating. The sand coating then delaminated and began to ‘peel’. This visually started, as confirmed in the images of the test, when the specimen surface temperature was 150°C and continued, at least visually on the surface, until the specimen surface was 230°C. This may be explained as the glass transition phase indicates that the polymer matrix becomes a rubbery state and load may therefore rebalance on the remaining glass fibres. Some fibres may have been loaded more than others possibly contributing to fracturing. The cracking of the sand coating seemed to stabilize after 230°C. This corresponds to a spike in longitudinal strain as measured by optics just prior to when the technology stopped being capable of providing reliable measurement (Figure 17). Beyond 400°C increased cracking was once again seen leading to ultimate failure as had been observed in the case of the steady state tests. Between 230°C and the specimen failure at 426°C no reliable optical measurement of strain was possible. Tracking deformation using optical measurement was pointless beyond the glass transition temperature region in the transient test as the sand coating showed negligible strain increase. Imaging of the test gave similar colour changes as were observed in the steady state tests (Figure 18).
