Fire Performance of Cultural Heritage and Contemporary Timbers

Manuscript as Accepted in Engineering Structures Journal

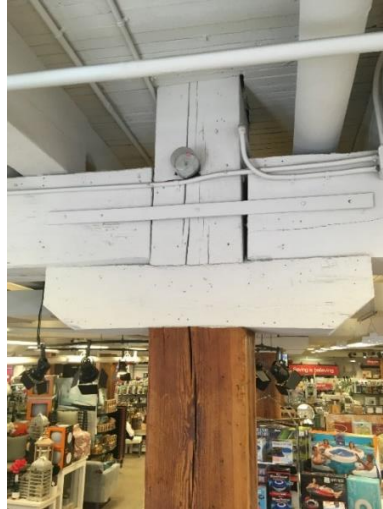
Fig. 1 A historic timber assembly found in Toronto, Canada

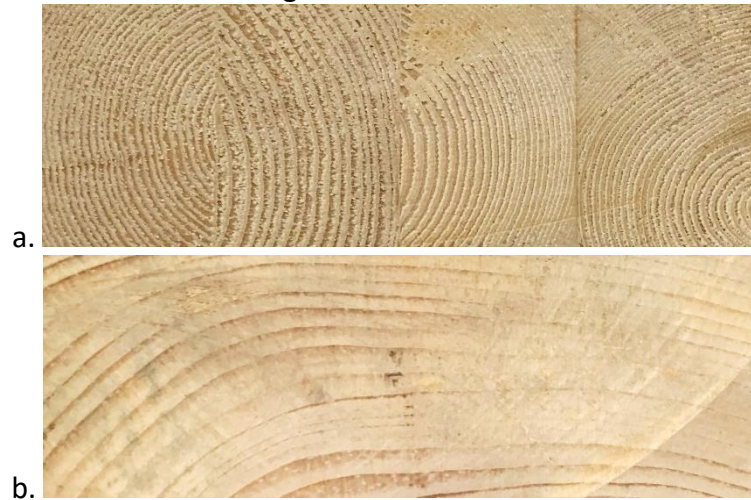
Historic timber differs from contemporary timber for several reasons. Historic timber was produced from trees that were grown hundreds of years ago. Ancient timber growing practices may be different than contemporary growing practices, which may affect properties inherent to the timber such as density and growth ring width [14, 15]. An example of this is seen in Fig. 4. In the particular samples shown in Fig. 4, it is apparent that the growth rings are significantly wider in the historic timber versus the contemporary Glulam. Furthermore, contemporary timber often frequently uses adhesives and other additives which may also impact the fire performance of the timber. Adhesive lines in the contemporary Glulam are seen as vertical lines holding together the wood laminates in Fig. 4a.

Fig. 4 Cross sections of showing the growth ring width of, a. contemporary Glulam and b. historic timber, from a building constructed in the 1840s

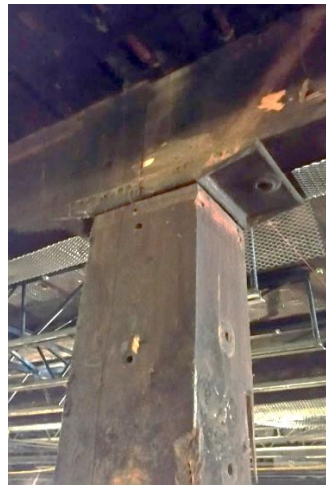
The structure used large timber beams and columns connected by a cast iron cap, which is seen in Fig. 6. Several timber members were (carefully) removed from the structure by the building owner to accommodate an adaptive reuse project, and the timber samples used in this research were sourced from one of these columns (originally located in the basement). The dimensions of the column were 240 x 290 mm. All timber described as ‘Column’ indicates that it is timber from one of the columns within the industrial mill building. The materials were wrapped in plastic to allow slow acclimatization to new laboratory conditions.

Fig. 6 The timber column in the basement of the structure before removal

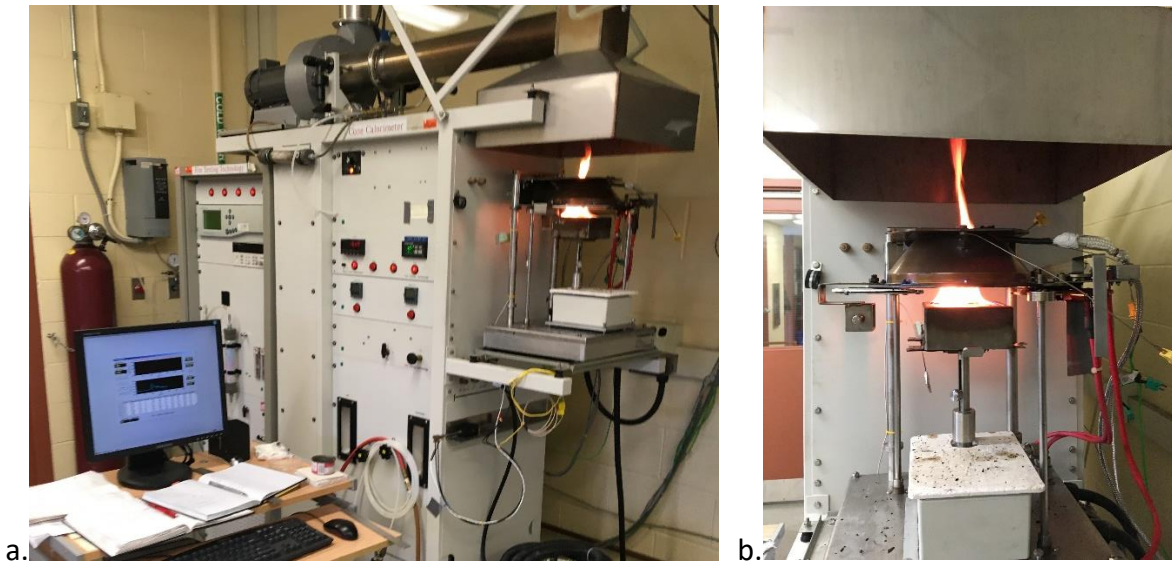
The Cone Calorimeter tests followed a modified ASTM E1354 procedure [19]. The Cone Calorimeter is an apparatus that uses radiant heating coils wound into a cone [20], and the irradiance of the apparatus can be controlled. Specimens can then be placed under the heater and exposed to the desired heat flux. The test setup is seen in Fig. 9. Modifications to the ASTM E1354 procedure were made in that each sample was removed from the Cone Calorimeter after a specific length of time and extinguished with water (which evaporated upon application to the timber). The use of water to extinguish a fire is representative of what would occur in a real fire scenario. Another modification to the procedure was that the spark igniter of the Cone Calorimeter was not used. The ASTM E1354 standard indicates that the exact irradiance levels or use of external ignition is not prescribed, and that these should be determined separately for each product [21]. The spark igniter was therefore not used in order to be most representative of a realistic fire, as if ignition were to occur, the timber would self-ignite.

Fig. 9 The Calorimeter test setup, a. the entire apparatus and data collection system, and b. the cone heater and a sample being tested

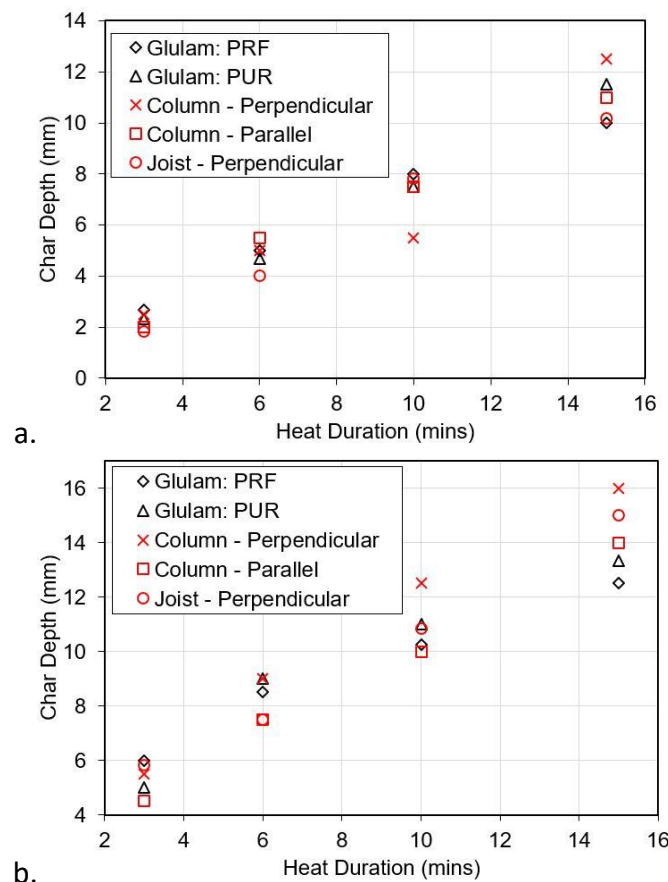
The charring of the timber samples was also recorded. Fig. 11 presents the char depth results for the 3, 6, 10 and 15 minute tests for all timber types. At 30 kW/m², the char depth of all of the timbers are relatively close. At 50 kW/m², there is a bit more deviation. At the longer heat durations, and especially at 15 minutes (which is the most severe heat exposure considered), the historic timbers have charred more than the contemporary timber. On average for 15 minutes at 50 kW/m² the historic timber had 1.75 mm (13%) more char than the Glulam.

Fig. 11 Average char depths for each type of timber at a. 30 kW/m² and b. 50 kW/m². Each data point represents the average of two samples

The results of the char depths and charring rates showed some discrepancy between the historic and contemporary timber. At 30 kW/m², all of the timber types charred similarly. At 50 kW/m², the historic timber had slightly more char depth, especially noticeable at the heat duration of 15 minutes. This may imply that at more severe heat durations the char depth of the historic timber will be slightly greater than the contemporary timber. One of the reasons

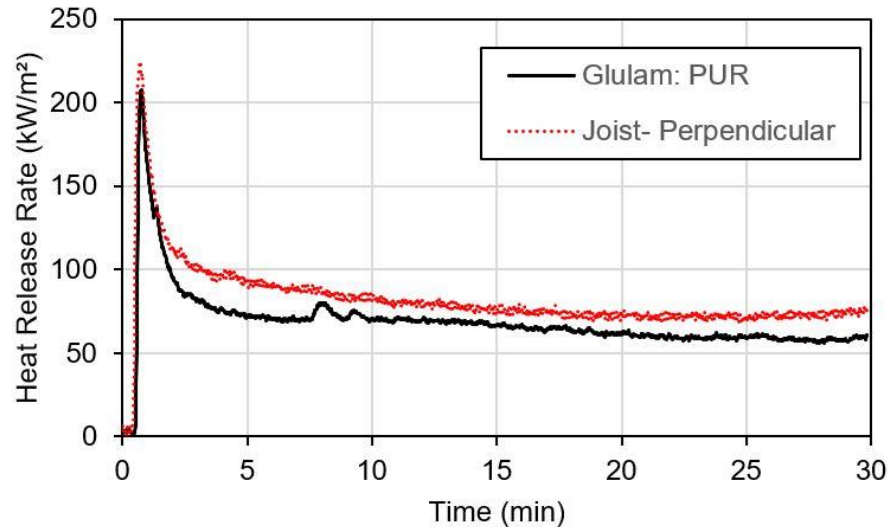
kW/m² in the Cone Calorimeter represent the heat fluxes generated by the apparatus, but do not necessarily represent the total heat exposure once the heat generated by the timber itself is considered. The heat release rate for the 30 minutes Cone Calorimeter tests are seen in Fig. 15. A higher heat flux will alter the performance of the timber, for example by accelerating chemical reactions which cause ignition at a faster rate [32, 33].

Fig. 15 Heat release rate of the 30-minute Cone Calorimeter tests
