Fire Performance of Heritage and Contemporary Timber Encapsulation Materials

Manuscript as Accepted in the Journal of Building Engineering

John Gales PhD (Principal Investigator, York University)
Bronwyn Chorlton (Graduate Student, York University)

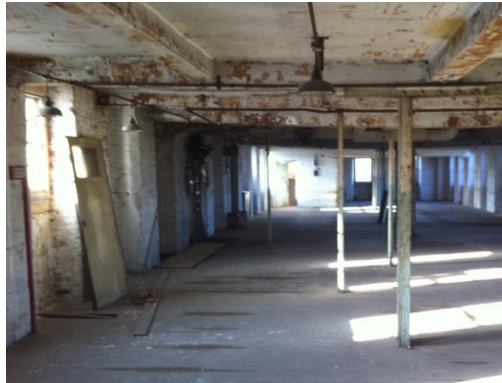
Fig. 1. Metallic plates installed since the 18th century structure, believed to make the structure incombustible

Timber is especially vulnerable to fire due to its combustible nature. For centuries, building owners and engineers have been implementing methods meant to make timber buildings more secure from fire. Often these strategies involved covering up (encapsulating) the timber with another material meant to improve its fire performance. While the encapsulation materials may have changed through time, this practice is still done today, examples being gypsum products in North America that are commonly recommended for enhancing the fire performance of a timber assembly [3]. A sample of commonly encountered historic encapsulation materials include plasters, metal plates, and lime-based (whitewash) paints. See Fig. 1 for example of an 18th century mill plated with metallic plates covering timber. Note that the plates in this building are by heritage designation not to be removed in renovation.

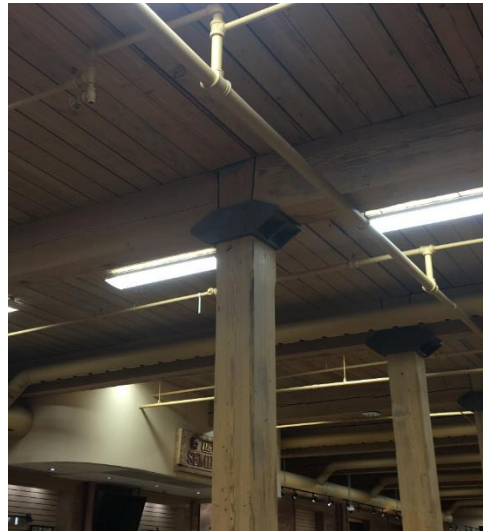
Fig. 3. An exposed timber building, with a timber ceiling, as well as timber beams and columns connected by a cast iron cap. This structure is located in Toronto, Canada, and was constructed in 1902 as a warehouse (but is currently being used for commercial retail purposes)

Prior to the use of documented encapsulation methods, timber buildings have long been left exposed. An exposed heritage timber building is seen in Fig. 3. In the late 18th century, a group of well regarded architects formed a committee (known as the Associated Architects) to deal with the fire problem that they believed was disrupting London, UK, and other cities [5], this committee was formed in response to a recent theatre fire. This association would be later viewed as the precursor to Royal Institute of British Architects (RIBA). Led by Henry Holland, they aimed to identify the causes of the recent conflagrations, as well as methods of preventing similar fires from occurring in the future. The Associated Architects, as they called themselves,

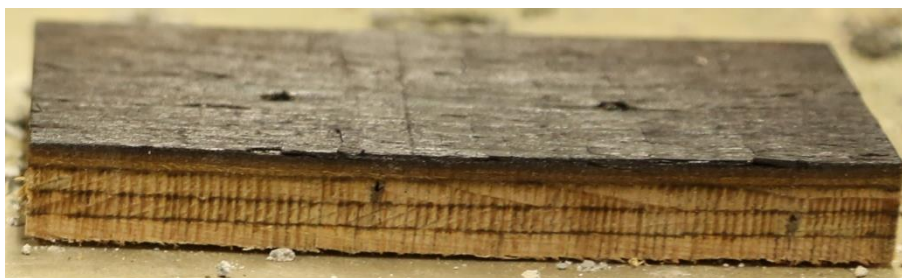
Fig. 12. Degradation process beginning on the timber, seen after removal of the iron plate

The metal plates somewhat improved the fire performance of the timber. While the iron plates had some flaming through the screw hole, a char depth of only 2.5-3 mm was measured after testing (indicating a smouldering fire under the plate), which is still considerably (75%) less than the 11 mm on the control sample. Though the authors caution that the duration of heating was small, and longer duration testing may not show favourable performance. While away from the screw hole no flaming occurred, heat transfer into the timber still occurred, causing degradation to begin in the depth of the timber. This can be seen in Fig. 12. As heat transfer was noticeably occurring through the iron plate and into the timber, the effectiveness of the iron plate at protecting the timber was limited.
