POSTFIRE PERFORMANCE OF GFRP STAY-IN-PLACE FORMWORK FOR CONCRETE BRIDGE DECKS

Journal Paper

ASCE Journal of Composites for Construction, *Vol. 23 Issue 3*

Nicoletta, B., Woods, J., Gales, J., Fam, A.

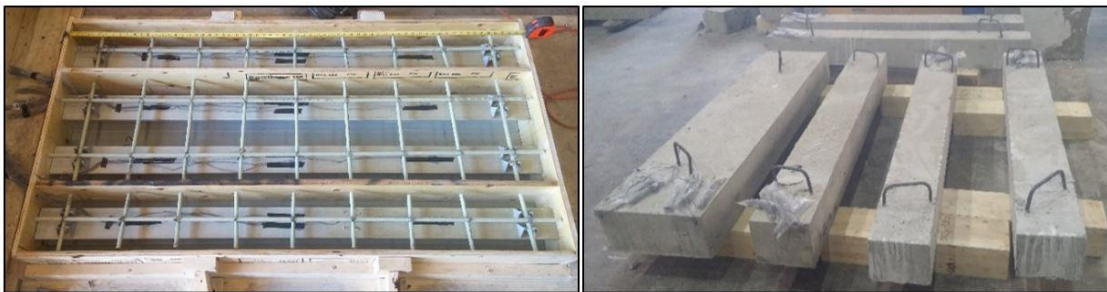
Fig. 3. Beam fabrication and casting.

A two-dimensional grid of 10-M GFRP V-ROD rebar was added to each specimen to better represent actual strips of a GFRP stay-in-place formwork bridge deck where a top rebar mesh would be used. The longitudinal rebar was placed 35 mm above each T-Up rib. The transverse bars were the lower rebar layer and spaced at 185 mm. The total beam height including the GFRP base plate was 186 mm. The specimen sizes are based on the dimensions from a full-scale comparison of a RC–steel composite bridge deck with a GFRP stay-in-place formwork–RC bridge deck (Nelson and Fam 2013). The GFRP formwork decks were designed to be comparable to a Canadian Highway Bridge Design Code (CAN/CSA-S6-14)–compliant RC–steel composite bridge deck, resulting in a GFRP member depth of 186 mm to achieve the same effective reinforcement depth as the traditional steel composite deck. However, the GFRP deck had a higher reinforcement ratio and additional vertical ribs compared with the traditional RC–steel deck (Nelson and Fam 2013). The concrete beam widths were chosen as the same spacing of the GFRP T-Up ribs to accommodate and center one full rib per beam (with the exception of C2). The beams and test cylinders were covered by wet burlap for the curing duration. The 50-day concrete compressive strength was 45.7 ± 1.2 MPa based on six cylinders tested in accordance with ASTM C39. The 90-day concrete compressive strength was measured as 47.9 MPa. Fig. 3 shows the strip specimens in the formwork prior to casting and the cured beams. No surface preparation of any kind was applied to the GFRP formwork prior to casting.

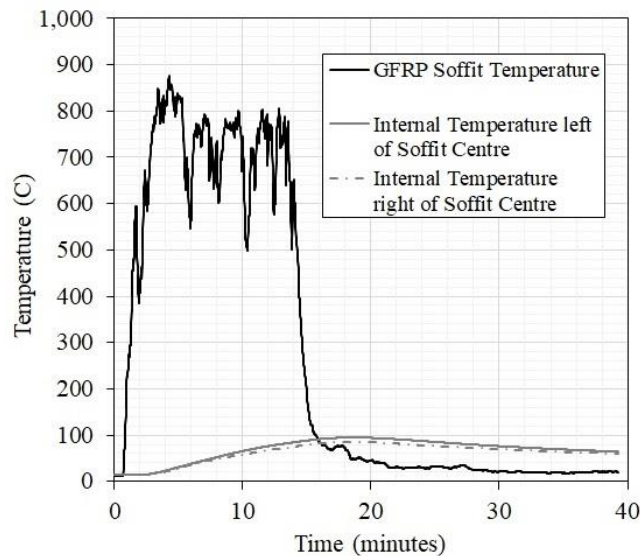
Fig. 6. Time temperature history for beam FD.

A variety of instrumentation techniques were used in this study to monitor the responses of the test specimens. Three linear voltage displacement transducers (LVDTs) were used to measure the deflections along the length of each beam. GFRP-rated strain gauges were installed at the quarter spans and midspan of the T-Up rib flanges to monitor changes in rib strain relative to damage extents. In general, FRPs can be very susceptible to high temperatures, especially in the case of externally bonded FRP reinforcements where adhesion can be compromised by heating as described in Del Prete et al. (2015). Specimen FD was instrumented with two thermocouples placed on the interior side of the GFRP base plate at the midspan to record the GFRP–concrete bond temperature. Two additional thermocouples were used to monitor the ambient air temperature in the laboratory and the temperature of the GFRP soffit. All thermocouples were simple k-type gauges and only measured point temperatures and are illustrated in Fig. 6 showing temperature versus time.

Both thermocouples on the interior side of the GFRP base plate measured peak temperatures of less than 100°C, while the gas temperature at the exposed surface measured a peak of approximately 900°C. A numerical study would be useful to investigate the heat transfer across the GFRP–concrete interface and assess the degree of heating the concrete can sustain beyond this layer. Because the concrete temperature adjacent to the GFRP soffit was below 100°C, there exists negligible degradation of concrete strength due to heating at any point in the concrete and spalling could not have occurred. This result is significant because it validates the authors'

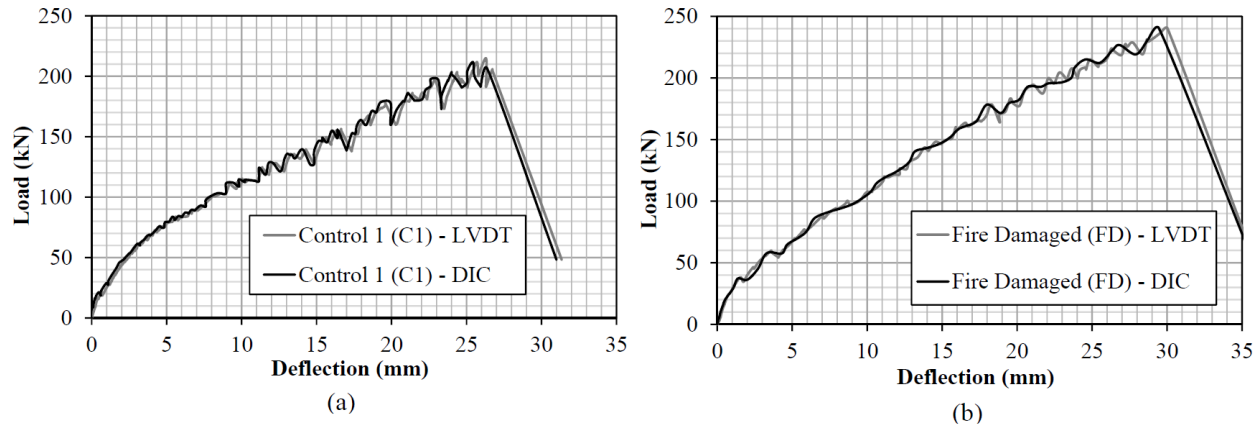
Fig. 9. Comparison of LVDT and DIC midspan deflection response: (a) beam C1 and (b) beam FD.

The camera used in this study was a 50-megapixel Canon 5Ds Mark III. The software used in analysis was GeoPIV-RG and MATLAB, which applies interpolation functions to track movement between points of interest in subsequent images. Gales and Green (2015) outline some qualitative errors associated with optical measuring and potential solutions to these issues. The measurement error associated with DIC is on the order of 0.0001 mm , arising from GeoPIV-RG's standard and rotational errors of 0.001 pixels (px) and 0.0001 px , respectively (Blaber et al. 2016). To validate the reliability of the DIC analysis, the calculated results of the vertical deflection at midspan for Beams C1 and FD were compared to the measured values from the LVDTs. Fig. 9 shows a comparison between LVDT and DIC vertical displacement results. These results show the very good agreement between the DIC and LVDT deflections. The slight discrepancies at higher

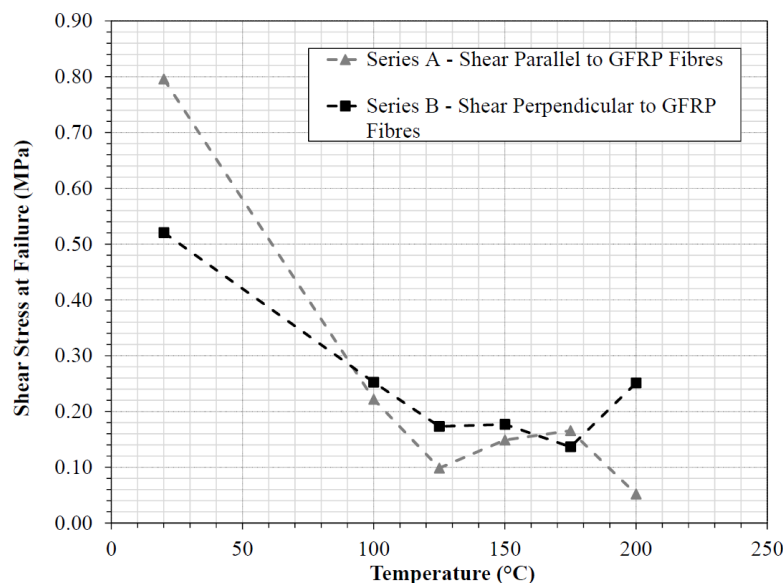
Fig. 16. Ultimate bond shear stress versus heated temperature.

The GFRP–concrete bond shear tests revealed information about the effect of elevated temperatures on the GFRP–concrete interface. In general, there was no evidence of a bond enhancement in direct shear due to resin post-curing or otherwise. There was a clear decrease in failure shear stress as bond temperatures increased. The DIC analysis monitored the bond deformation as shear loading increased. Due to the brittle failure of the test samples, recorded deformations are small but still within the accuracy of the DIC technology, as discussed earlier. Of particular interest was the relative displacement of the GFRP–concrete interface across the bond. Table 7 gives the ultimate loads and stresses for each sample and presents the relative displacements across the GFRP–concrete bond normalized by shear stress at failure. Based on the aforementioned data and physical deformities, Specimen A2 was believed to be defective, likely due to damage or issues encountered during casting, and was omitted from the associated plots. For temperatures at which two samples were tested, the results were averaged in the plots below. Fig. 16 plots the relationship between heated temperature and ultimate shear stress, while Fig. 17 plots the normalized relative GFRP–concrete displacement versus the bond temperature. These plots show that heating the GFRP–concrete interface decreases the ultimate bond shear stress and increases the relative bond deformation when tested in direct shear after the bond temperature has returned to ambient. Although a limited sample size was tested, the relationship between bond deformation and heated temperature appears to be nonlinear; however, additional testing may be required to further study the residual GFRP–concrete bond strength at elevated temperatures.

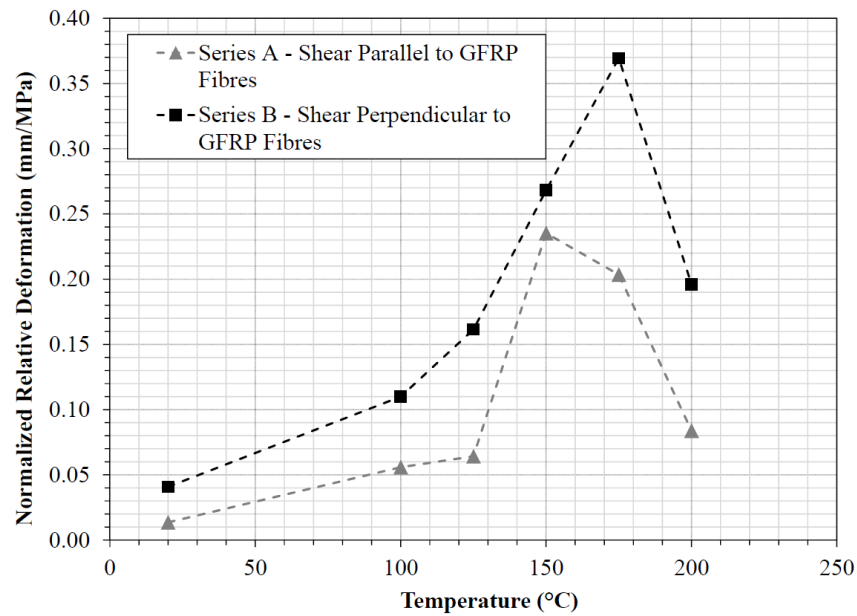
Fig. 17. Normalized GFRP-concrete bond displacement versus heated temperature.

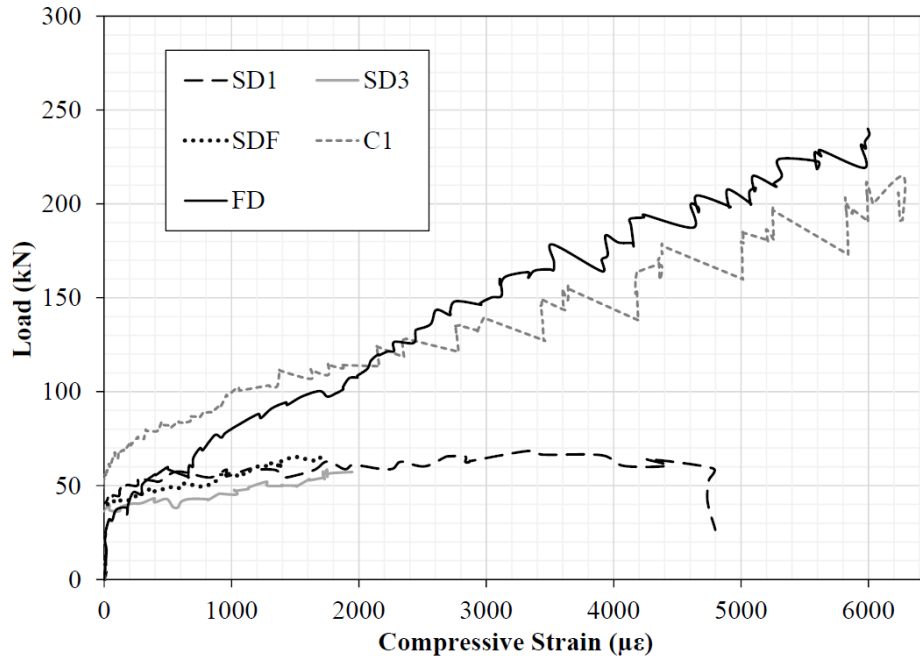
Fig. 21. T-Up rib flange compressive strain response at midspan.

One research goal was to determine whether the embedded T-Up ribs would bear additional load in the event of damage to the base GFRP plate. Fig. 21 outlines the GFRP rib flange load-strain responses at midspan for all tests. Beam SD2 had all four strain gauges fail and is not shown on the plot. It is observed that there is a large increase in strain developed in the T-Up ribs in the SD tests when compared to C1 and FD. This is likely due to the larger curvatures developed in the SD GFRP formwork and reduced composite action that eventually led to GFRP fracture. Beam SDF had the highest capacity of all simulated damaged beams, suggesting it may be more beneficial to have a uniform region of damage instead of discrete damage boundaries. The strains in C1 and FD are of the same order of magnitude. The rib flange of Beam FD shows a decrease in a stiffness when compared to C1 due to the reduced area of GFRP reinforcement from fire damage and an extended zone of pyrolysis. The measured rib strains are compressive due to the loss of composite action between the GFRP formwork and the concrete. As demonstrated in Fig. 22, as composite action is lost, a strain discontinuity is created between the strain distributions

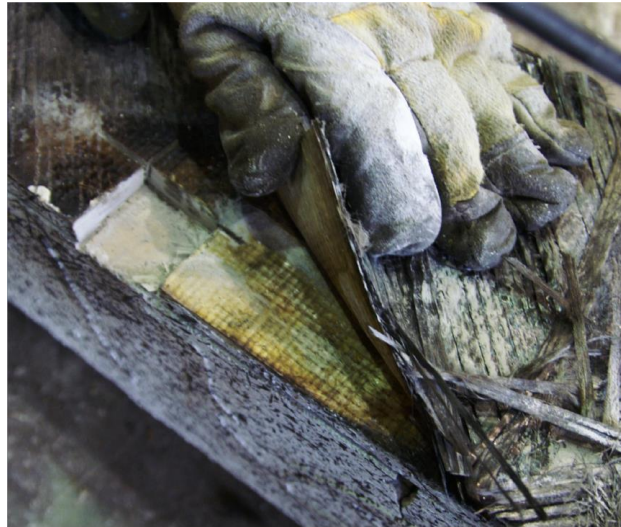
Fig. 23. Delaminated pyrolysis/char layer on GFRP base plate soffit.

Beam FD performed better than suggested by Gales et al. (2016) under exposure to the pool fire. A char layer extended approximately 2 ± 0.5 mm or 15% into the exposed 13.7 mm thick GFRP base plate as measured in six locations across the damaged soffit. The small variation in char

depth (0.5 mm) over the damaged region of Beam FD provides the authors with confidence that heating was moderately uniform along the exposed region. The variations in char depth could be due to flame dispersion effects. It should be noted that the region directly beneath the char layer still contributes structurally to the member but may have undergone some level of chemical change, including pyrolysis during heating. This layer will have altered postfire mechanical properties based on chemical change from partial GFRP decomposition. Delamination of outer laminates occurred on the charred GFRP surface. The GFRP experienced flame-out almost immediately after the pool fire fuel was exhausted. This suggests that a more severe fire may be required to sustain a flame on the GFRP surface after flame-out. Fig. 23 shows the delamination and charring of the base plate observed during the test.
