# Mechanical Performance of Laminated Veneer Lumber and Glulam Beams after Short-Term Incident Heat Exposure

Manuscript as Accepted in Construction and Building Materials

John Gales PhD (Principal Investigator, York University)  
Bronwyn Chorlton (Graduate Student, York University)

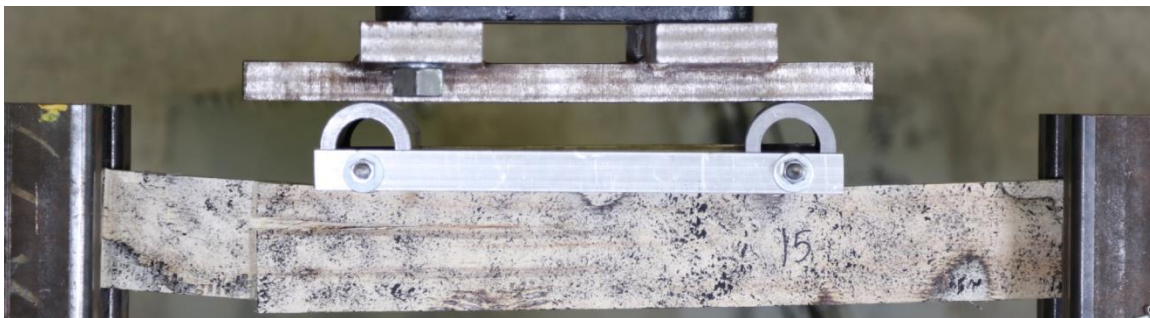
**Fig. 6** Failure of an LVL beam, carved to the 10 mm damage state (carved area seen on the left-hand side of beam, bound by the split in the wood, and the support)

The LVL beams carved in the shear region displayed differing results between the 5 mm and 10 mm damage states. For the 5 mm damage in the shear region, the carved beams failed at a higher load than the charred beams. The opposite is true for the 10 mm damage state. The reason the carved beams failed at a lower failure load than anticipated may be that the carving of the beams causes the full width of a number of the laminates to become exposed. As a result, the failure mode that is observed is that the laminates that have become detached fail earlier than the rest of the cross-section. This failure mode can be seen in Fig. 6. This is less of an issue for the less severely damaged beams, as fewer of the layers of laminates have become exposed during the carving process.

The slope of the load-displacement curves of the LVL beams carved to 10 mm in the shear region (Fig. 7b) begin similarly to the charred and controlled beams, but they eventually begin to plateau. This represents the point at which the outer laminates fail (the failure mode seen in Fig.6), though the remainder of the beam is still able to carry some load. Also notable is that the load versus displacement curves for the Glulam (Fig. 7c) show that one of the beams charred in the shear region (Sample #26 – Charred) experienced a number of drops in its carried load. The initial drop occurs upon initiation of a crack within the shear region. The following drops represent the growth of this crack, which ultimately led to its failure.

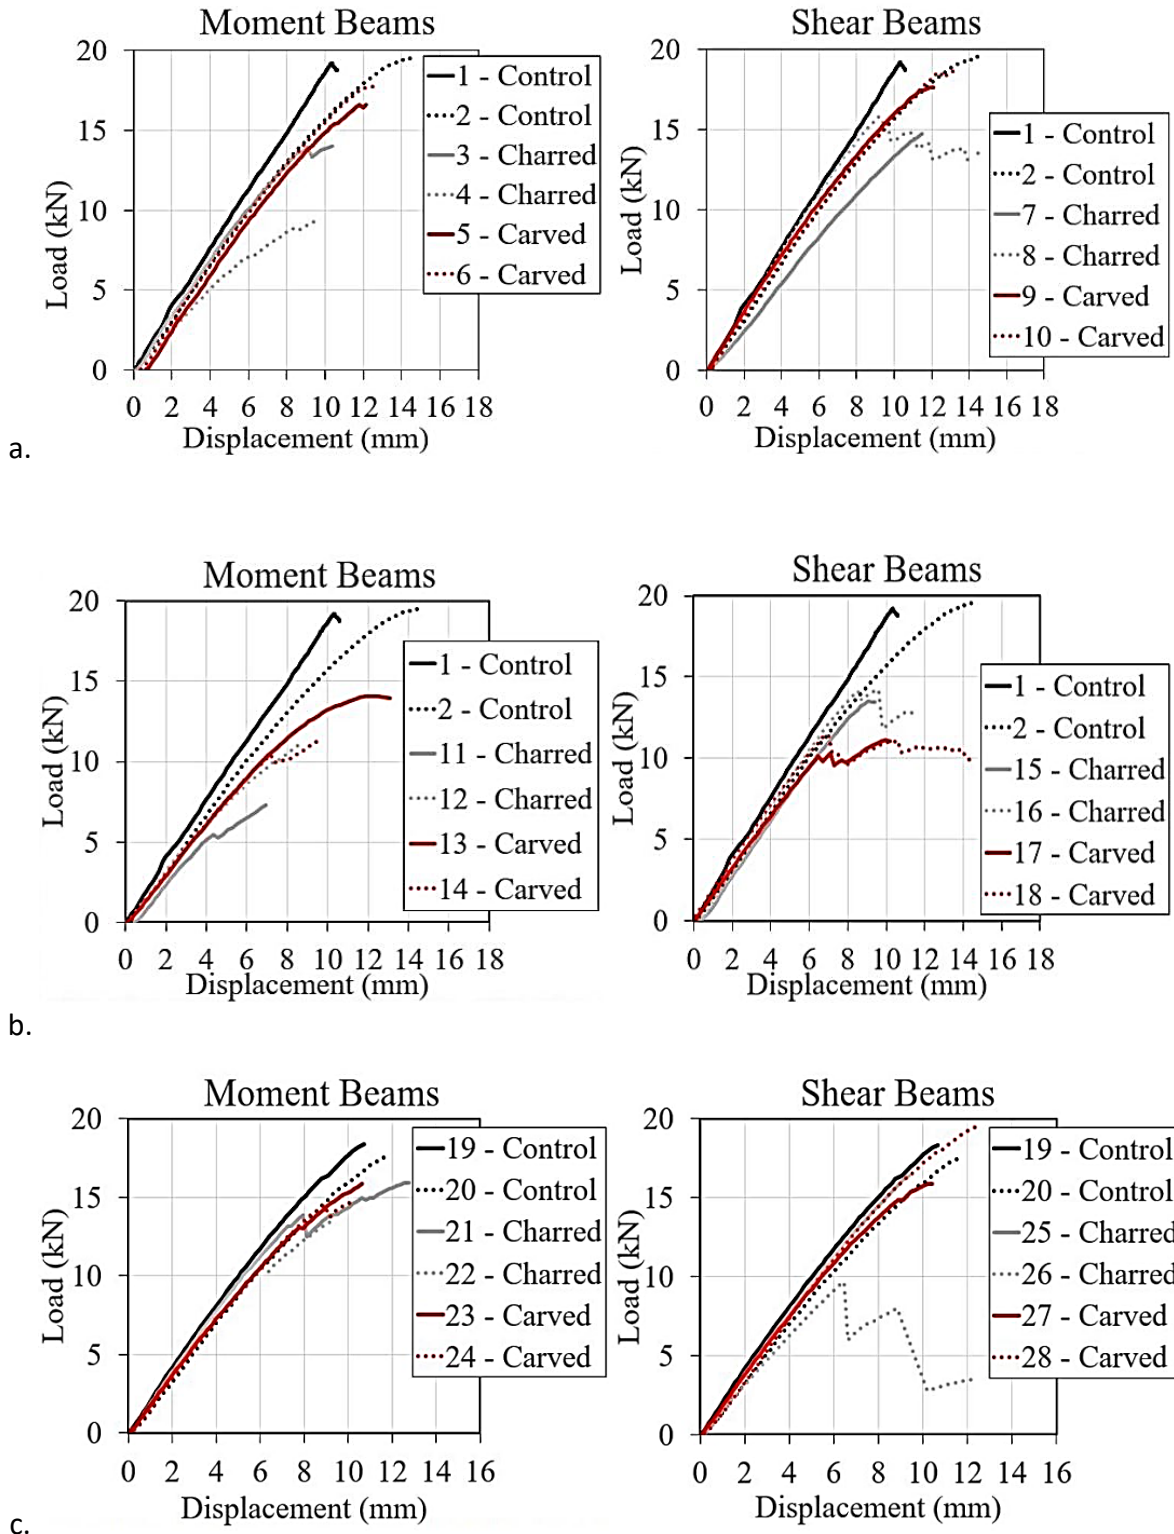
**Fig. 7** Load versus displacement curves a. LVL at the 5 mm char depth, b. LVL at 10 mm char depth, and c. Glulam at 10 mm char depth

DIC was used to plot the load versus displacement curves for all the beams. These graphs may be seen in Fig. 7. One of the LVL shear beams charred to 5 mm in the shear region had its capacity drop suddenly a number of times (denoted by Sample #8 – Charred). This beam failed by gradually deflecting, and ultimately cracking in its damaged region. This was also the failure mode for the other charred beam, though they did not exhibit such a sudden failure. This discrepancy may be explained a possible material defect within the LVL, causing it to fail at a lower load than expected.
