# Performance of Type X Gypsum Board on Timber to Non Standard Fire Exposure

Manuscript as Accepted in Fire and Materials Journal

(Manuscript Author order: Chorlton, Forrest, Weckman, Gales)

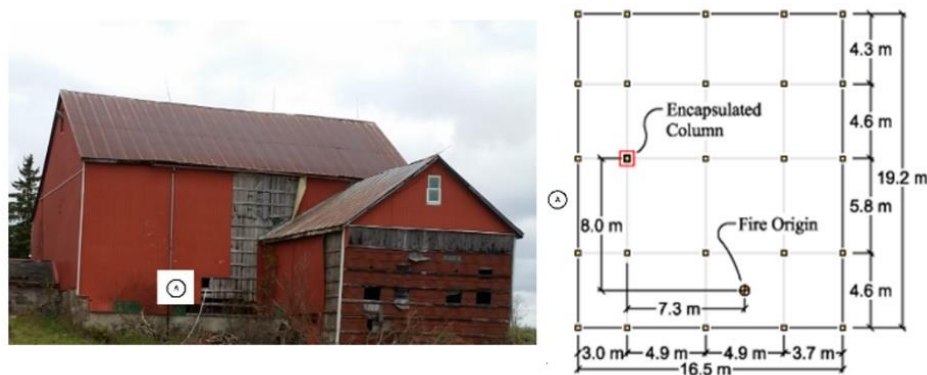
**Figure 2.** Back side of timber farm structure (left), and atrium dimensions (right- annexes not rendered).

Although the structure was relatively empty of contents, some mixed hay, as well as small amounts of loose lumbers, books, and plastic tarps remained. The primary fuel source for the fire was therefore the exposed timber of the barn. A full structural survey and material condition assessment of the structure was conducted prior to burning. It was determined through this examination that the timber structure was decaying along the exterior frame. This well - ventilated farm structure should not to be construed as typical of any new farm or even residential/commercial structure, but its structural components do provide value as well as opportunities for assessing timber construction behaviour in high temperature exposures. The interior timber column taken under consideration was in good condition, of Oak timber species, with no evidence of rot or decay through analysis (pull out of screws, field tests for rot, etc). This column was ideal to be encapsulated to study its behaviour under fire exposure (denoted as Column 1 herein). The dimensions of the column were 230 mm x 267 mm, which was similar to the size of columns used in existing tall timber structures in Canada. It was hypothesized (and later confirmed) that the column was also unlikely to be affected by any collapsing debris surrounding it that the structure might impose (ie., it was expected the column would remain standing without debris impact for most of the duration of the test). It was also assumed that the column chosen had similar loading to surrounding columns due to the rectangular column grid. The column had no additional loading beyond service loads. Figure 2 shows the structure's condition, appearance and dimensional features illustrating the column.

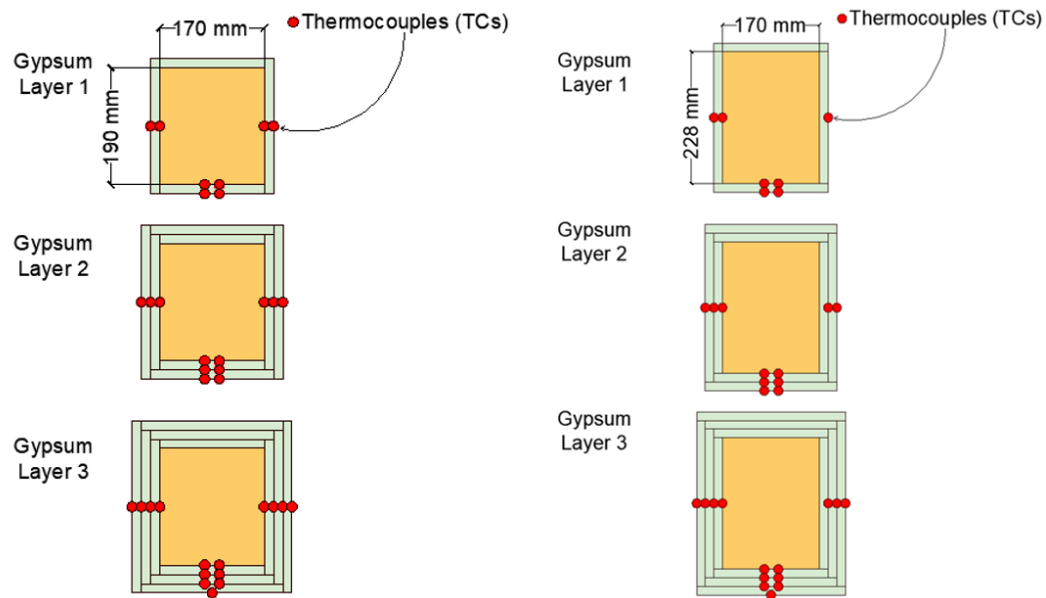
**Figure 4.** Laboratory encapsulated column thermocouple placement Column 2 (left) and Column 3 (right).

unreliable in recording board surface temperature exposures as visual indicators illustrated that they detached in testing. Figures 4 and 5 show the thermocouple configurations for each column (2 to 5). The columns and screws were not finished as it was of interest to also observe the possible effects of heat transfer through the screw to the timber (worst case).

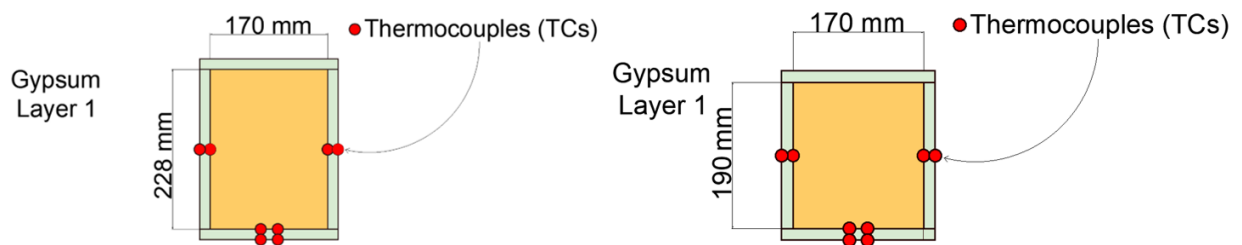
**Figure 5.** Laboratory encapsulated column thermocouple placement Column 4 (left) and Column 5 (right).

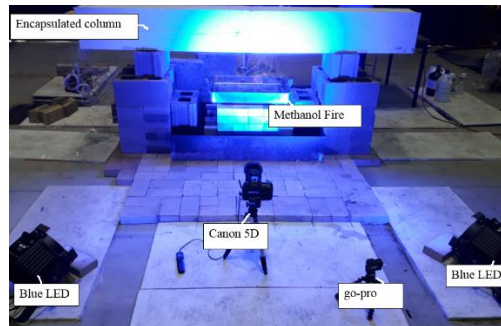
**Figure 7.** Specimen, apparatus, camera and LED light locations

Following the previous technique validation produced by Gatien et al. [14], qualitative observations and quantitative measurement during testing was performed using narrow-band spectrum illumination and image processing in order to study qualitative changes (cracking/delamination) to the gypsum board at high temperature, as well as approximate deformations and deflection of the columns during testing. The use of narrow-band spectrum illumination and matched optical filters can enhance visibility through clean burning flames [15]. Such a technique has defensibly been shown applicable in laboratory scales (flame spread testing using a LIFT for example). The technology has not yet been adapted nor defended for use in standard furnace (enclosed) fire testing (but such testing is outside the scope of this research). Verification and modification of the technology should be considered for that application in future research. The authors utilised the exact experimental and camera specifications derived from the Gatien et al. study [14] to observe the columns when exposed to the methanol fires. The lab set up included two Spectra Par 100-Watt luminaries with all blue (450 nm wavelength) Light Emitting Diodes (LEDs) to illuminate the sample (see Figure 7). A Canon EOS 5Ds Mark III DSLR camera was used to image the column specimens, this was placed 1.5 m away from the column at an angle of 17 degrees. This camera's resolution (images of 5792 x 8688 pixels) allows placement far away from the specimen during testing to maintain high resolution of the specimen, while reducing the risk of damage to the camera and lenses due to excessive heating and thermal radiation from the pool fire. The following camera settings were used due to the influence of previous research by Gatien et al. [14]: frame rate of 5 frames per second, ISO 2000, aperture f/13, shutter 1/800. A bandpass optical filter consisting of two stacked filters (HOYA Corporation B440 and Midwest Optical Systems BP470) were attached to the front of the camera's default lens. These two stacked filters provided a low-cost and effective band-pass filter at the desired frequency (450 nm). The camera was shooting at an angle, which was measured in order to translate downward and upward movement of the column in these tests into a measurable deflection. Geo-PIV RG [16] was utilised for approximating quantifiable deflection and seam deformation measurements. The technique is considered as an approximation and not a definitive calculation as the technique is not fully adaptable to a material undergoing a phase change. Gypsum boards lose their first coating (paper) layer through combustion and the application of tracking paint is therefore prohibitive. The interested reader is encouraged to read about image correlation limitations further [17].

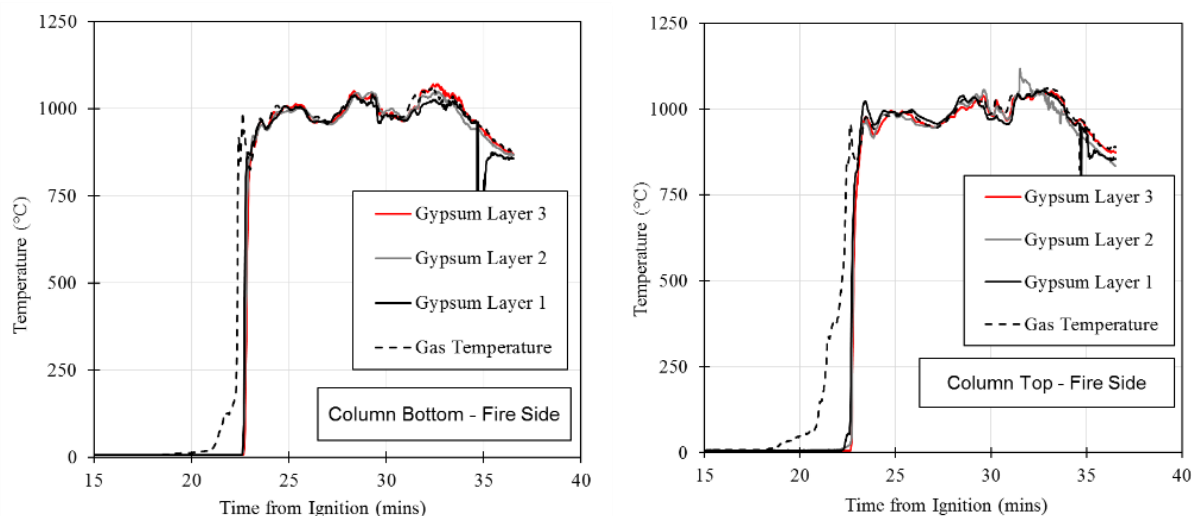
**Figure 8.** Fire side temperatures measured at (left) the top of the Column 1, and (right) the bottom of the Column 1 (t= 0 ignition)

The performance of Column 1 was evaluated primarily through examination of the temperatures reported by the thermocouples and through recorded video footage as plotted and illustrated in Figures 8 to 11. In the plots shown in Figures 8 to 10 below, Gypsum Layer 1 refers to the thermocouple under one layer of gypsum, Gypsum Layer 2 under the second layer, and Gypsum Layer 3 is between the inner most gypsum layer and the timber column itself. Gas temperature refers to the temperature measured by a thermocouple placed on the outer most layer of gypsum board at the top and bottom of the column on both sides. Fire side refers to the side of the column facing the room of fire origin, and the non-fire side refers to the opposite side of the column (not facing the room of fire origin). While cameras were placed throughout the interior and exterior of the farm structure, the thick flames and smoke made it difficult to see the column within the structure and, in particular the gypsum board encapsulation after the initial period. While it is beyond the scope of this manuscript to discuss the resulting fire dynamics, in brevity temperatures were only recorded at the column location, and the thermocouples were manually terminated by the authors as structural collapse was considered possible and the data acquisition unit had to be retrieved. The structure eventually collapsed approximately 30 minutes beyond the steep temperature rise. It is not possible to deduce temperatures beyond when the thermocouples were taken off line.

From Figures 8 to 10, it is seen that the gas temperatures away from the column rise sharply at 20 minutes after ignition when the fire exposure spreads to the column's location (Figure 10). Within two minutes, rapid heating occurs, and all of the temperatures beneath each layer of gypsum board rise quickly above 1000°C. This behaviour can suggest several aspects relating to cracking of the board, and sealing effect – where fall off of (all) the gypsum board layers is ruled out, as discussed below.

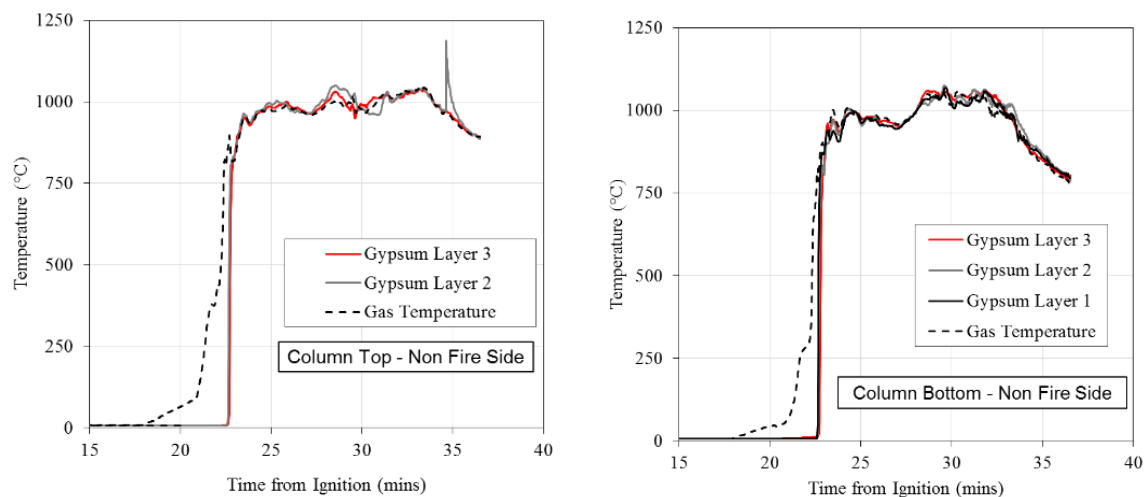
**Figure 9.** Non-Fire Side temperatures measured at (left) the top of the Column 1 and, (right) the bottom of the Column 1

the layers. From Figure 9, which focuses only on times around the sudden temperature rise (plotting scales between 22 and 24 minutes), it is seen that the gas temperature rises first, followed by the thermocouple covered by one layer of gypsum, then two layers, and finally the thermocouple at the face of the timber rises in temperature last. These hypotheses suggest that the gypsum board had probably not fallen off at this point as is visually confirmed in Figure 12, and instead hot gases were able to penetrate between layers through an unconfirmed mechanism (at this point). It can be clearly shown that at least one layer of the gypsum board seems to be fastened to the column despite the rise in temperature measured in all layers of the field study – it is therefore doubtful that the simultaneous rise in temperature in all layers was observed because all layers fell off. The exact mechanism cannot be determined without examining the column itself in-situ. Post-fire in-situ investigation was prohibited by the fire department in attendance due to concerns for smoke exposure and its contamination to the materials. In any case, these results suggest that the gypsum board was not successful in functioning fully to burn-out of the fire – at least in terms of performance objectives where heat transfer is concerned. This particular field study therefore justifies additional investigations being required to determine the true influences from board cracking, sealing and fall off in controlled tests performed at laboratory scale.

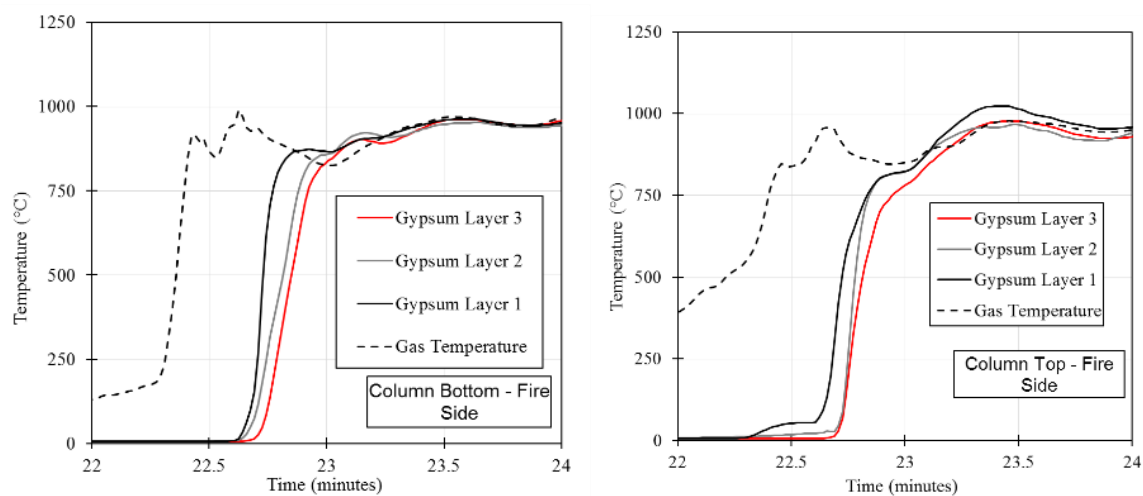
**Figure 10.** Scale magnified of fire side temperatures measured at, (left) the top of the Column 1, and (right) the bottom of the Column 1 ( $t = 0$  ignition)

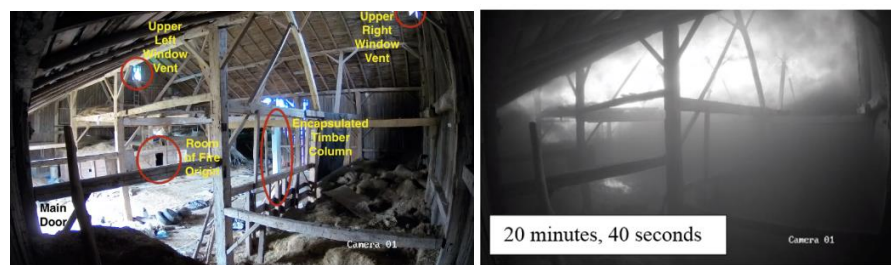
**Figure 11.** Pre heating view of compartment prior to fire ignition (left), atmosphere of compartment when fire spreads to column (right)

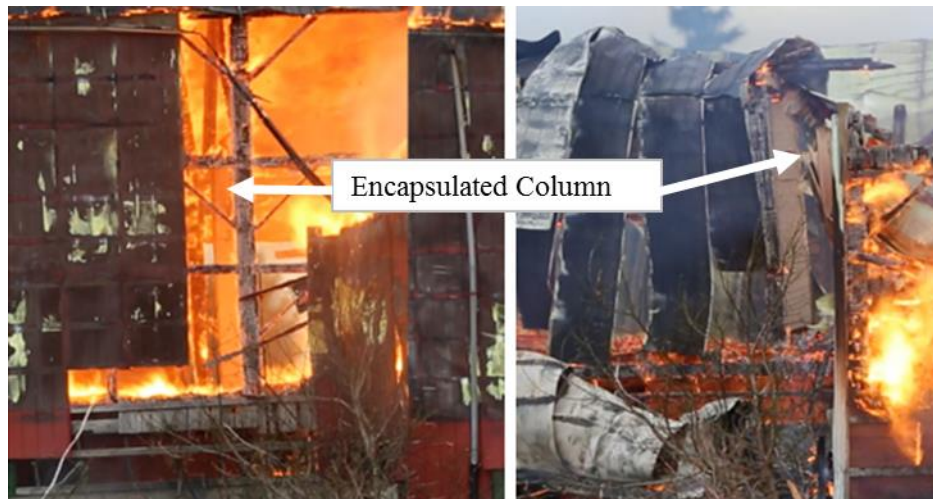
**Figure 12.** Images of Column 1 during field test (left) prior to structural collapse (right) post flashover event

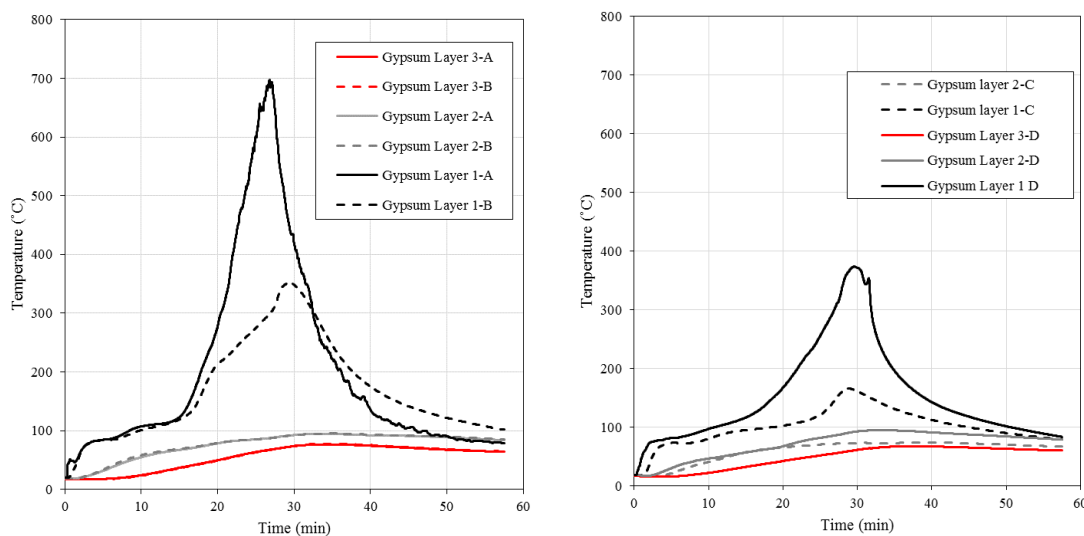
**Figure 13.** Recorded temperatures between the gypsum board layers for Column 2 (175x190x2532) (Note: TC 3C was not installed properly)

The performance of the timber columns (2 through 5) within the laboratory study were evaluated first through examination of the temperatures reported by the thermocouples as plotted in Figures 13 to 16. In these plots shown, for Columns 2 and 3, Gypsum Layer 1 refers to the thermocouple under one layer of gypsum, Gypsum Layer 2 under the second layer, and Gypsum Layer 3 is between the inner most gypsum layer and the timber columns themselves. Where Columns 4 and 5 have only one layer for consistency it is called Layer 1. Exposed surface and Gas temperatures were unreliable measures in these tests as the thermocouples appeared to delaminate visually from the surface during testing. For the thermocouples underneath at least one layer of gypsum, it could not be entirely verified whether the thermocouple was measuring the gas temperature immediately below the surface of the column, or if the temperature was being measured on the surface of the gypsum which was lower. However, as exact quantities of fuel are given as well as burning rates of the fuel (burn rate of approximately 0.5 L/min) it is possible for the interested practitioner to characterize the exposure if they wish to utilise the results for modelling or replication purposes (which are beyond the scope of this paper). Careful examination of fire dynamics text book literature provides information on repeatability and quantification of heat exposure from pool fires [18].

Figures 17 to 19 are provided to place the temperature profiles into context. Column 2 has a noticeable increase in temperature during the heating portion of the test, increasing to

temperatures of 700°C and 350°C between the 1<sup>st</sup> and 2<sup>nd</sup> gypsum board layer. It is not unexpected that the temperatures do not measure the same between them, on forensic post-fire examination it was observed that these thermocouples were located in the region that coincided with charred zone of the timber. Whereas in Column 3, which showed no temperature incline in the temperatures recorded by the thermocouples, examination post-fire showed that these thermocouples were installed away from this charred zone on the second gypsum layer as observed in Figures 17 and 18. This behaviour gives credence that the fire exposure between the first and second boards likely occurred at an isolated location near the seam, resulting in a localized charred area and not along the full length of the column, as it was only a localised fire exposure. The results seem to verify the temperature measurement trends and hypothesis observed in the field study that indicated temperature rise through penetration between the gypsum layers. In the controlled case, however, the temperatures measured beyond the second layer of gypsum board did not exhibit a spike increase in temperature. Temperatures do discretely rise as expected with duration. The penetration of heating in these tests is likely due to the larger seam opening in the first gypsum layer which correlates to a partial delamination of the gypsum board as tracked through narrow spectrum and image filtration technologies (sometimes called blue light technology). Column 2 illustrates a potential fall off (peel away) of the board in progress as the heating duration halted seen in Figure 20. The post-test examination of Columns 4 and 5 reveals the extent of char damage below the board. Figure 15 reveals that ignition of the Column 4 had occurred during the cooling phase of the tests manifesting as a smouldering fire under the side boards away from the fire. Once the boards were removed after 30 minutes of cooling, the fire was damped out with light amounts of water. Excessive smoking also occurred for these columns post heating phase confirming a small self-sustaining (without additional application of heat) fire. Figure 19 illustrates that Column 4 developed a 25mm deep crack running along the entirety of the heated zone beyond the charred zone which was not present during the installation of the gypsum boards pre testing. Figure 16 does not show evidence of a fire event on the side boards of the column, though analysis after the test revealed thermocouples C and D for column 5 were not in the charred region of the column.

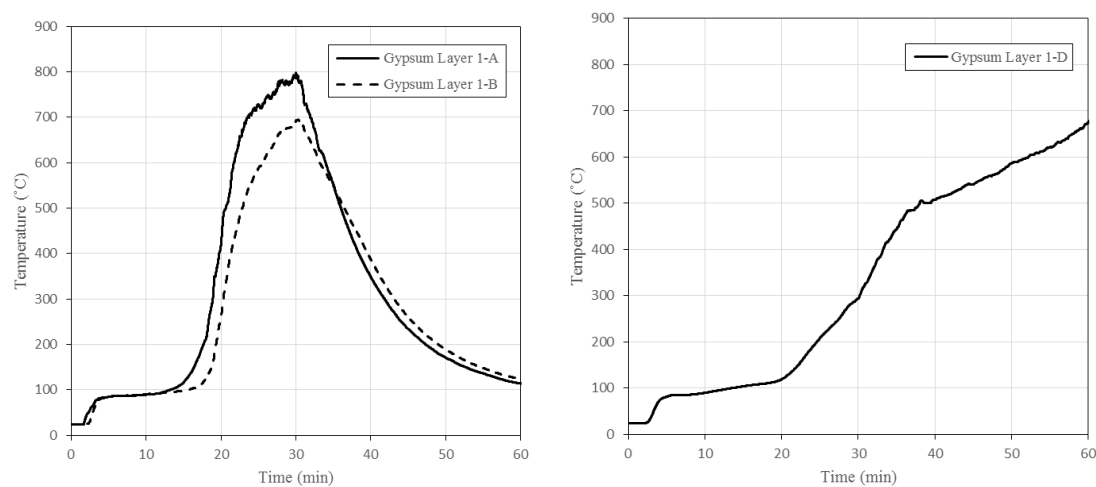
**Figure 15.** Recorded temperatures between the first and second gypsum board layers for Column 4 (175x228x2532) (Note: TC 1C was not installed properly)

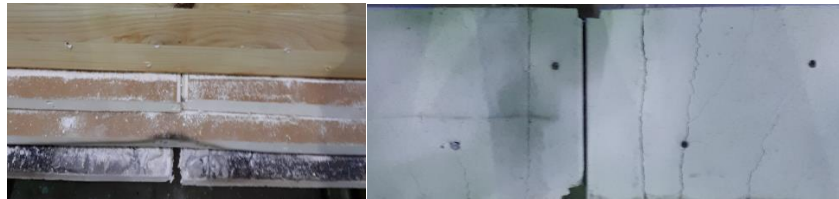
**Figure 17.** Post-fire 'seam' opening in Column 3

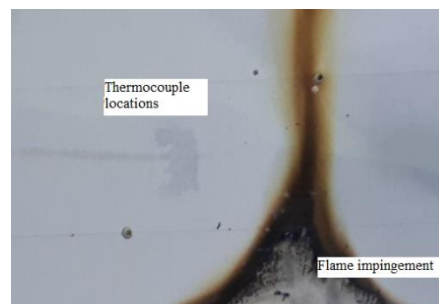
**Figure 18.** Flame impingement after fire of Column 3

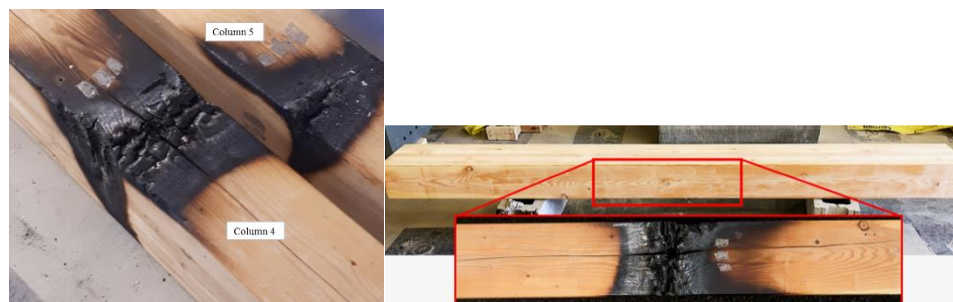
**Figure 19.** (left) Post-test condition of Columns 4 and 5 (right) post-fire cracking of Column 4 (note Columns 2 and 3 showed no signs of char damage)

should be noted that the second and third layers of gypsum upon removal during post heating assessment illustrate no visible damage. However, columns 4 and 5 with only 1 layer of board illustrate maximum charring depths of 25 and 15 mm respectively spanning a length of 41 and 29 cm respectively for a maximum 1cm seam opening during the test. While the metallic screws utilised were hypothesized to have potential to transmit heat to the timber below the board, it was observed upon extraction of the screws outside central charred locations that no evidence of localised charring was present in the timber screw holes for post-test evaluation for all tests. A longer heating duration should be explored to test the amount of potential heat penetration into the timber column through the screws. But overall these remained fixed for the duration of all Column 2 to 5 tests.

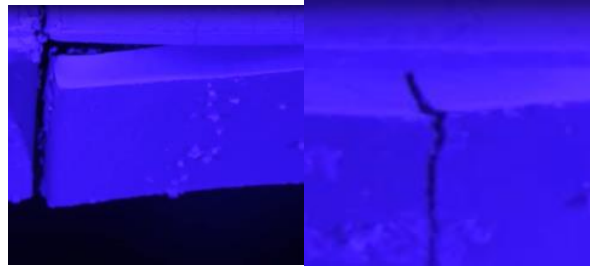
**Figure 20.** Delamination and cracking action of Gypsum Board at seam Column 2 during heating

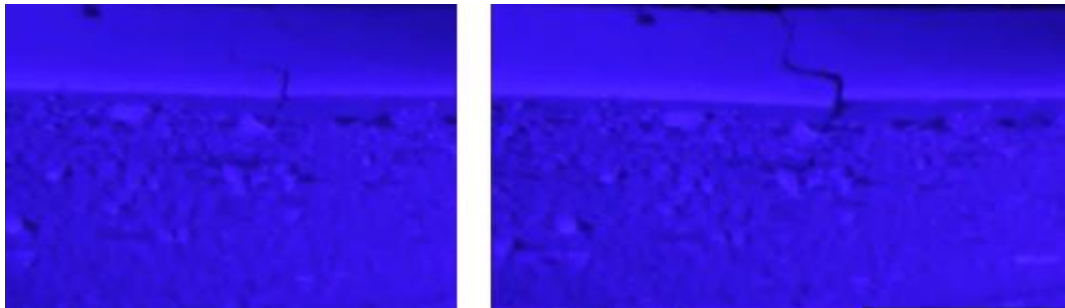
**Figure 21.** Crack opening after heating in Column 3 (left at end of heating, right at end of cooling)

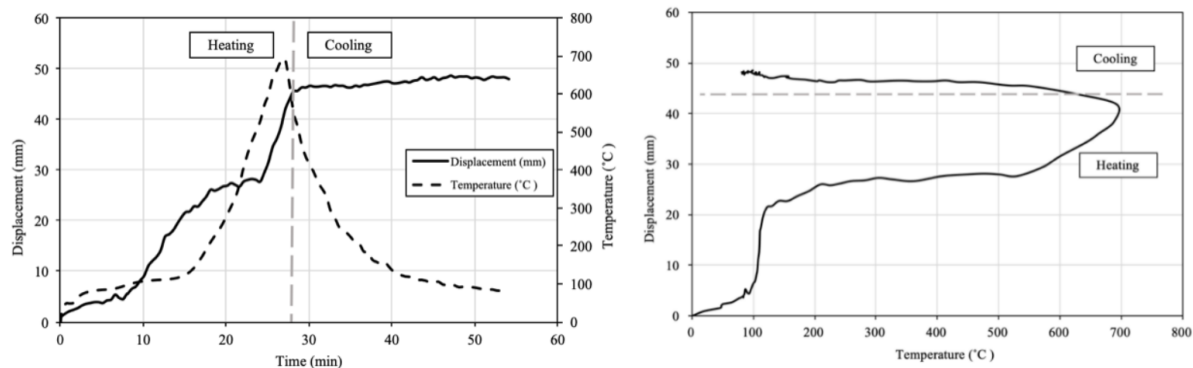
**Figure 22.** Peel away of soffit gypsum board in Column 2 with respect to time and temperature (temperatures are those recorded by Gypsum Layer 1-A)

Table 3 quantifies the exact deflections and seam opening measurements taken from the image analysis. Figure 22 illustrates the measured fall off behaviour with respect to temperature of Column 2. It is supported by the narrow band spectrum illumination technology that fall off/delamination behaviour is driven predominately by the dehydration of the board (100°C) to when fall off of the board will initiate and is not linked to a specific temperature. Seam openings exaggerated in size during the cooling phase and were substantially large for penetration of air to the surface of the timber, particularly if the board began to peel away from the columns as seen in these tests.
