Structural Repair of Fire-Damaged Glulam Timber

Article in *Journal of Architectural Engineering* · March 2021

As accepted in the Journal of Architectural Engineering

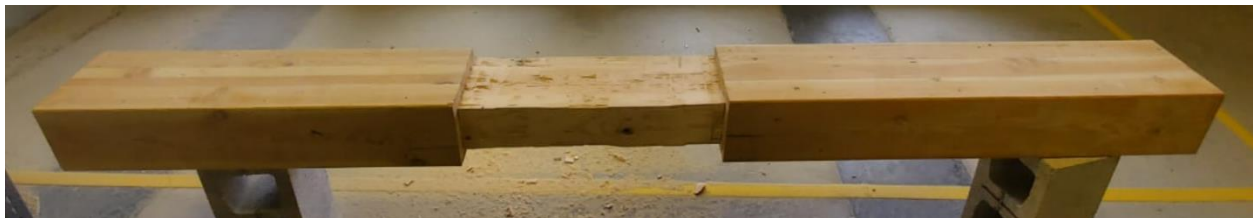
Fig. 2. Carved member before repair.

The carving procedure consisted of using a saw to create guides of a specified depth along the damaged region of the members. The majority of the damaged material was then removed with a chisel. A belt sander was then used to create a smooth and uniform surface, precisely to the desired depth. A carved member before repair is seen in Fig. 2 (where the sides of the member are parallel to the floor, and the bottom is towards the camera).

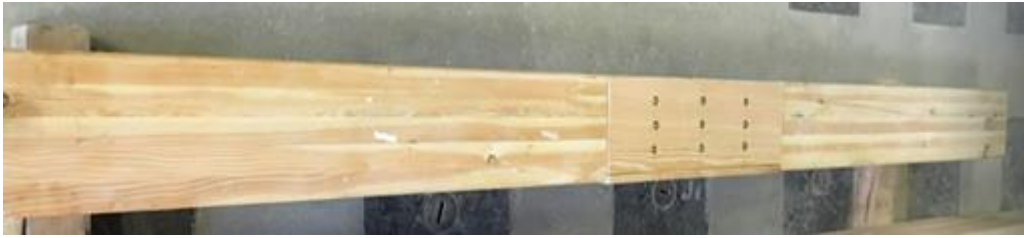
Fig. 3. Side of a repaired member.

The members were repaired using new laminates of timber of the same species and equivalent grade (per NLGA Standard Grading Rules for Canadian Lumber (National Lumber Grades Authority 2017)). The panels were cut to the appropriate size and planed to the appropriate depth, such that they would fit in the areas that were previously carved out. The panel along the bottom of the member spanned the entire width of the member (175 mm), while the panels along the sides of the members were in line with the top of the member, and the top of the bottom panel. This configuration was chosen to maximize the potential to recover strength from

the contributions of the bottom panel, where the tensile stresses would be highest. A side panel is seen in Fig. 3.

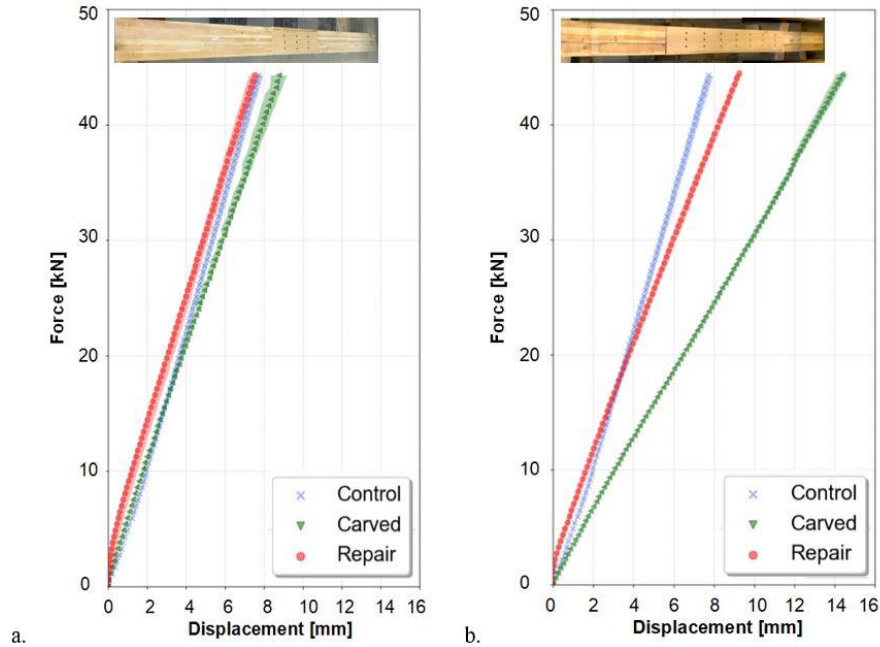
Fig. 6. Loading and unloading of the members of 175×190 mm cross section: (a) Members 1 (control) and 3 (previously encapsulated); and (b) Members 1 and 5 (previously exposed).

The results of loading the members to 45 kN are seen in Fig. 6 and 7. Note that in Fig. 6 and 7, each data set represents the average of the three trials, where shaded areas represent standard deviation across trials. It should also be noted that in Fig. 6 and 7, the displacement determined is from digital image correlation, and the force is the total force from both point loads. Fig. 6 shows that the members which were originally smaller in cross sectional area (Members 1, 3 and 5) saw a significant recovery of stiffness. Member 5, which was previously directly exposed to the fire and had more extensive damage (and therefore a greater repaired area), deflected 5.1 mm less once repaired (versus when carved), bringing the total repaired deflection to only 1.4 mm

more than the control member. Member 3 which had a smaller repaired area had 1.2 mm less deflection than it did prior to repair. Because the initial degree of damage of the carved member had a deflection not significantly greater than the control member, the repaired member had less deflection than the initial control member.

From Fig. 6 and 7, it is seen that in all cases, the repaired members were able to recover some stiffness compared to the carved members, although to varying degrees. The repairs of the members which were smaller in cross section (Members 3 and 5) both resulted in significantly less deflection compared to the carved members. Member 3 was able to regain sufficient stiffness such that the deflection of the repaired member was less than the deflection of the carved, and even control member. Maximum deflections of all members are seen in Table 4. The relatively strong performance of Member 3 may be due in part to the notion that the carved member did not deflect significantly more than the control member. When the repair was performed, the increased stiffness was sufficient in enabling the member to deflect even less than the control member. Moreover, Member 3 was the repaired member that held the greatest percentage of the failure load of the control member of the corresponding size (66%). Thus, while the member regained a promising amount of stiffness when loaded to 45 kN, it still failed at a lower force than the control member.

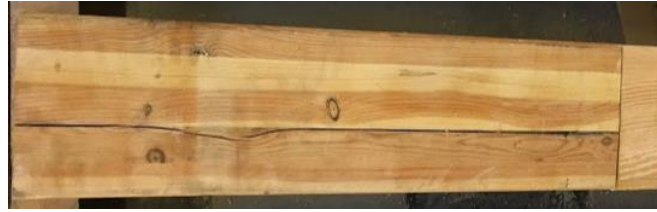
Fig. 9. Side of Member 5.

The failure load of Member 5 was 57% of the control failure load. This is less than the capacity of the other repaired member of the same size (Member 3 that failed at 66% of the control load). One factor that could have played into the low failure load of Member 5 (relative to Member 3) was cracks that were present along the side of the member (primarily along the adhesive lines). These are seen in Fig. 9 and were present after the fire exposure of the member (before any mechanical loading). While this crack or delamination may have a different effect on the structural performance of the member if loaded in compression (as is typically done for Glulam members of 16c-E stress grade, where cracking can impact the moment of inertia reducing buckling capacity of some columns), it will also impact the member tested in bending. The presence of these cracks may have reduced the capacity of the member and made it more difficult to achieve composite action. The effect of cracks and delamination in Glulam members is also something that needs to be considered with regards to repair. Cracks occur in many timber structures, both historic structures as well as structures that were constructed relatively recently. Cracking and delamination in the column of a contemporary timber structure in Toronto, Canada is seen in Fig. 10, where the structure was constructed in 2015, with the photo taken four years later. The column seen in Fig. 10 shows both delamination along the adhesive lines as well as within the timber itself. The presence of cracks and delamination in timber members complicates both the structural and fire performances of the member, as well as the repair procedure. The effect of cracks and delamination in timber should be addressed in future research, with regards to the structural fire performance as well as how they may impact the repair.
