**THE THERMOMECHANICAL RESPONSE OF STRUCTURAL TIMBER IN REAL  
FIRE EXPOSURES**

A DISSERTATION SUBMITTED TO THE FACULTY OF GRADUATE STUDIES IN  
PARTIAL FULFILLMENT OF THE REQUIREMENTS OF THE DEGREE DOCTOR OF  
PHILOSOPHY

GRADUATE PROGRAM IN CIVIL ENGINEERING  
YORK UNIVERSITY  
TORONTO, CANADA

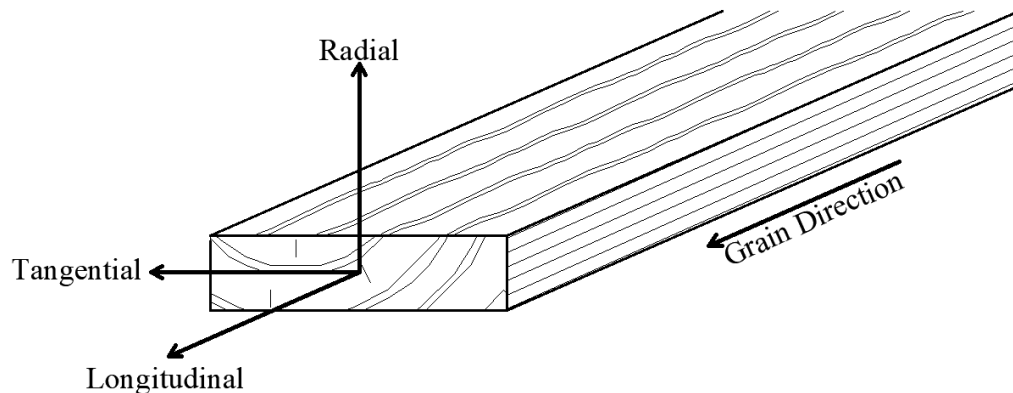
In order for the thermomechanical response of timber to be evaluated, the fundamental material properties must first be understood. Timber is a somewhat unique building material in that it is orthotropic due to the orientation of the grain. The three axes directions are relative to the grain direction and growth rings; longitudinal (to the grain), tangential (to the growth rings), and radial (radial to the growth rings and perpendicular to the grain). In structural engineering, timber is typically considered to be either parallel or perpendicular to the grain (longitudinal or radial directions, respectively). In general, timber is stronger when loaded parallel to the grain, and weaker when loaded perpendicular to the grain.

Figure 2.1 Timber axes relative to grain orientation and growth rings (adapted from [13]).

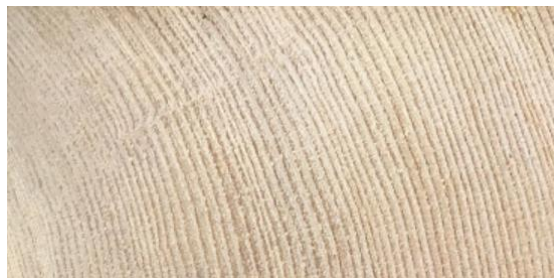
When trees grow, they grow outwards through the development of growth rings. New wood cells are produced on the inside of the bark, producing earlywood and latewood. Earlywood is developed earlier in the season (typically the spring), and usually has cells with large cavities and thin walls, while latewood (which develops later in the season) has smaller cavities and relatively thicker walls [14]. Earlywood is lighter weight and weaker than latewood, attributed to the higher density of latewood [14]. In seasonal climates, earlywood and latewood will be different colours (with the latewood being darker than the earlywood), allowing the approximate age of the tree to be counted as one year per growth ring. Trees may grow more than one growth ring per season if the growth cycle is interrupted (by droughts or other reasons) or may not have any defined growth rings (due to species or climates with indistinct seasons). Factors such as the speed of growth may have an effect on the size of growth rings and density of the wood, however, researchers have not unanimously agreed on this correlation [15].

Figure 2.2 Growth rings as seen on a piece of Pine timber (author's photo).

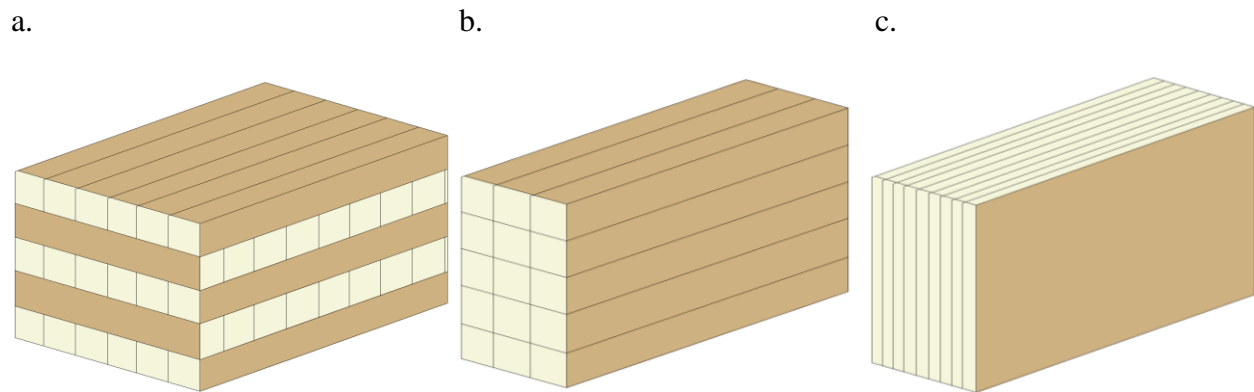
walls or floors and uses layers of timber alternating in direction. Glulam is often used for beams or columns and uses small sections of timber all in one direction. Laminated veneer lumber is also used for components such as beams and is built up by multiple very thin laminates of timber, again oriented in the same direction. All of these engineered timber products are adhered together. Examples of these products are shown in Figure 2.3.

Figure 2.3 Examples of engineered timber, a. CLT, b. Glulam, and c. LVL.

Engineered timber products, such as Glulam and Cross Laminated Timber (CLT) are being used increasingly in larger and more complex structures (cross sections of engineered timber types are seen in Chapter 2, Figure 2.3). As previously discussed in Chapter 4, one notable demonstration project is the Brock Commons Building in Vancouver, Canada. It is a demonstration-style engineered timber structure as it exceeded height limitations at the time of construction using an exemption in the British Columbia (regional) building code. In this building nearly all Glulam and CLT elements were encapsulated with multiple layers of fire rated gypsum board, from which the timber elements achieve their required fire resistance [93]. Standing at 18 storeys (53 m) high, the Brock Commons building was the tallest timber building at the time construction was completed in 2017. A few years later however, the Norwegian Mjøstårnet building was completed in 2019, standing at 85 m tall. This structure was constructed of CLT and Glulam, much like the Brock Commons building, however in this case the fire protection strategy considered the performance of the timber itself (in conjunction with other strategies such as fire retardant paints, gypsum board encapsulation in stairwells, sprinklers, etc.) [94]. From these two case studies, a couple of observations are made. First, there has been an increasing desire to build taller structures, as

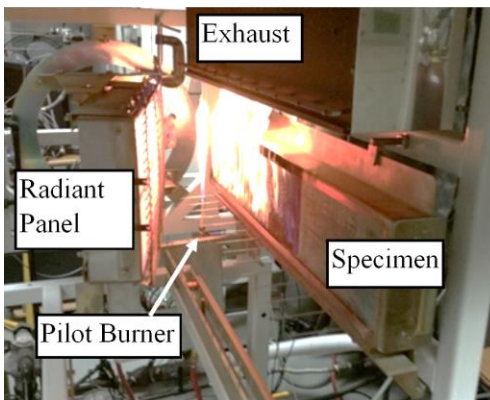
the amount of molecular energy of a material compared to a reference. The setup of the LIFT consists of a few key components. The first is a specimen holder, of which a specimen of approximately 155 x 800 mm could fit into. Along the bottom of the specimen holder is a series of pegs, spaced 50 mm apart (the pegs allow for flame spread to be visually tracked along the specimen during testing). Facing the specimen is a radiant heater (where radiation is heat transfer through electromagnetic waves). The radiant heater is placed at an angle to the specimen, such that it is closer to the specimen at one end and further away at another. This introduces a heat flux gradient along the specimen. The final component is the pilot burner, increasing the likelihood of ignition. Above the test specimen, smoke is collected by an exhaust. The LIFT setup is seen in Figure 2.4. The heat flux of the apparatus is calibrated prior to testing the specimen by reading the incident heat flux with a heat fluxmeter (a water-cooled sensor) at 50 mm intervals. The accuracy of the heat fluxmeter of a LIFT apparatus is calibrated to  $\pm 5\%$  [16].

Figure 2.4 LIFT test setup.

Tests were also conducted using a LIFT apparatus, following a modified ASTM E1321 procedure (Figure 2.4 – Chapter 2) [16]. The LIFT apparatus is useful for exploratory testing, which can then be used to direct larger scale tests [60]. This is adequate for the purposes of the research herein, which is to begin to compare the fire performance of different types of timber. Like the Cone Calorimeter, the LIFT also uses a radiant heater, though in this case the samples were tested vertically facing the heater and the spark igniter was used. The heat flux of the LIFT apparatus ranges from 50 kW/m<sup>2</sup> at one end of the radiant panel and decreases to approximately 2 kW/m<sup>2</sup> at the other end. The LIFT apparatus can be used for tracking flame spread across the sample. A series of pegs are located along the bottom of the sample holder, and the time at which the flame reaches each peg can manually be tracked. Samples were left in the LIFT for 18 minutes, chosen somewhat arbitrarily as a time which was deemed appropriate for allowing the flame to spread across the samples. Only a subset of timber types were tested in the LIFT, with Glulam – PUR used to represent a contemporary timber, and timber from the Column representing a historic timber. Both timbers were tested with heat exposure perpendicular to the grain. After the samples were removed from the LIFT and had cooled, the char depth and the char front were measured. The char front was measured at the centreline of the beam.

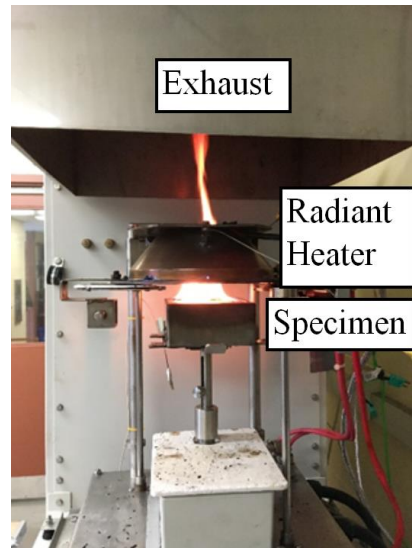
Another test apparatus used for small scale experiments is the Cone Calorimeter. The Cone Calorimeter is used to test samples of 100 x 100 mm. In this test setup, the sample is placed in a sample holder below a coiled radiant heater. The radiant heater can then impose a constant, specified heat flux on the specimen. A spark igniter may be used to increase the likelihood of ignition. The Cone Calorimeter can be used to measure several properties, including the time to

ignition. The apparatus also collects data such as mass loss and heat release rate (the rate at which heat energy is released). The test setup of the Cone Calorimeter is seen in Figure 2.5. The incident heat flux is read prior to testing by a heat fluxmeter. The accuracy of the load cell of the Cone Calorimeter is within 0.1 g, and the accuracy of the heat fluxmeter within the Cone Calorimeter is within  $\pm 3\%$  [17].

Figure 2.5 Cone Calorimeter test setup.

A Cone Calorimeter apparatus was used for testing, following the ASTM E1354 standard. This test setup can be seen in Figure 2.5. The Cone Calorimeter apparatus is useful in allowing for controlled and repeatable tests. Each of the test specimens was exposed to heat for 5 minutes, at a heat flux of  $50 \text{ kW/m}^2$ . The test severity was determined through trial and error, as an upper limit of what an unencapsulated piece of plywood can withstand before charring completely through its depth. After testing, the char depth was measured under the encapsulations. It is of note, that for practicality the testing was not extended beyond 5 minutes or at more severe heat exposures. A material specific test was used to rank performances, further research could be done to explore performance of these materials against more severe testing, however as will be described in Section 4 of this chapter, most heritage material coatings performed poorly in short duration and low heat flux testing.

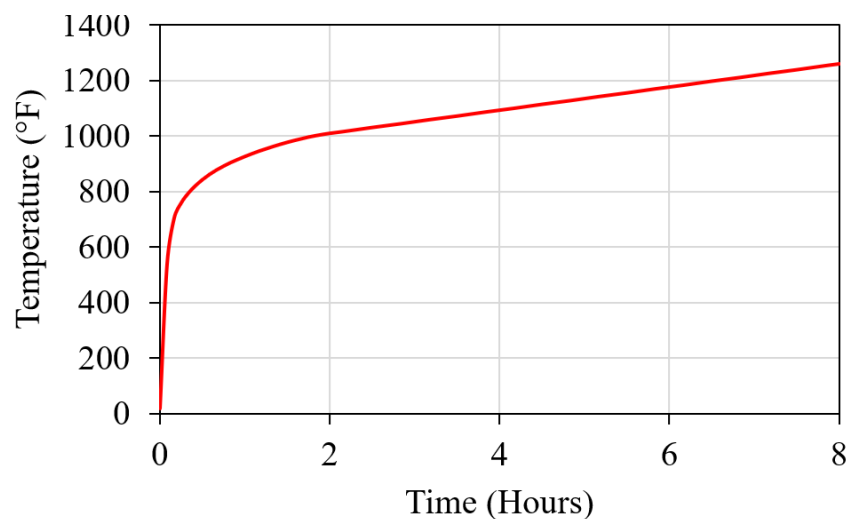
In fire testing, there are several ways to create heat exposure. Many of these can be done using the equipment described in Section 2.2. The heat exposure could be characterized by the heat flux incident on the specimen, as is the case for the Cone Calorimeter and the LIFT. Alternatively, heat exposure could follow a temperature-time curve. A temperature-time curve is a heat exposure in which the temperature of the compartment changes over time. This can be done using a furnace. A common temperature-time curve that is used for fire testing is known as the standard temperature-time heating curve. The standard temperature-time heating curve follows a similar curve in each of the different standards in which it has been adopted, such as ASTM E119, and ISO 834 [18, 19]. The ASTM E119 curve is seen in Figure 2.6.

Figure 2.6 Standard temperature-time heating curve (from [18]).

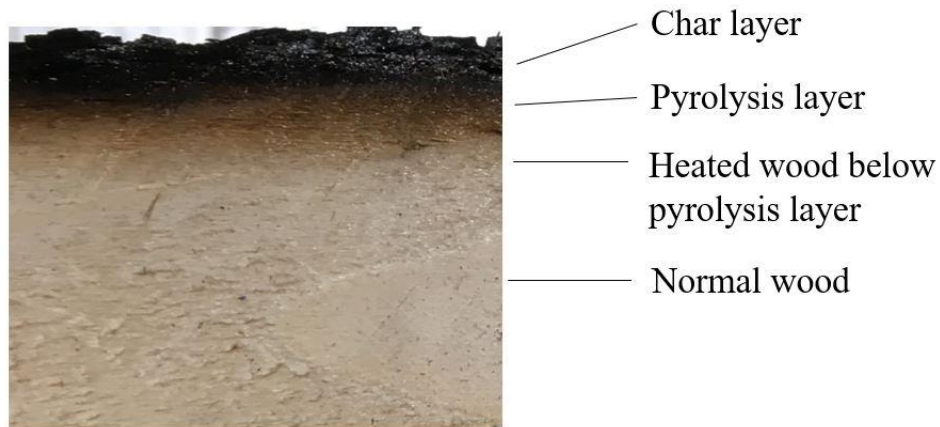
Under extreme heating, wood begins to undergo a process known as pyrolysis around 100°C as its chemical properties begin to change. The wood strength begins to degrade until 300°C which is recognized as the charring temperature of wood, at which point the pyrolysis process has completed and the wood is completely converted to char. The pyrolysis and char layers can be seen in Figure 2.7. After this point, char may continue to develop as the wood behind the char

Figure 2.7 Char formation on a piece of Glued Laminated Timber (Glulam).

was measured (+/- 1 mm) along the centreline. Char depth was assessed visually, with the author's interpretation of the char layer seen in Figure 2.7 (Chapter 2).

The use of timber in tall buildings is challenging since timber is a combustible material [30, 113, 114]. Residual strength of the structural timber members after fire need to be understood to provide in depth guidelines for the designers. Current code allowances enable the calculation of the strength of an engineered timber member after fire [29]. The strength losses can be determined by calculating the char depth and adding an allowance for degradation effects known as the zero-strength layer. The remaining cross-section is considered to be undamaged. Char depth is typically calculated as a function of the time exposed to fire, and the type of timber in consideration. For Glulam and LVL, the charring rate is taken as 0.70 mm/min for notional charring, which accounts for effects such as corner rounding [29, 115]. A visualization of the thermal degradation of wood can be seen in Chapter 2, Figure 2.7.

charred layer as well as a pyrolysis layer), assessed visually by colour with the authors' interpretation of the char and pyrolysis layers seen in Chapter 2, Figure 2.7. Multiple researchers were used to concur on colour interpretation but in all cases definition of char depth was subjective but consistent between specimens.

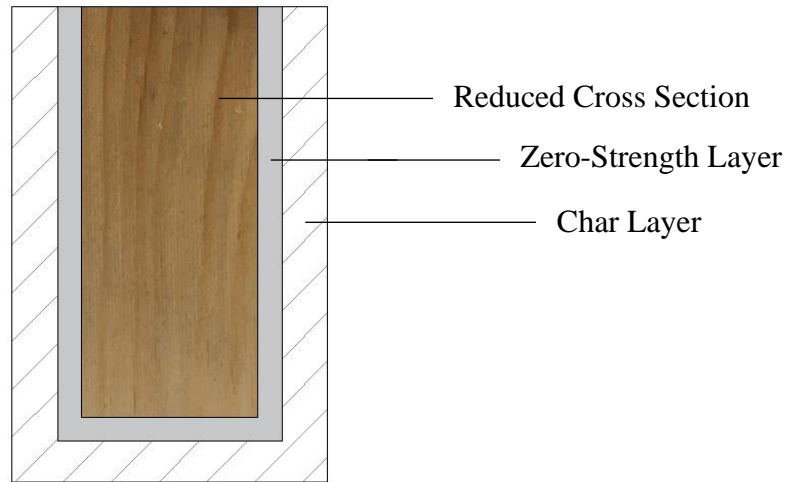
cross-section method' herein) begins by taking the original dimensions of the member, subtracting the char depth and an allowance of additional degradation, known as the zero-strength layer, and assuming that remaining area has retained full strength. A visualization of the reduced cross-section method is seen in Figure 2.8.

Figure 2.8 Reduced cross-section of a timber beam.

As mentioned in Chapter 2 examining the background of timber fire engineering, the reduced cross section method allows for a portion of the cross section of a fire-damaged timber section to be considered undamaged, by subtracting a calculated char depth and zero-strength layer from the original cross section, where the zero-strength layer is taken as 7 mm for fires of 20 minutes or longer (see Chapter 2, Figure 2.8 for a diagram showing zero-strength and char layers) [29]. However, this guidance is in need of review as the current quantification of the zero-strength layer has been debated in recent literature, ranging from 7 to 23 mm depending on the type of fire and the severity [11, 101, 102].

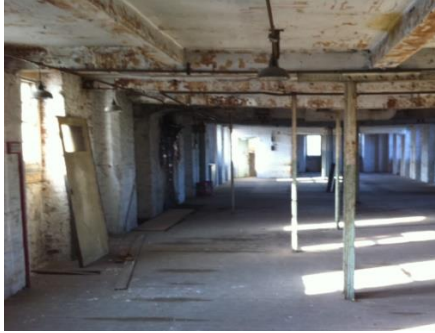
For centuries, building owners and engineers have been implementing methods meant to make timber buildings more secure from fire. Often these strategies involved covering up (encapsulating) the timber with another material meant to improve its fire performance. While the encapsulation materials may have changed through time, this practice is still done today, examples being gypsum products in North America that are commonly recommended for enhancing the fire performance of a timber assembly [29]. A sample of commonly encountered historic encapsulation materials include plasters, metal plates, and lime-based (whitewash) paints. See Figure 3.1 for example of an 18<sup>th</sup> century mill plated with metallic plates covering timber. Note that the plates in this building are by heritage designation not to be removed in renovation.

Figure 3.1 A structure with metallic plates installed in the 18th century (by permission).

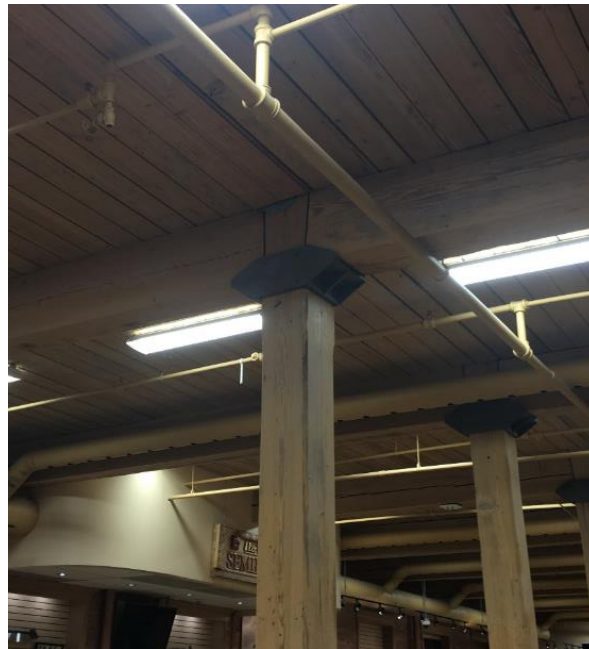
Prior to the use of documented encapsulation methods, timber buildings have long been left exposed. An exposed heritage timber building (currently used as a retail store) is seen in Figure 3.3. In the late 18<sup>th</sup> century, a group of well regarded architects formed a committee (known as the Associated Architects) to deal with the fire problem that they believed was disrupting London, UK, and other cities [41], this committee was formed in response to a recent theatre fire. This association would be later viewed as the precursor to Royal Institute of British Architects (RIBA). Led by Henry Holland, they aimed to identify the causes of the recent conflagrations, as well as methods of preventing similar fires from occurring in the future. The Associated Architects, as they called themselves, described and instructed the use of metal plates and plasters for use as fire protection encapsulations.

Figure 3.3 An exposed timber building, constructed in 1902 as a warehouse in Toronto, Canada (author's photo).

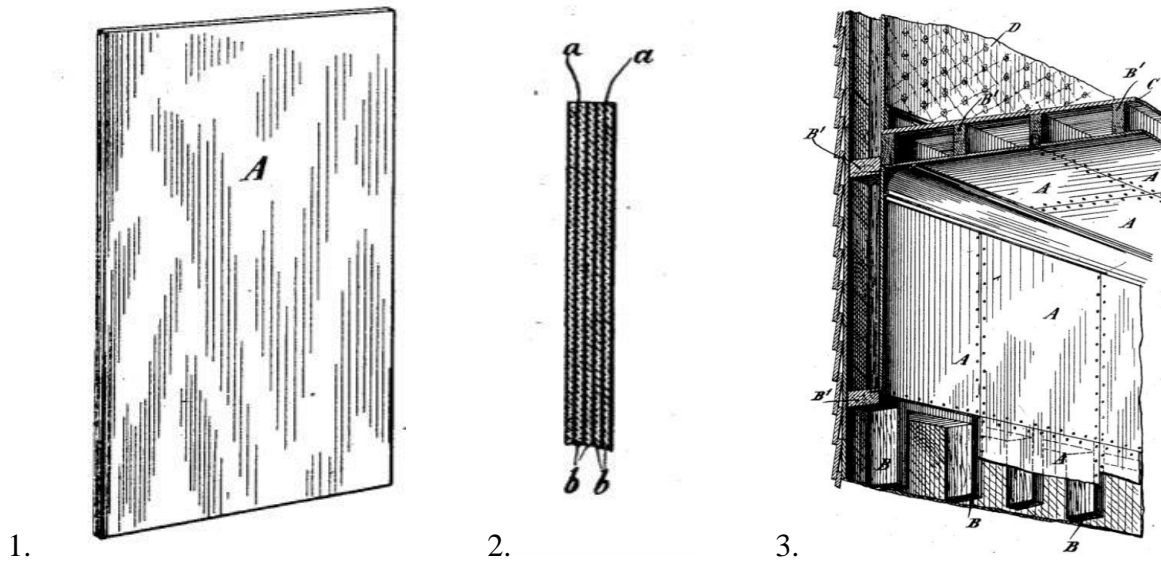
Figure 3.8 Images from Sackett's patent for an interior wall covering, 1. plan view, 2. cross-section view, showing built up layers of paper and calcined gypsum, and 3. possible applications of the boards (from [50]).

The precursor to gypsum board was first documented in the late 19<sup>th</sup> century and was then known as Sackett Board. In 1894, Augustine Sackett patented his inside wall covering [50]. In his patent, Sackett describes a board which is to be applied to the interior walls of rooms, made up of multiple layers of paper and calcined gypsum, which makes a firm and durable wall surface. Sackett also claims his invention to be fire-proof and discourages the use of any materials that soften when heated in the creation of the boards (such as ozocerite and bitumen) [50]. The images included in Sackett’s patent are seen in Figure 3.8. In Figure 3.8, ‘A’ denotes Sackett Board, ‘B’ and ‘B’ denote vertical and horizontal framing respectively, ‘C’ is the floor, ‘D’ is a decorated wall, ‘a’ is layers of paper and ‘b’ is layers of plaster [50]. Gypsum board is still used for fire purposes today, usually considered as a board with a non-combustible core (usually primarily of gypsum), with paper on the outer surfaces [51]. Today, current code provisions in Canada (the thesis author’s jurisdiction) allow for the use of multiple layers of Type X gypsum board to provide a fire resistance rating of 15-60 minutes to timber elements (provided that requirements for joints fastening are adhered to) [29]. In the 1917-1919 column test series led by Simon Ingberg, gypsum board technologies were assessed for the first time to the standard temperature-time heating curve (these tests will be discussed further in Chapter 5) [52]. While the academic community is still studying this technology with respect to installation and fall off in fire, it is relatively understood

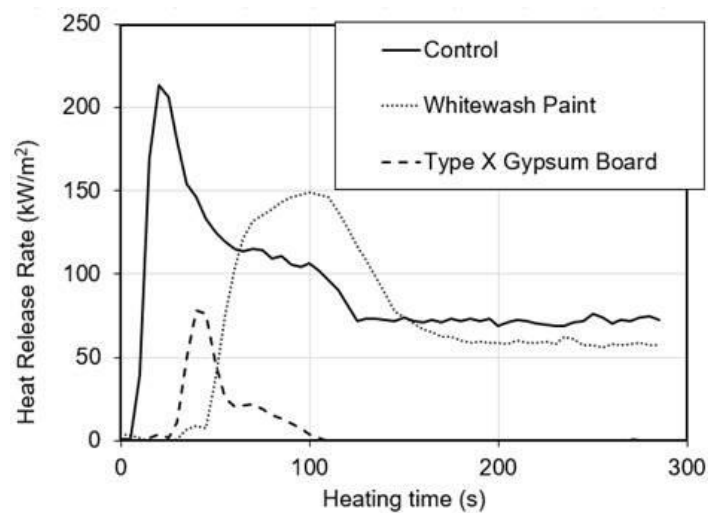
Figure 3.9 Heat release rates over time for the control, whitewash, and gypsum board encapsulations.

Other properties which were recorded include the heat release rates over time. These heat release rates can be seen in Figure 3.9 (all heat release rates represent the average of two samples). This figure shows the heat release rates of the control sample, gypsum board, and whitewash paint. These three are the only samples that had flaming, and the peak heat release rates of the remaining samples were under 15 kW/m<sup>2</sup> and are therefore not included in this figure. The final property which will be discussed is the mass loss of the samples. The mass loss over time for every

Whitewash paint improved the fire performance of the timber only minimally. Ignition of the sample was delayed by about 20 seconds compared to the control sample, as seen in Figure 3.9. The char depth was only slightly reduced, at 9.5-10 mm compared to the 11 mm measured on the control sample, a reduction of about 11%. This indicates that the whitewash paint method only marginally improved the fire performance of the timber, by very slightly delaying the time to ignition.

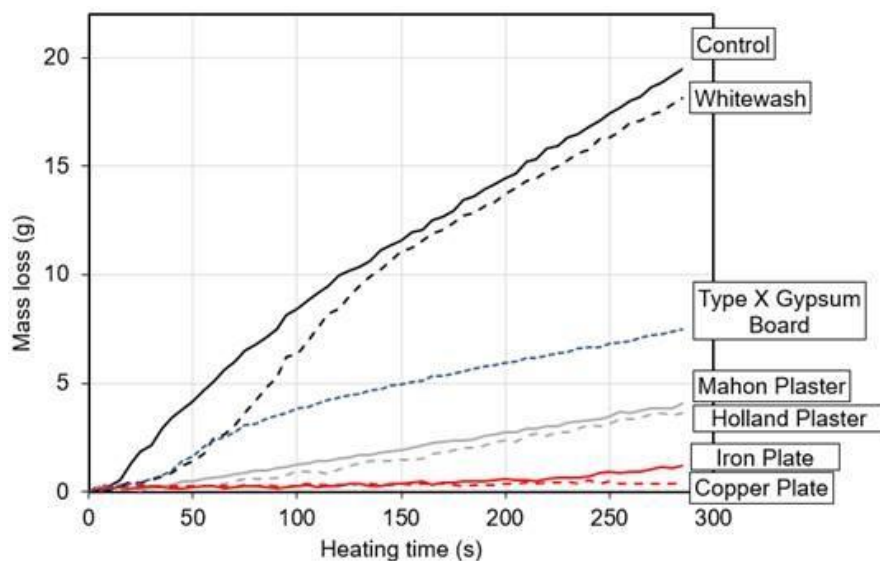
Figure 3.10 Mass loss of the control sample, as well as the historic and contemporary encapsulations.

encapsulation material is seen in Figure 3.10 (all mass losses represent the average of two samples).

confirming historic fire tests performed by Mahon [46]. Some mass loss was recorded (Figure 3.10), which is attributed to moisture evaporation in the plaster since no flaming or charring occurred on the timber. A major challenge facing the historic plasters was their cohesiveness. Since the plasters were applied to the plywood horizontally, they remained attached during testing, however afterwards they fell off when removed from the testing apparatus, which may be attributed to the dehydration of the plaster. This indicates that the plasters would not be suitable for vertical or upside-down applications, such as walls or ceilings (where they would be installed), as they would be likely to fall off of the surface they are applied to when exposed to fire. Since the plasters do not stay attached to the timber surfaces, they had little to offer with regards to improving fire performance.

Finally, the contemporary gypsum board did improve the fire performance of the timber. The layer of paper on top of the gypsum board ignited approximately 35 seconds after beginning the test and flamed for approximately 15 seconds. This is reflected in the heat release rate seen in Figure 3.10. Regardless of the small amount of flaming observed, the wood under the gypsum board was uncharred. Mass loss occurred in the gypsum board, which is attributed to moisture loss of the gypsum. The contemporary gypsum board was the only encapsulation method tested that improved the fire performance of the timber, whilst staying properly fastened.

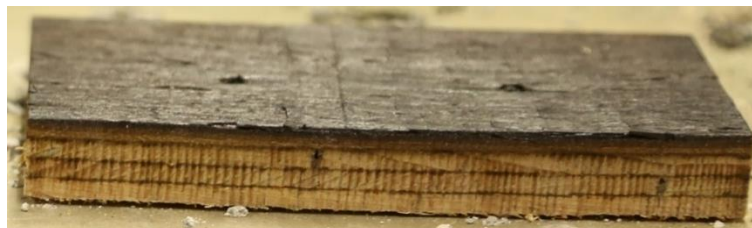
Figure 3.11 Degradation process beginning on the timber, seen after removal of the iron plate.

The metal plates somewhat improved the fire performance of the timber. While the iron plates had some flaming through the screw hole, a char depth of only 2.5-3 mm was measured after testing (indicating a smouldering fire under the plate), which is still considerably (75%) less than the 11 mm on the control sample. Caution is advised in interpreting this result, as the duration of heating was small, and longer duration testing may not show favourable performance. While away from the screw hole no flaming occurred, heat transfer into the timber still occurred, causing degradation to begin in the depth of the timber. This can be seen in Figure 3.11. As heat transfer was noticeably occurring through the iron plate and into the timber, the effectiveness of the iron plate at protecting the timber was limited.

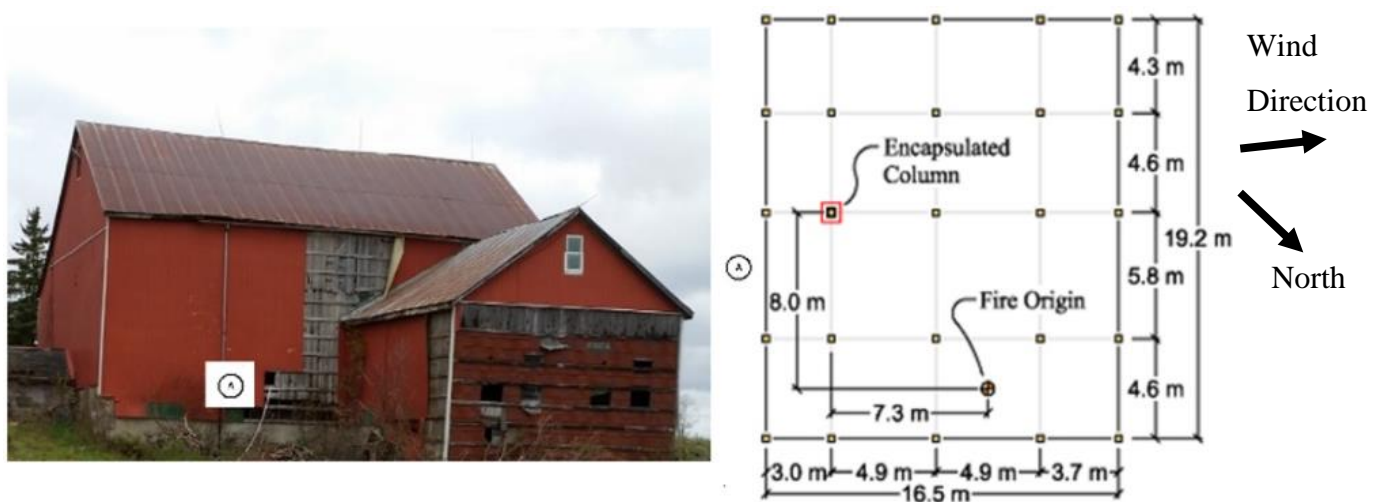
Figure 4.2 Backside of timber farm structure (left), and atrium dimensions (right- annexes not rendered).

through analysis (pull out of screws, field tests for rot, etc.). This column was ideal to be encapsulated to study its behaviour under fire exposure (denoted as Column 1 herein). The dimensions of the column were 230 mm x 267 mm, which was similar to the size of columns used in existing tall timber structures in Canada. It was hypothesized (and later confirmed) that the column was also unlikely to be affected by any collapsing debris surrounding it that the structure might impose (i.e., it was expected the column would remain standing without debris impact for most of the duration of the test). It was also assumed that the column chosen had similar loading to surrounding columns due to the rectangular column grid. The column had no additional loading beyond service loads. Figure 4.2 shows the structure's condition, appearance and dimensional features illustrating the column.

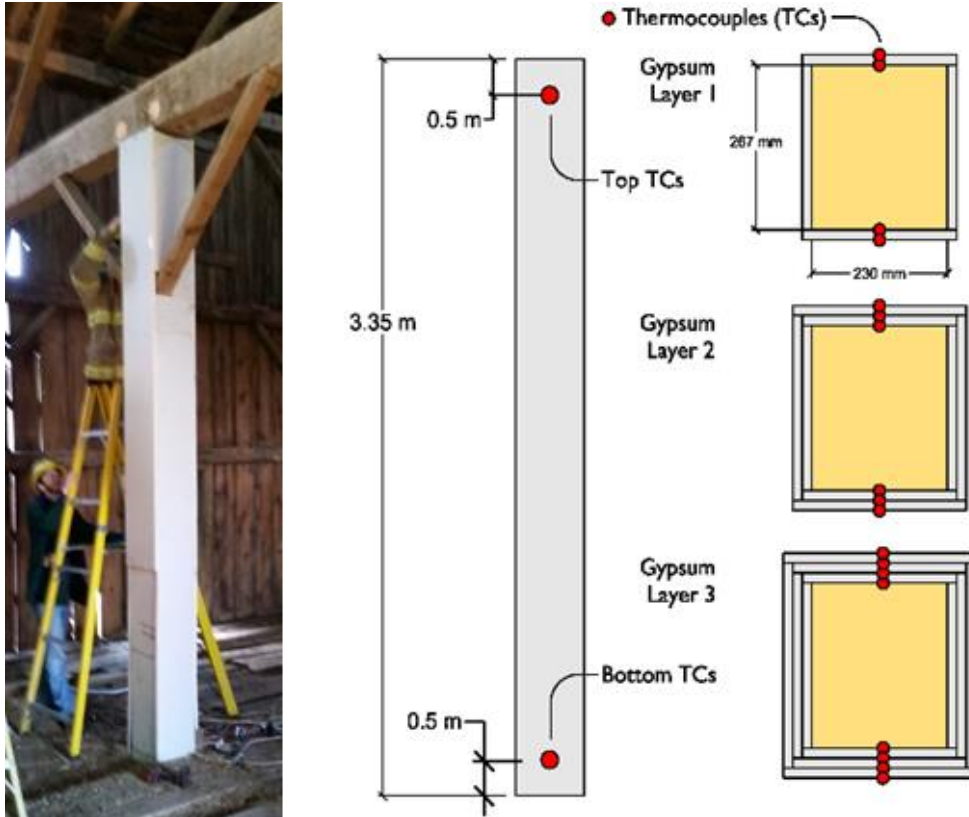
Figure 4.3 Field study encapsulated Column 1 during construction (left), thermocouple placement (right).

timber column in the farm structure was encapsulated with three layers of fire-rated 15.9 mm Type X gypsum board. Strict allowances for screw spacing and depth of screws into the timber structure were considered and followed from CSA O86-14 standards precisely. The spacing requirements from CSA O86-14 that were followed included having a maximum screw spacing of 300 mm on centre, having each board fastened by two rows of fasteners (offset by half the row spacing), and ensuring that each fastener penetrates the wood by at least 25 mm [29]. Each layer of gypsum board was installed and screwed separately. The gypsum board installation procedure is illustrated in Figure 4.3 and was meant to be a representative installation of existing tall timber structures. Although the plan was initially to install four layers, there was only time to install three layers and therefore that number of layers would control the amount of gypsum layers seen in laboratory stage for consistency. The remainder of the farm structure was left unprotected (without encapsulation). Figure 4.3 provides instrumentation details of the encapsulated timber column.

As shown in Figure 4.3, the column was instrumented with 16 K-Type thermocouples (as limited by the available data acquisition channels) distributed on the surface of the encapsulation, between layers, and on the surface of the timber (thermocouple error limited to the greater of 2.2 °C or 0.75% of the temperature in °C). A National Instruments (Model NI-9213) distributed data acquisition unit was used, running Labview software. Thermocouple leads were protected with Rockwool insulation and aluminum wrapping as they extended out of the structure. Thermocouples were not placed inside the timber, as the focus of this experiment was on the performance of the encapsulation system only (not the performance of the timber). The data acquisition unit was left a distance of 10 m from the structure's exterior. Prior to the structure's full collapse, safety and equipment maintenance protocol dictated that once visual indications of structural failure began (noticeable tilt of the back exterior portion of the structure), portable

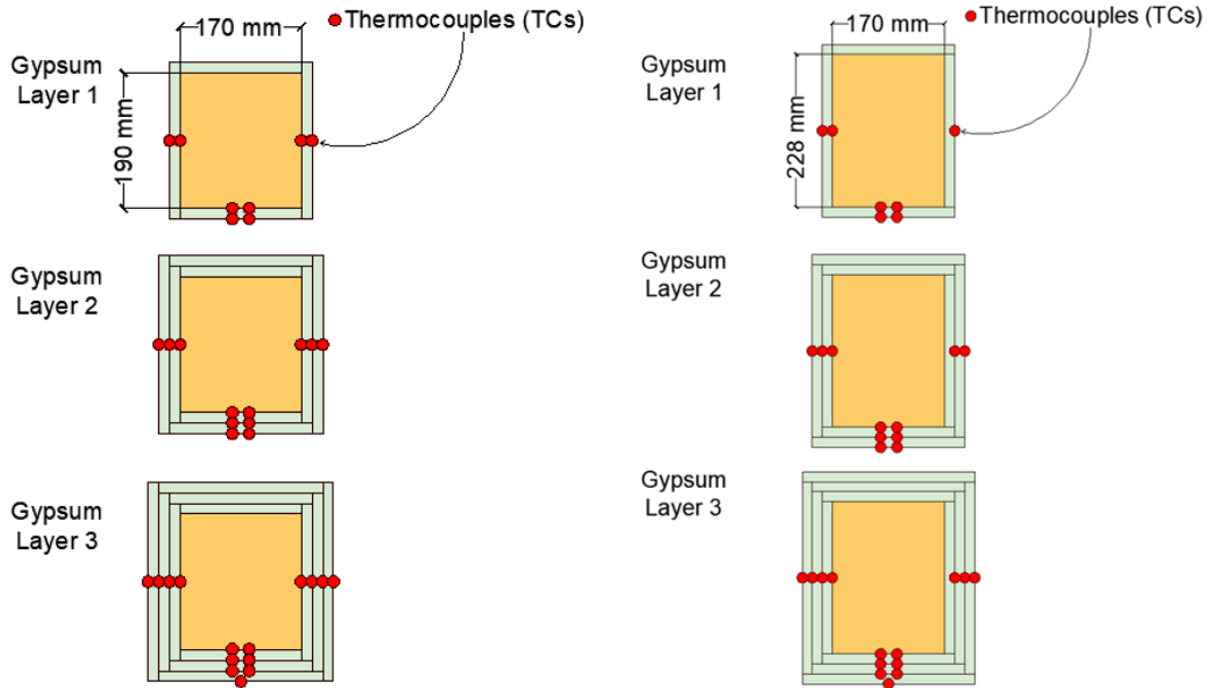
Figure 4.4 Laboratory encapsulated column thermocouple placement Column 2 (left) and Column 3 (right).

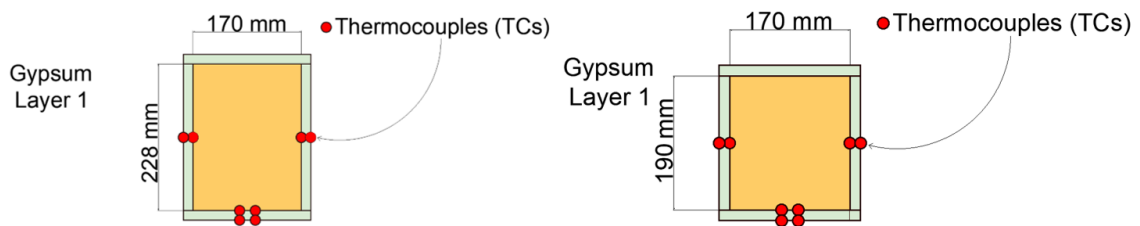
Figure 4.5 Laboratory encapsulated column thermocouple placement Column 4 (left) and Column 5 (right).

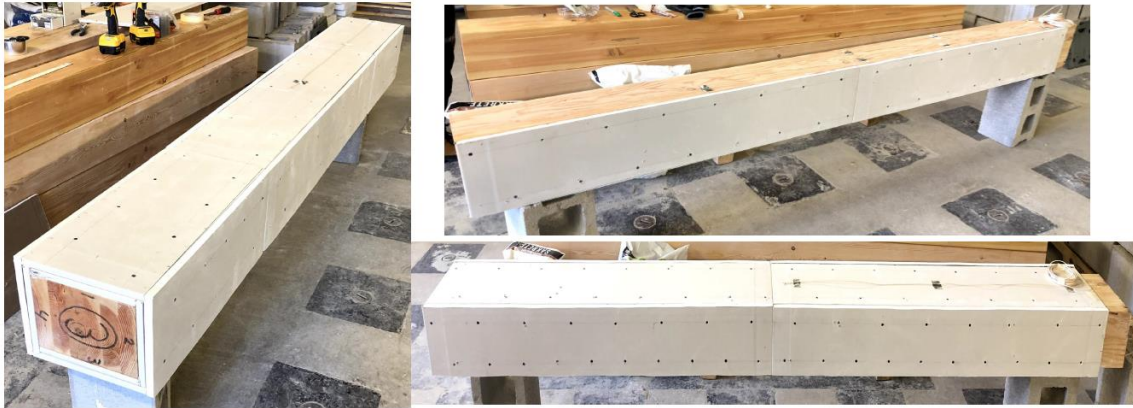
Figure 4.6 Encapsulation procedure of a column protected by three layers of gypsum board, clockwise from top right: first layer installation in progress, first layer complete, third layer complete.

loading capabilities for later research (Appendix B). These columns were encapsulated in conformance with CSA O86 with single and multiple layers of gypsum board. The encapsulation of Columns 2 and 3, like Column 1, included three layers of fire-rated 15.9 mm Type X gypsum board as defined in Section 4.2.1. Columns 4 and 5 were encapsulated with only one layer of this same gypsum board, in order to directly understand how much a single layer impacts the fire performance of the timber. The installation procedure deviated slightly in application in order to specify a ‘seam’ (two boards side by side) in the fire exposed gypsum layer on the column at mid-span for all Columns 2 to 5. This was in order to study possible heat exposure and impact of seams on the overall performance. The ‘seam’ only appears on the outermost layer and below the board is continuous where applicable. This would be akin to prior wall finishing and a plausible configuration. Columns 6 and 7 were control (unencapsulated) samples. K-type thermocouples were utilized in order to provide temperature measurement at mid-span. Many thermocouples were placed in redundancy (such as the extra thermocouples located on the bottom of every beam) however thermocouples directly exposed to flame temperatures were unreliable in recording board surface temperature exposures as visual indicators illustrated that they detached in testing. Figures 4.4 and 4.5 show the thermocouple configurations for each column (2 to 5). Columns 6 and 7 had thermocouples in the same configuration, on the face of the timber only. The columns and screws were not finished as it was of interest to also observe the possible effects of heat transfer through the screw to the timber (worst case). The column encapsulation process is seen in Figure 4.6.

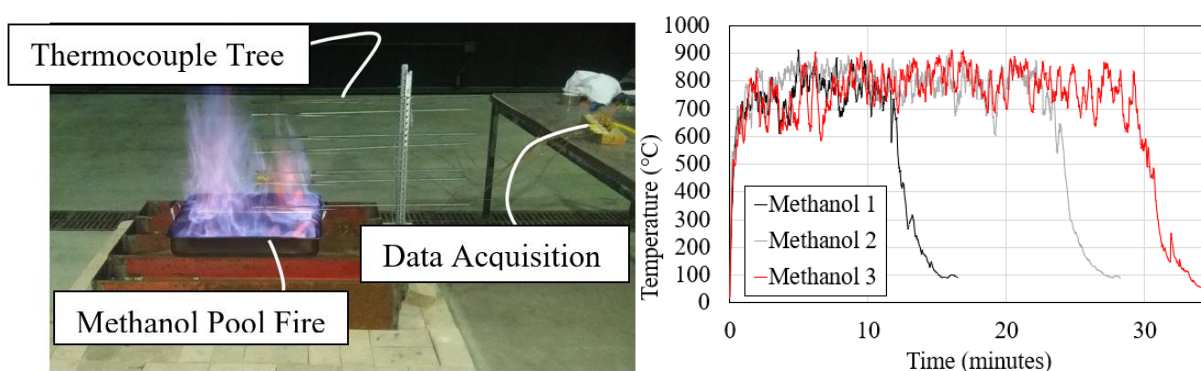
Figure 4.7 Characterization of methanol non-standard fire, where Methanol 1, 2, and 3 represent the trials considered in determining the volume of fuel required ( $h = 200$  mm).

Multiple test fires were performed using various volumes of methanol in different pan shapes to characterize and demonstrate repeatable exposures. For each 30-minute test, 14.3L of fuel in a 0.48 m (width) x 0.6 m (length) stainless steel pan was needed to achieve the desired fire exposure. Stainless steel was chosen as the material for the pan as it was unlikely to melt during testing and was readily available. The size of pan was selected as it was the only pan available that was able to safely contain the quantity of fuel required (it was the largest available). Expected exposure temperatures were measured 200 mm above the initial surface of the fuel. The time-temperature curves for the trial methanol fires, performed to determine the volume of methanol needed (denoted methanol 1 to 3, where the number represents the trial number in determining the quantity of fuel needed for a 30-minute fire), are shown in Figure 4.7.

In Figure 4.7, each of the time-temperature curves represents the temperature read by a single thermocouple, however, the maximum difference in peak temperature recorded across the three trials was only 12 °C. Localised heating to one-third of the column was considered, opposed to uniform heating, as clear comparisons of undamaged and damaged locations could be made on the column and the possible propagation of flames beneath the board to unheated regions could be considered if applicable. The column was rotated as a beam and was placed so that the bottom face of the member was 200 mm away from the initial surface of the unburnt liquid fuel. This orientation was chosen so that the fire would reach the seam of the gypsum board, and the damage location could be controlled precisely. It is of note that while the steep gradient in temperature was possible at the initial stages of the exposure fire, it was not possible to generate the equivalent peak temperatures observed from the field study (potentially due to supply of oxygen in the very heavily ventilated barn or the large quantity of fuel from the timber of the barn). Therefore, the laboratory tests cannot and should not be considered the same non-standard equivalency as the field test. This was an acceptable deviation, as using the other fuels with higher temperature exposures would have obscured visualization of the gypsum board surface and prohibit qualitative and quantitative observations as will be described in Section 4.3. Once the heating was completed the columns were then monitored during a 30-minute cooling phase in order to assess if damage(s) such as cracking or further delamination of the gypsum board(s) is exaggerated after the fire burns out. 30-minutes was deemed sufficient as a cooling phase duration as at this time, the unencapsulated samples had auto-extinguished, so this cooling duration was kept constant across all test samples. Water was not used for fire suppression in these tests to observe auto-extinction of the timber, and strict environmental protocols were used for testing and wastage disposal of materials.

Fire exposure was applied to the soffit of the CLT model. As a baseline, the thermal boundary condition of the area of CLT directly above the localized fire was characterized as radiation and convective contributions from the pool fire described in Chapter 4 and seen in Figure 4.7. This boundary condition does not account for the contribution of the timber, and therefore experimental results could expect to see different temperatures or heat fluxes.

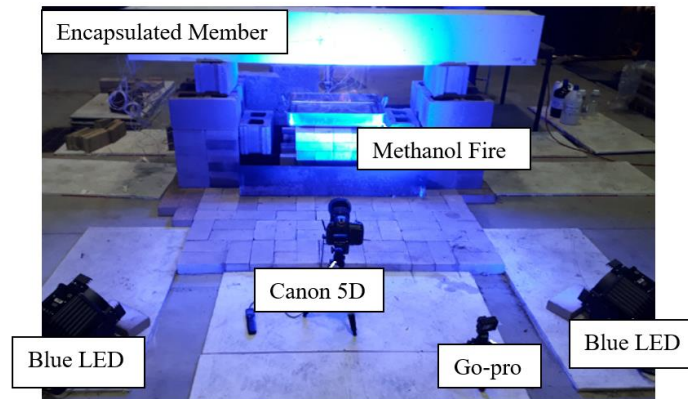
Figure 4.8 Specimen, apparatus, camera and LED light locations.

Following the previous technique validation produced by Gatien et al. [60], qualitative observations and quantitative measurement during testing was performed using narrow-band spectrum illumination and image processing in order to study qualitative changes (cracking/delamination) to the gypsum board at high temperature, as well as approximate deformations and deflection of the columns during testing. The use of narrow-band spectrum illumination and matched optical filters can enhance visibility through clean-burning flames [61]. Such a technique has defensibly been shown applicable in laboratory scales (flame spread testing using a LIFT for example). The technology has not yet been adapted nor defended for use in standard furnace (enclosed) fire testing (but such testing is outside the scope of this research). Verification and modification of the technology should be considered for that application in future research. The exact experimental and camera specifications derived from the Gatien et al. study [60] was used to observe the columns when exposed to the methanol fires. The lab set up included two Spectra Par 100-Watt luminaries with all blue (450 nm wavelength) Light Emitting Diodes (LEDs) to illuminate the sample (see Figure 4.8). A Canon EOS 5Ds Mark III DSLR camera was used to image the column specimens, this was placed 1.5 m away from the column at an angle of 17 degrees. This camera's resolution (images of 5792 x 8688 pixels) allows placement far away from the specimen during testing to maintain high resolution of the specimen while reducing the risk of damage to the camera and lenses due to excessive heating and thermal radiation from the pool fire. The following camera settings were used due to the influence of previous research by Gatien et al. [60]: frame rate of 5 frames per second, ISO 2000, aperture f/13, shutter 1/800. A bandpass optical filter consisting of two stacked filters (HOYA Corporation B440 and Midwest Optical Systems BP470) was attached to the front of the camera's default lens. These two stacked filters provided a low-cost and effective band-pass filter at the desired frequency (450 nm). The

camera was shooting at an angle, which was measured in order to translate the downward and upward movement of the column in these tests into a measurable deflection. Geo-PIV RG [62] was utilized for approximating quantifiable deflection and seam deformation measurements. The technique is considered as an approximation and not a definitive calculation as the technique is not fully adaptable to a material undergoing a phase change. Gypsum boards lose their first coating (paper) layer through combustion and the application of tracking paint is therefore prohibitive. The interested reader is encouraged to read about image correlation limitations further [63].

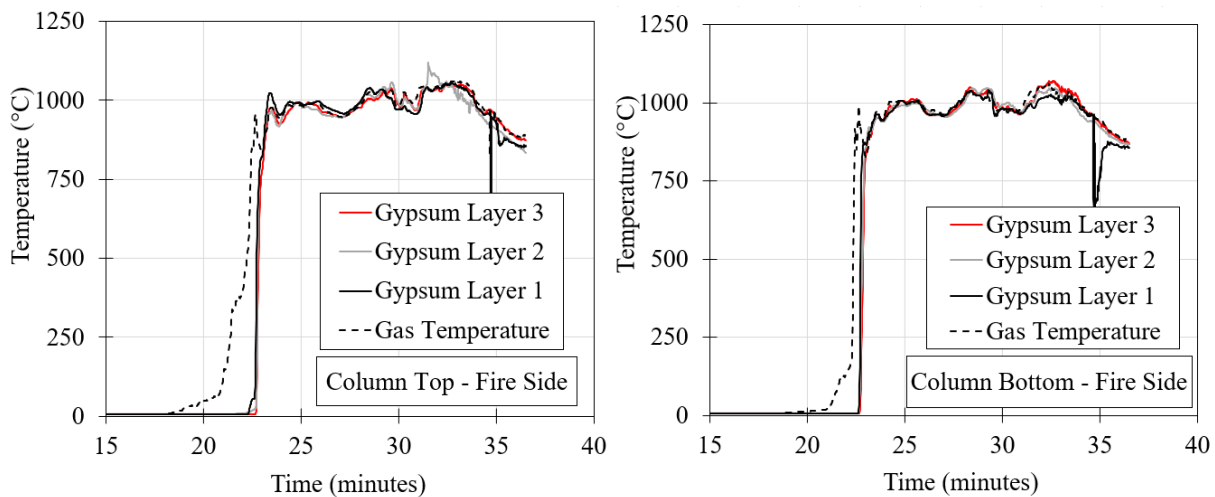
Figure 4.9 Fire side temperatures measured at (left) the top of the Column 1, and (right) the bottom of the Column 1 ( $t = 0$  ignition).

The performance of Column 1 was evaluated primarily through examination of the temperatures reported by the thermocouples and through recorded video footage as plotted and illustrated in Figures 4.9 to 4.12. In the plots shown in Figures 4.9 to 4.11, Gypsum Layer 1 refers to the thermocouple under one layer of gypsum, Gypsum Layer 2 under the second layer, and Gypsum Layer 3 is between the innermost gypsum layer and the timber column itself. Gas temperature refers to the temperature measured by a thermocouple placed on the outer most layer of gypsum board at the top and bottom of the column on both sides. The fire side refers to the side of the

column facing the room of fire origin, and the non-fire side refers to the opposite side of the column (not facing the room of fire origin). While cameras were placed throughout the interior and exterior of the farm structure, the thick flames and smoke made it difficult to see the column within the structure and, in particular, the gypsum board encapsulation after the initial period. While it is beyond the scope of this chapter to discuss the resulting fire dynamics, in brevity temperatures were only recorded at the column location, and the thermocouples were manually terminated as structural collapse was considered possible and the data acquisition unit had to be retrieved. The structure eventually collapsed approximately 30 minutes beyond the steep temperature rise. It is not possible to deduce temperatures beyond when the thermocouples were taken offline.

From Figures 4.9 to 4.11, it is seen that the gas temperatures away from the column rise sharply at 20 minutes after ignition when the fire exposure spreads to the column's location (Figure 4.11). Within two minutes, rapid heating occurs, and all of the temperatures beneath each layer of gypsum board rise quickly above 1000 °C. This behaviour can suggest several aspects relating to cracking of the board, and sealing effect – where fall off of (all) the gypsum board layers is ruled out, as discussed below.

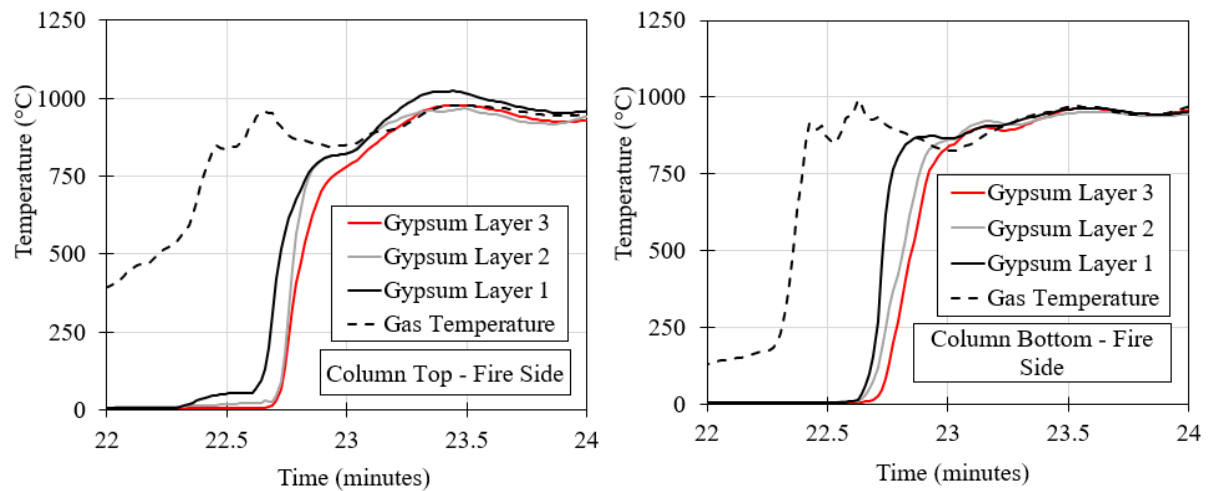
Figure 4.10 Non-Fire Side temperatures measured at (left) the top of the Column 1 and (right) the bottom of Column 1.

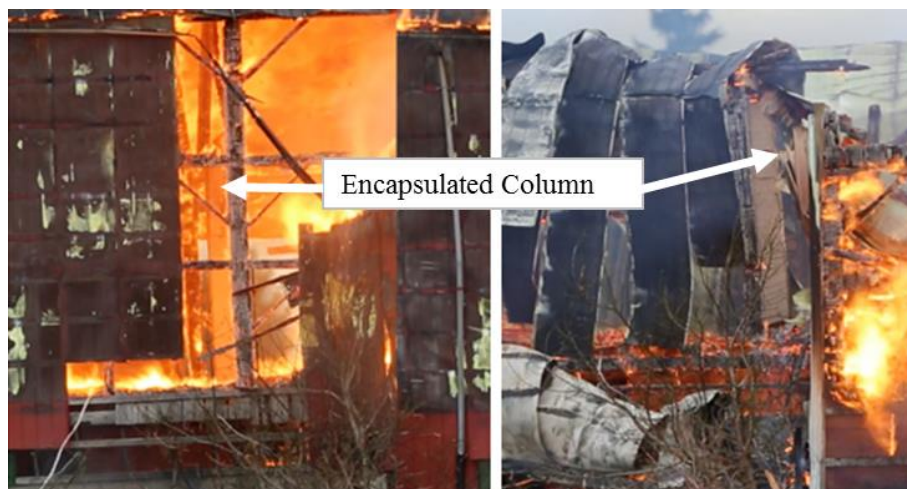
Figure 4.13 Images of Column 1 during field test (left) prior to structural collapse (right) post flashover event.

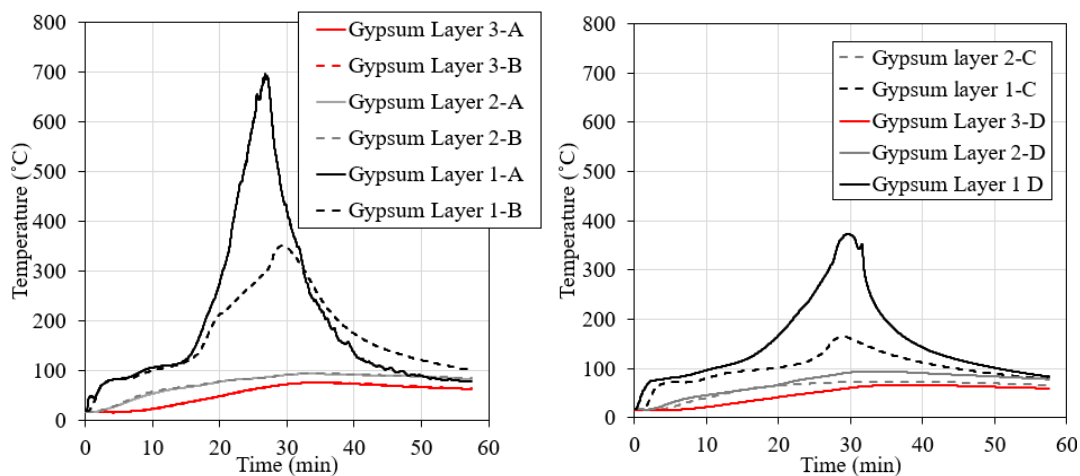
Figure 4.14 Recorded temperatures between the gypsum board layers for Column 2 (175x190x2532)  
(Note: TC 3C was not installed properly).

The performance of the timber columns (2 through 7) within the laboratory study were evaluated first through the examination of the temperatures reported by the thermocouples as plotted in Figures 4.14 to 4.17. In these plots shown, for Columns 2 and 3, Gypsum Layer 1 refers to the thermocouple under one layer of gypsum, Gypsum Layer 2 under the second layer, and Gypsum Layer 3 is between the innermost gypsum layer and the timber columns themselves. Where Columns 4 and 5 have only one layer for consistency it is called Layer 1. Exposed surface and Gas

Figures 4.18 to 4.20 are provided to place the temperature profiles into context. Column 2 has a noticeable increase in temperature during the heating portion of the test, increasing to temperatures of 700°C and 350°C between the 1<sup>st</sup> and 2<sup>nd</sup> gypsum board layers. It is not unexpected that the temperatures do not measure the same between them, on forensic post-fire examination it was observed that these thermocouples were located in the region that coincided with the charred zone of the timber. Whereas in Column 3, which showed no temperature incline in the temperatures recorded by the thermocouples, examination post-fire showed that these thermocouples were installed away from this charred zone on the second gypsum layer as observed in Figures 4.18 and 19. This behaviour gives credence that the fire exposure between the first and second boards likely occurred at an isolated location near the seam, resulting in a localized charred area and not along the full length of the column, as it was only a localized fire exposure. The results seem to verify the temperature measurement trends and hypothesis observed in the field study that indicated temperature rise through penetration between the gypsum layers. In the controlled case, however, the temperatures measured beyond the second layer of gypsum board did not exhibit a spike increase in temperature. Temperatures do discretely rise as expected with duration. The penetration of heating in these tests is likely due to the larger seam opening in the first gypsum layer which correlates to partial delamination of the gypsum board as tracked through narrow spectrum and image filtration technologies (sometimes called blue light technology).

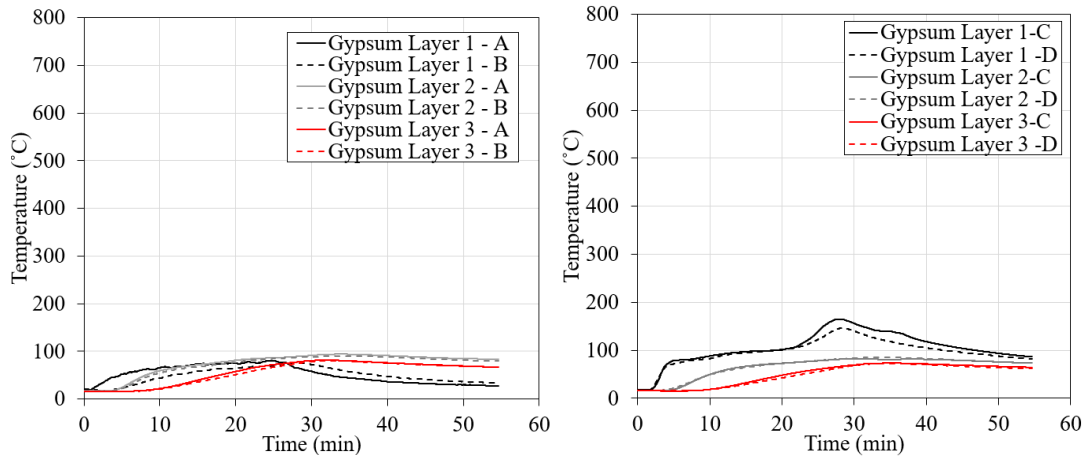
Figure 4.15 Recorded temperatures between the gypsum board layers for Column 3 (175x228x2532).
