**THE THERMOMECHANICAL RESPONSE OF STRUCTURAL TIMBER IN REAL  
FIRE EXPOSURES**

A DISSERTATION SUBMITTED TO THE FACULTY OF GRADUATE STUDIES IN  
PARTIAL FULFILLMENT OF THE REQUIREMENTS OF THE DEGREE DOCTOR OF  
PHILOSOPHY

GRADUATE PROGRAM IN CIVIL ENGINEERING  
YORK UNIVERSITY  
TORONTO, CANADA

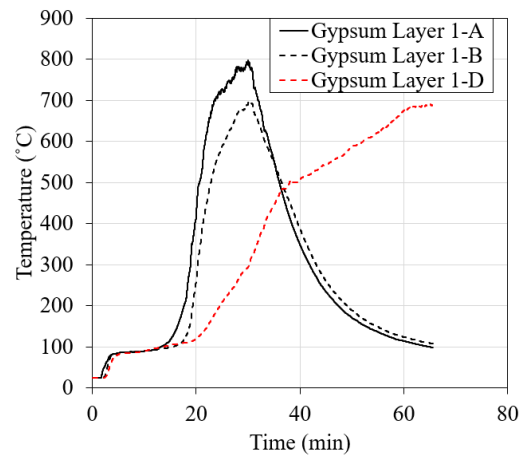
Figure 4.16 Recorded temperatures between the first and second gypsum board layers for Column 4 (175x228x2532) (Note: TC 1C was not installed properly).

Column 2 illustrates a potential fall off (peel away) of the board in progress as the heating duration halted seen in Figure 4.20. The post-test examination of Columns 4 and 5 reveals the extent of char damage below the board. Figure 4.16 reveals that the ignition of the Column 4 had occurred during the cooling phase of the tests manifesting as a smouldering fire under the side boards away from the fire. Once the boards were removed after 30 minutes of cooling, the fire was damped out with light amounts of water. Excessive smoking also occurred for these columns post heating phase confirming a small self-sustaining (without additional application of heat) fire. Figure 4.21 illustrates that Column 4 developed a 25mm deep crack running along the entirety of the heated zone beyond the charred zone which was not present during the installation of the gypsum boards pre-testing (note Columns 2 and 3 showed no signs of char damage). Figure 4.17 does not show evidence of a fire event on the side boards of the column, though analysis after the test revealed thermocouples C and D for Column 5 were not in the charred region of the column.

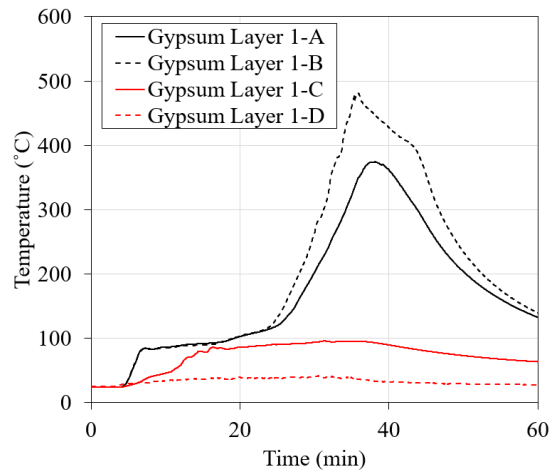
Figure 4.17 Recorded temperatures between the gypsum board layers for Column 5 (175x190x2532).

The performance of the timber columns (2 through 7) within the laboratory study were evaluated first through the examination of the temperatures reported by the thermocouples as plotted in Figures 4.14 to 4.17. In these plots shown, for Columns 2 and 3, Gypsum Layer 1 refers to the thermocouple under one layer of gypsum, Gypsum Layer 2 under the second layer, and Gypsum Layer 3 is between the innermost gypsum layer and the timber columns themselves. Where Columns 4 and 5 have only one layer for consistency it is called Layer 1. Exposed surface and Gas

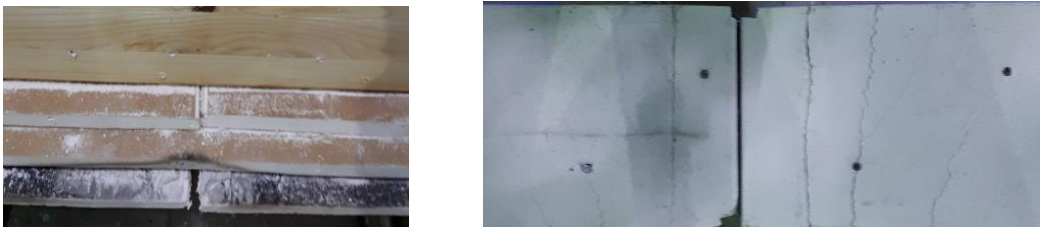
Figure 4.18 Post-fire 'seam' opening in Column 3.

Figures 4.18 to 4.20 are provided to place the temperature profiles into context. Column 2 has a noticeable increase in temperature during the heating portion of the test, increasing to temperatures of 700°C and 350°C between the 1<sup>st</sup> and 2<sup>nd</sup> gypsum board layers. It is not unexpected that the temperatures do not measure the same between them, on forensic post-fire examination it was observed that these thermocouples were located in the region that coincided with the charred zone of the timber. Whereas in Column 3, which showed no temperature incline in the temperatures recorded by the thermocouples, examination post-fire showed that these thermocouples were installed away from this charred zone on the second gypsum layer as observed in Figures 4.18 and 19. This behaviour gives credence that the fire exposure between the first and second boards likely occurred at an isolated location near the seam, resulting in a localized charred area and not along the full length of the column, as it was only a localized fire exposure. The results seem to verify the temperature measurement trends and hypothesis observed in the field study that indicated temperature rise through penetration between the gypsum layers. In the controlled case, however, the temperatures measured beyond the second layer of gypsum board did not exhibit a spike increase in temperature. Temperatures do discretely rise as expected with duration. The penetration of heating in these tests is likely due to the larger seam opening in the first gypsum layer which correlates to partial delamination of the gypsum board as tracked through narrow spectrum and image filtration technologies (sometimes called blue light technology).

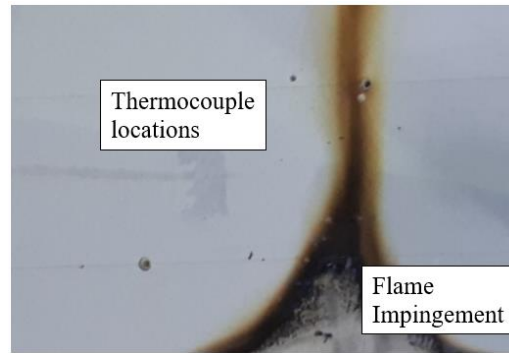
Figure 4.19 Flame impingement after fire of Column 3.

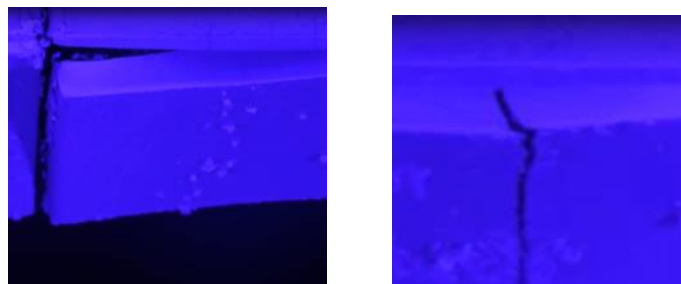
Figure 4.20 Delamination and cracking action of Gypsum Board at seam Column 2 during heating.

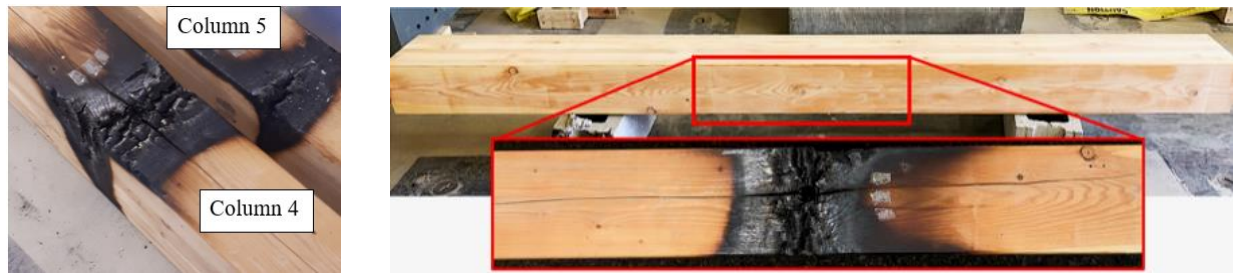
Figure 4.21 (left) Post-test condition of Columns 4 and 5 (right) post-fire cracking of Column 4.

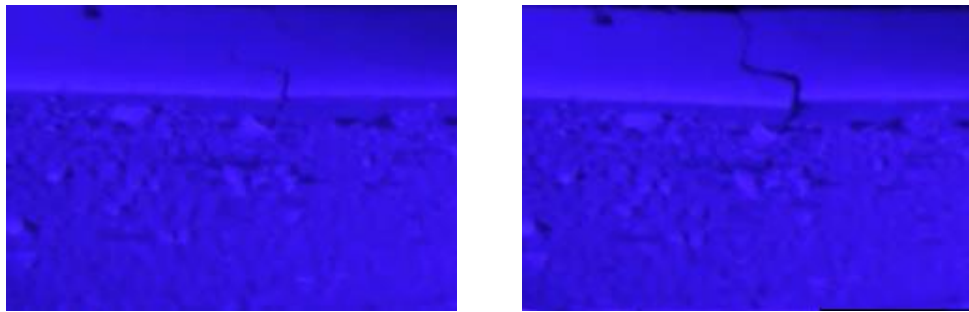
As the gypsum board heats up, a web of discrete fine cracks forms on the board on Column 3 immediately after the rapid temperature rise. This does not seem to affect heat transfer at the location of measurement. Note that in Column 2, this phenomenon appears absent along the surface; instead, Column 2 demonstrates a larger crack opening along the surface and partial delamination as previously discussed. Figure 4.22 illustrates that cracking patterns tend to exaggerate during the cooling process, a phenomenon that seemed apparent with any large gypsum board crack opening for all columns.

Figure 4.22 Crack opening after heating in Column 3 (left at end of heating, right at end of cooling).

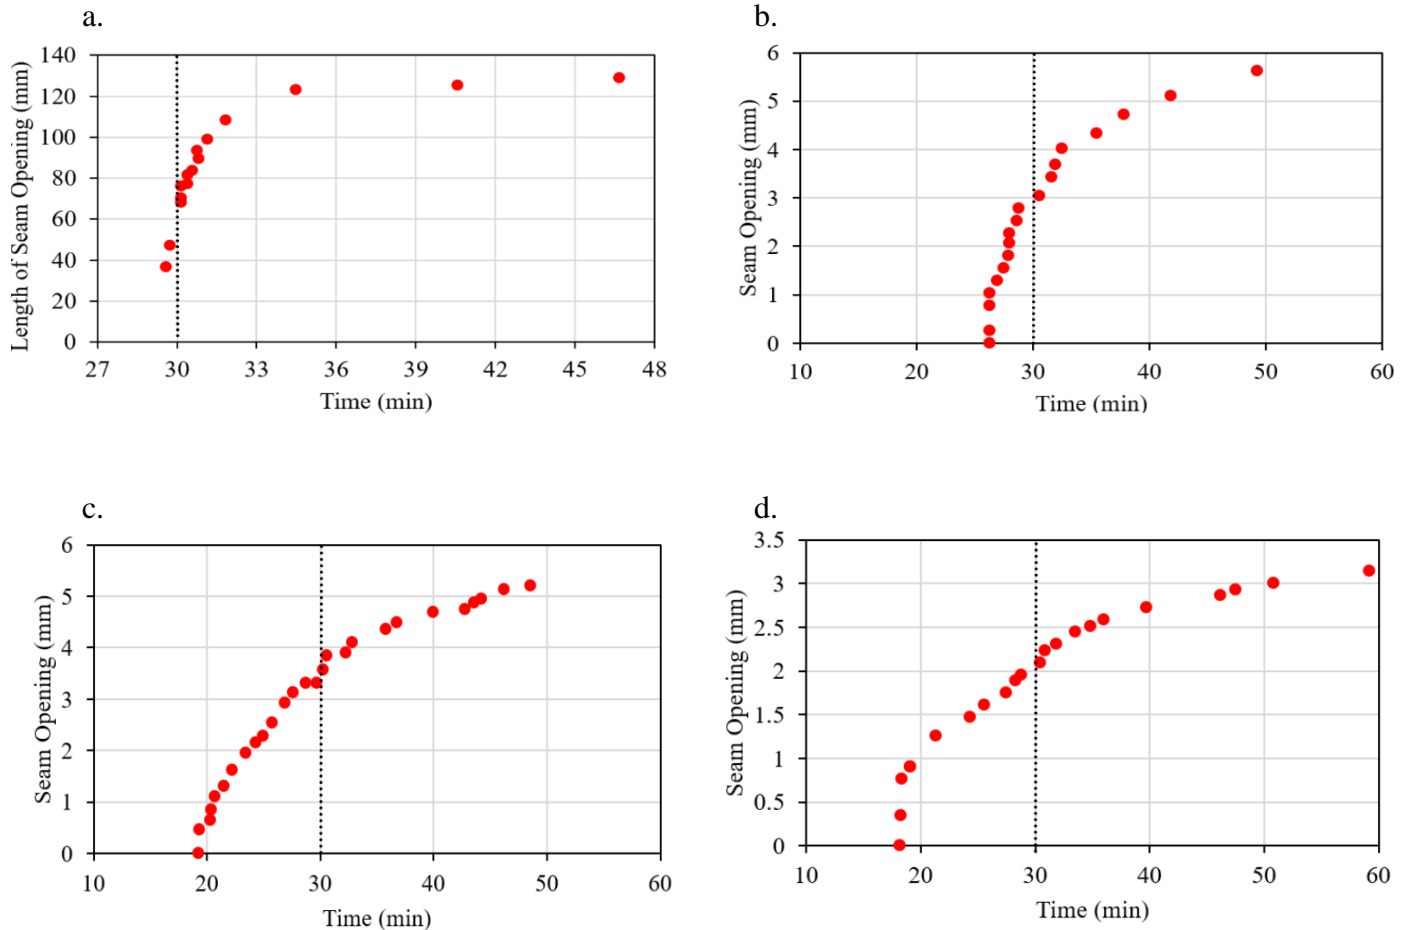
Figure 4.23 Seam opening in the heating and cooling phases (left and right of the dashed lines) for a. Column 2, b. Column 3, c. Column 4, and; d. Column 5.

the peeling of the gypsum board away from the timber. This is seen in Figure 4.23 for Columns 2 to 5.

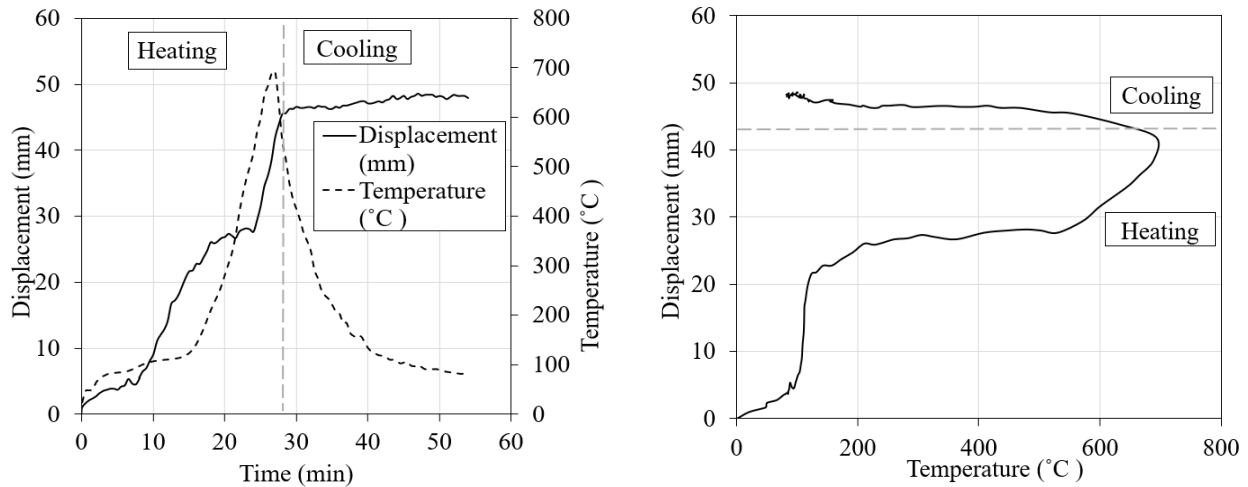
Figure 4.24 Peel away of soffit gypsum board in Column 2 with respect to time and temperature (temperatures are those recorded by Gypsum Layer 1-A).

Table 4.4 quantifies the exact deflections and seam opening measurements taken from the image analysis. Figure 4.24 illustrates the measured fall off behaviour with respect to the temperature of Column 2. It is supported by the narrow band spectrum illumination technology that fall-off/delamination behaviour is driven predominately by the dehydration of the board (100°C) to when fall off of the board will initiate and is not linked to a specific temperature. Seam openings exaggerated in size during the cooling phase and were substantially large for penetration

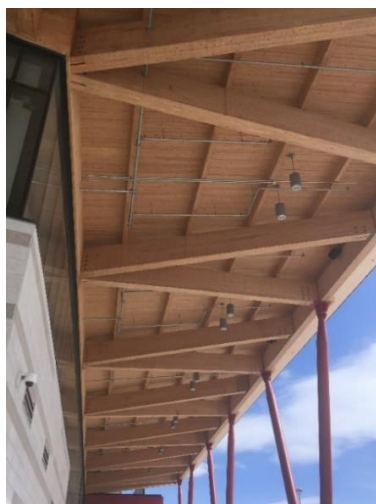
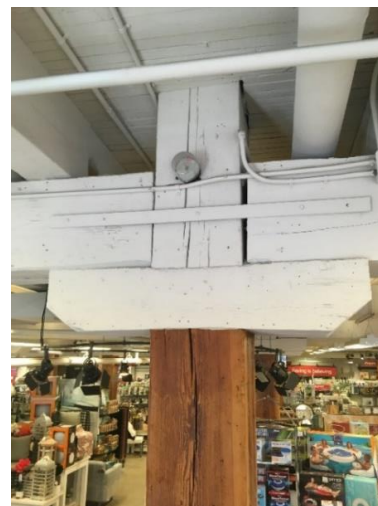
Figure 5.1 a. A contemporary timber structure; b. a historic timber assembly (author's photos).

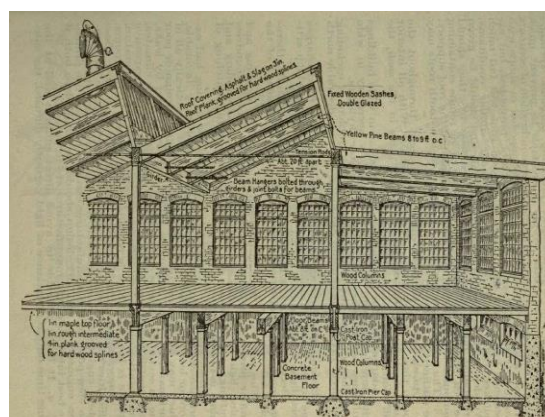
Figure 5.2 Depiction of a building similar to the 1898 mill (image from [68]).

An example where a fire in a historic timber building did not cause the complete destruction of a structure was presented by Otto et al. (2017) [67]. In this case study, an 1898 mill type building in Ontario experienced a fire. A schematic of a similar building is seen in Figure 5.2. Of particular interest is the basement, which utilizes closely spaced wooden columns and beams with cast iron caps, a non-combustible flooring system, and a wooden ceiling above. One of the basement columns was intentionally ignited as an act of arson. The column was exposed to a flame for approximately 40 minutes prior to its ignition. The fire auto-extinguished. The char depth was calculated by removing the char from the column and comparing its post-fire dimensions to the dimensions of the adjacent columns. From this analysis, it was found that the column charred less than 25 mm per side. The fire did not extensively spread along the beams or ceiling to other structural members and was isolated to only the column where the initial fire began.

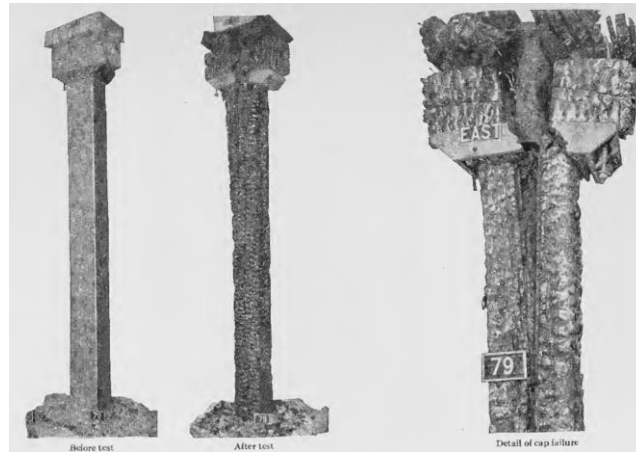
Figure 5.4 Qualitative results of the fire testing of one of the specimen, an unprotected longleaf pine column with a cap and pintle bearing (from [75]).

The time to failure of these columns was reported in the results and ranged from 35-50 minutes for the exposed columns and up to 2 hours and 15 minutes for the encapsulated columns. The failure mode of these columns was due to deformation at the steel or cast-iron caps. One of these columns may be seen, before and after testing, in Figure 5.4. The study outlines a number of limitations on its findings, including that the moisture content of the timber species was not comparable (and as a result, a comparison could not be made between the tests of the two timber species). Typically, the columns with the cast iron caps withstood longer than those with the steel caps. From these tests, the Bureau of Standards has offered a Fire Resistance duration for each of

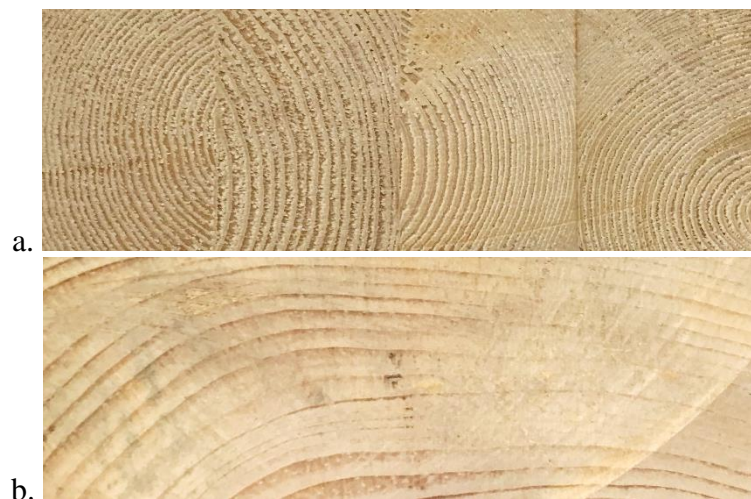
Figure 5.5 Cross sections of showing the growth ring width of, a. contemporary Glulam and b. historic timber, from a building constructed in the 1840s (author's photos).

Historic timber differs from contemporary timber for several reasons. Timber is a polymer, and it cannot be assumed that all polymers within a group (including wood) will act identically in fire [77]. Historic timber was produced from trees that were grown hundreds of years ago. Ancient timber growing practices may be different than contemporary growing practices, which may affect properties inherent to the timber such as density and growth ring width [78, 79]. An example of this is seen in Figure 5.5. For the particular samples shown in Figure 5.5, the contemporary timber shows more uniformity in its growth rings, whereas the historic sample has more variation. Furthermore, contemporary timber often frequently uses adhesives and other additives which may also impact the fire performance of the timber. Adhesive lines in the contemporary Glulam are seen as vertical lines holding together the wood laminates in Figure 5.5a.

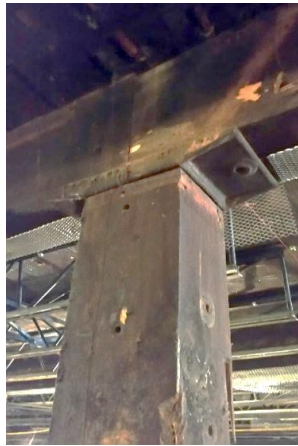
Figure 5.6 The timber column in the basement of the structure before removal.

The structure used large timber beams and columns connected by a cast iron cap, which is seen in Figure 5.6. Several timber members were (carefully) removed from the structure by the building owner to accommodate an adaptive reuse project, and the timber samples used in this research were sourced from one of these columns (originally located in the basement). The dimensions of the column were 240 x 290 mm. All timber described as ‘Column’ indicates that it is timber from one of the columns within the industrial mill building. The materials were wrapped in plastic to allow slow acclimatization to new laboratory conditions.

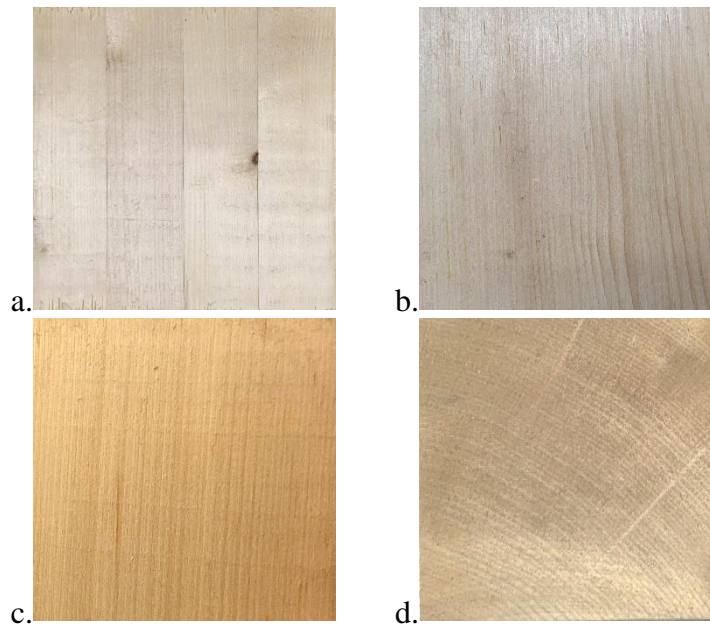
Figure 5.8 Each of the timber samples and the surface exposed to heat, a. Glulam, b. Joist, c. Column – Perpendicular, and d. Column – Parallel.

All of the types of timber are seen in Figure 5.8. The Glulam and the Joist timbers are Spruce, and the Column timber is Pine. The wood species affects the fire performance of timber (for example, Pine is typically considered to char at a faster rate than Spruce) [82], and this should be considered when interpreting the results herein, however variations in species may be

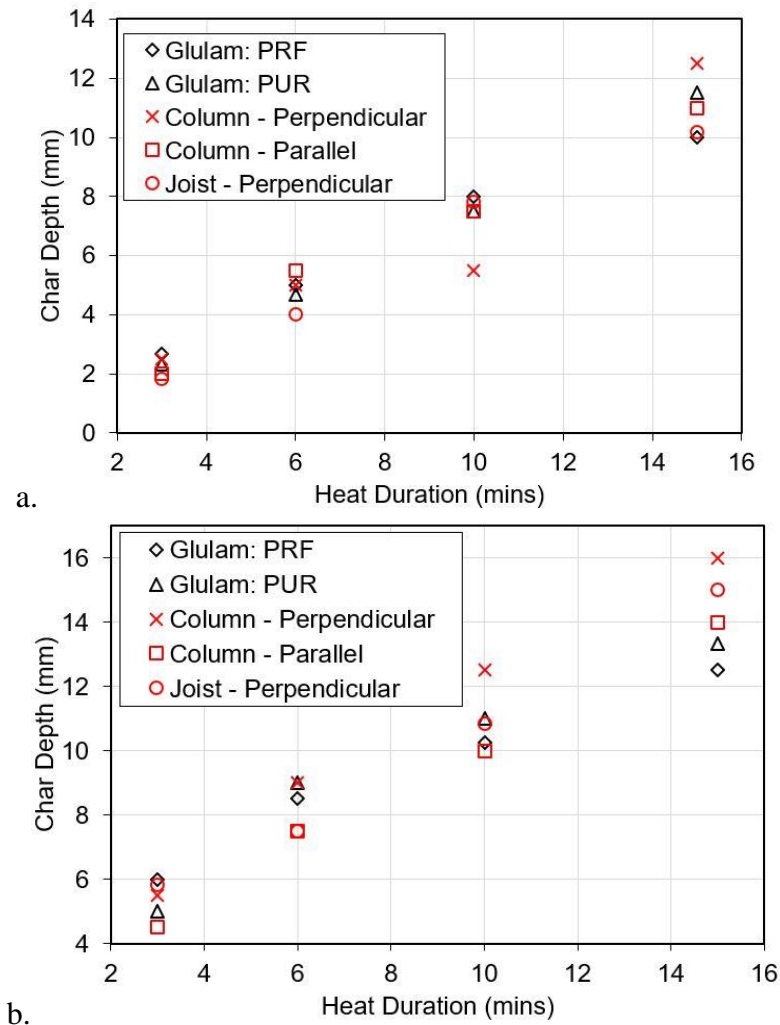
The charring of the timber samples was also recorded. Figure 5.9 presents the char depth results for the 3, 6, 10 and 15 minute tests for all timber types (in Figure 5.9, each data point represents the average of two samples). At  $30 \text{ kW/m}^2$ , the char depth of all of the timbers are relatively close. At  $50 \text{ kW/m}^2$ , there is a bit more deviation. At the longer heat durations, and especially at 15 minutes (which is the most severe heat exposure considered), the historic timbers have charred more than the contemporary timber. On average for 15 minutes at  $50 \text{ kW/m}^2$  the historic timber had 1.75 mm (13%) more char than the Glulam.

Figure 5.9 Average char depths for each type of timber at a. 30 kW/m<sup>2</sup> and b. 50 kW/m<sup>2</sup>.

The results of the char depths and charring rates showed some discrepancy between the historic and contemporary timber. At 30 kW/m<sup>2</sup>, all of the timber types charred similarly. At 50 kW/m<sup>2</sup>, the historic timber had slightly more char depth, especially noticeable at the heat duration of 15 minutes. This may imply that at more severe heat durations the char depth of the historic timber will be slightly greater than the contemporary timber. One of the reasons that may help to explain the difference in char depths and charring rates is the density of the timber. The Glulam

From Figures 5.9, 5.10, and 5.11, there seems to be relatively similar performance of all timber types at 30 kW/m<sup>2</sup>, and at 50 kW/m<sup>2</sup> up until 15 minutes, at which point the heritage timber begins to char faster. The cause for the initially similar performance that then begins to deviate could potentially be attributed to differences in growth ring width and cellular structure of the timber. As previously mentioned in this chapter, the Glulam timber tested had very thin growth rings, whereas the historic timber had wider growth rings which could possibly be due to differences between historic and contemporary growing practices. When the timber is heated, the timber converts to char and begins to crack as the timber dehydrates. To the author's awareness, there is little information regarding the effect of timber's properties such as density and cellular structure on the formation and size of cracks developed during a fire, however, one possible factor contributing to the difference in performance between the historic and contemporary timber is that the very thin growth rings seen in the Glulam could be less susceptible to the formation of large cracks. Cracks allow for the ready escape of volatiles [26], which affects the charring performance of timber. At lower heat fluxes and durations, there may not have been an opportunity for sufficient cracks to form causing this effect, though this could potentially be seen at higher heat fluxes and

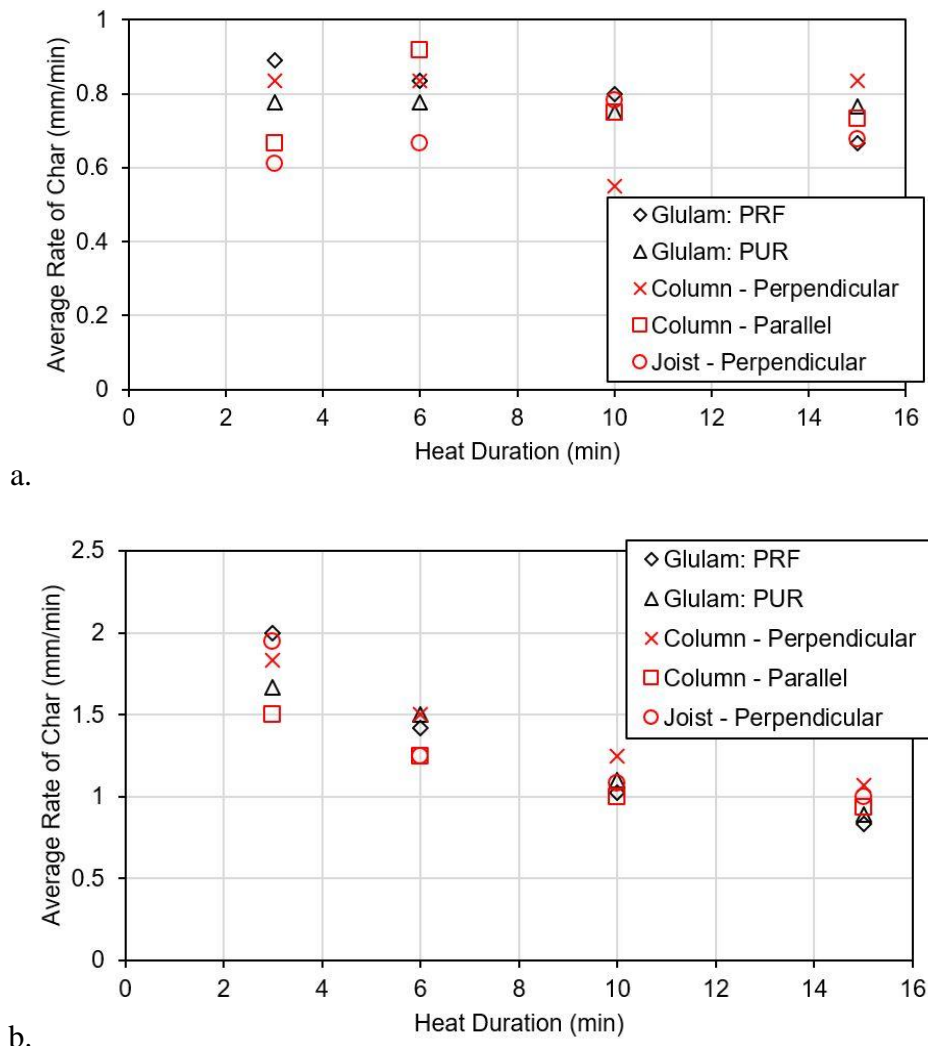
The charring rate of the timber was calculated from the char depths and the heat duration. The charring rate was taken as the total char depth in millimetres, divided by the total heat duration in minutes. The charring rates for the 3, 6, 10, and 15 minute tests are seen in Figure 5.10. Similar to the char depths observed, the charring rates at  $30 \text{ kW/m}^2$  do not seem to indicate that any type of timber is charring particularly quickly or slowly. At  $50 \text{ kW/m}^2$ , it can be seen that the charring rates begin charring quicker and then level off. While all the timbers seem to be charring at similar rates, it is notable that at the most severe heat exposure of  $50 \text{ kW/m}^2$  for 15 minutes, all of the historic timbers report a faster charring rate than the contemporary timber, however the charring rates at this heat exposure only range from 0.83 mm/min (Glulam – PRF) to 1.07 mm/min (Column – Perpendicular). These charring rates are slightly above the charring rates previously reported in

Figure 5.10 The charring rates for the 3, 6, 10 and 15 minute test durations at a. 30 kW/m<sup>2</sup> and b. 50 kW/m<sup>2</sup>.

As seen in Figures 5.10 and 5.11, the charring rates of the timber at 50 kW/m<sup>2</sup> are beginning to plateau. Considering only Glulam PUR and the historic joist, the charring rate appears to be plateauing around 0.68 mm/min for the Glulam, and 0.85 mm/min for the joist. The joist was therefore charring at a rate 20% faster than the Glulam.

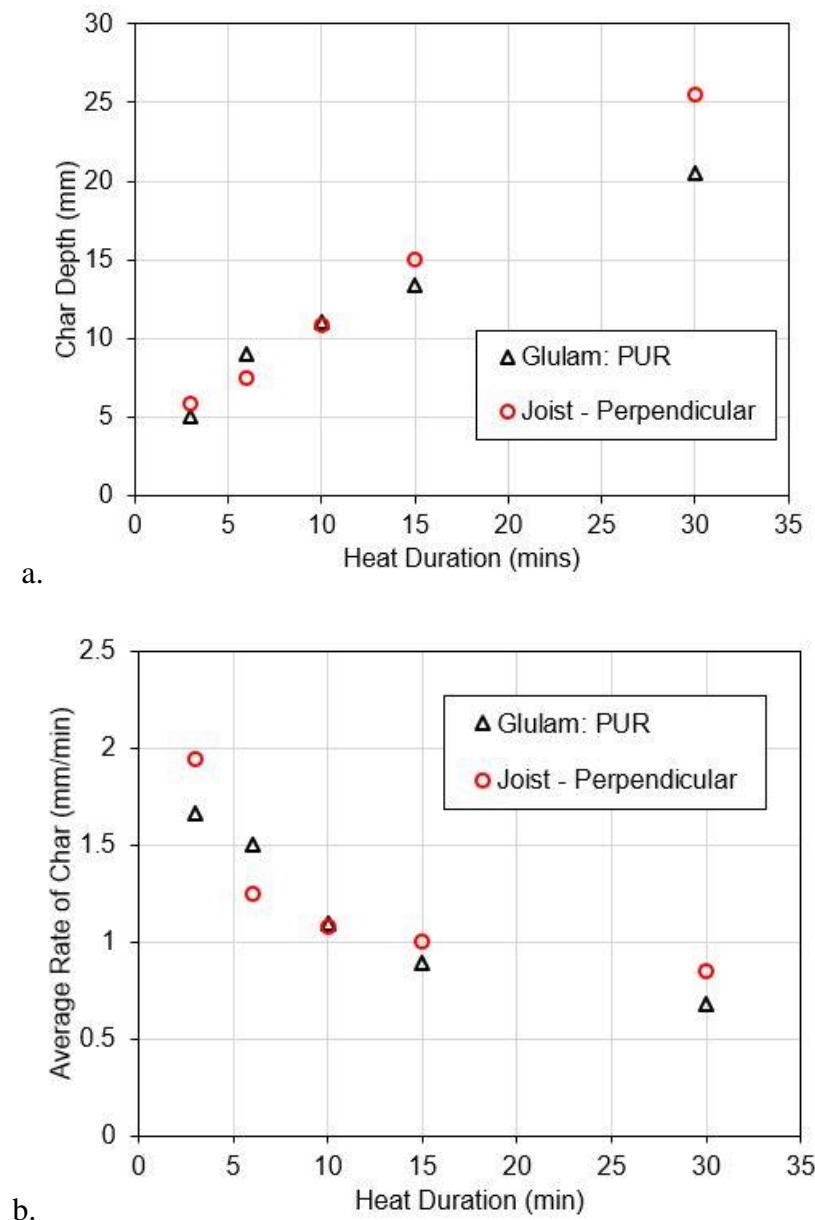
Figure 5.11 Results for Glulam – PUR and Joist inclusive of the 30 minute tests, a. char depth and b. charring rate.

Two timber types (Glulam – PUR and Joist) were also tested for 30 minutes at 50 kW/m<sup>2</sup>. The charring depths and charring rates for these timber types for every test duration are seen in Figure 5.11. Some of the trends previously described are exemplified by the 30 minute test. For

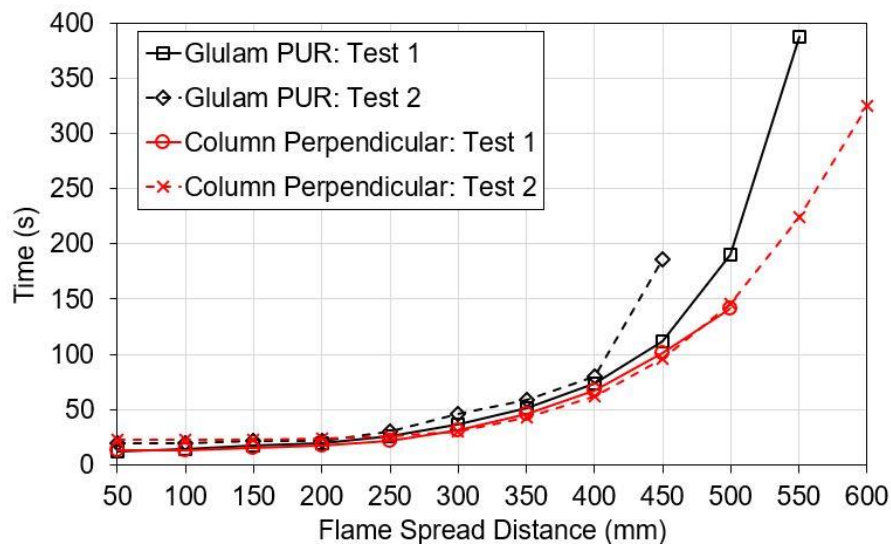
The flame spread results of the LIFT tests are seen in Figure 5.12. Recall that in these tests, only Glulam PUR and Column – Perpendicular (heat exposure perpendicular to the grain) were tested. Data ends where the flames auto-extinguished or the flame stopped spreading. The flame spread on the historic Column was faster and spread further than the flaming on the contemporary Glulam. The flames on the historic Column stopped spreading at 141 and 325 seconds (for Test 1 and Test 2, respectively), whereas the flames on the Glulam took longer to stop spreading, at 186 seconds and 388 seconds (for Tests 1 and 2).

Figure 5.12 Flame spread along Glulam – PUR and the historic Column.

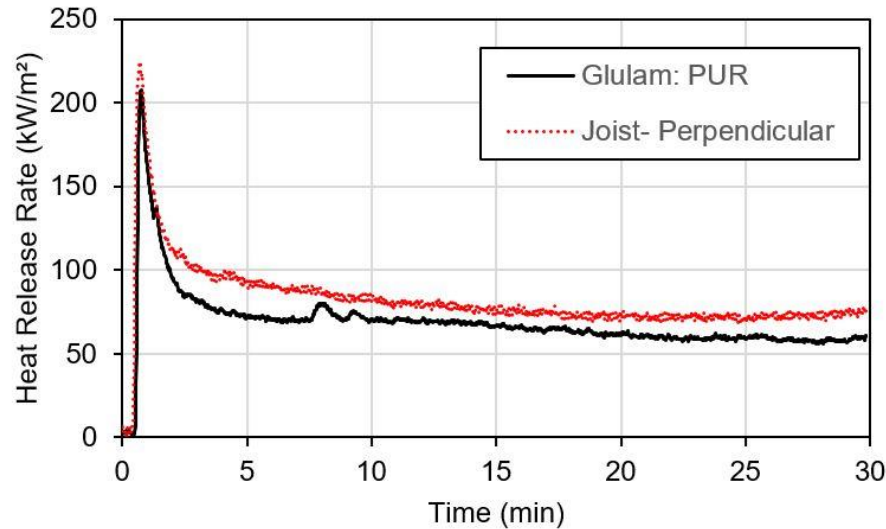
Figure 5.13 Heat release rate of the 30-minute Cone Calorimeter tests.

As seen in Figure 5.13, the heritage timber and contemporary timber have different heat release rates. In these tests which use radiant heaters, the heat flux emitted by the heater is not dependant on the heat created by the timber itself, as opposed to furnace testing where the quantity of fuel will be adjusted in order to follow a specified time temperature curve. For the tests examined in this test series, all timber was subject to a heat flux of either 30 kW/m<sup>2</sup> or 50 kW/m<sup>2</sup>, though as discussed above the actual severity the samples were exposed to may vary based on composition of the timber and due to ignition of the material. From Figure 5.13, the contemporary Glulam does not have as high of HRR as the historic timber from the joist for the majority of the test duration, even though the heat flux subjected by the radiant heaters was the same.<sup>3</sup> In this sense, the heat conditions created on the surface of the timber are dependant on the performance of the timber, and the external heat flux (from the radiant heater) is not reduced for a higher HRR. These tests therefore give a representative comparison of the relative charring of one type of timber to another, and in this aspect the test procedure used in this study is beneficial for comparative

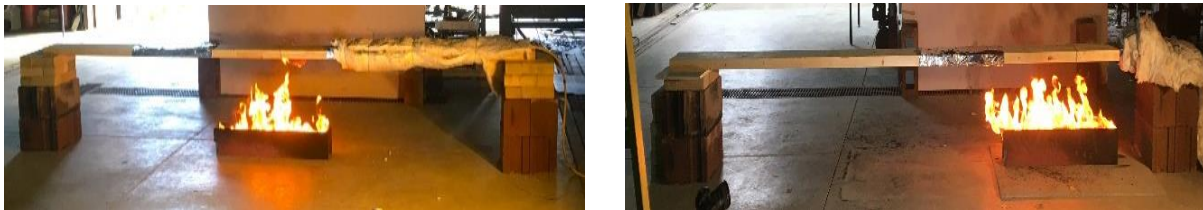
A custom experimental procedure was designed for the fire response tests conducted. This testing consisted of localised fire exposure (shear and moment regions of the specimens) followed by mechanical testing of the beams afterwards. The first phase test setup, consisting of a single beam locally exposed to a fire is shown in Figure 6.1. The fire for each test was fuelled by 1 litre

of kerosene, contained in a one-meter long modified steel (W section) trough.<sup>4</sup> While the fire exposure is dependent on the fuel type considered, in this case the objective was simply to create a quantifiable and repeatable char depth on the specimen. The fire dynamics of this test series was therefore not of interest and only the repeatable damage state was of concern, and it was decided that any fuel type that would generate an easily repeatable damage state would suffice.

The fire burned for approximately 5 minutes, producing a peak surface average temperature of 900°C on the exposed beam. The heating configuration was determined through a series of test burns. The beams were exposed to fire twice; once along each of the depths (sides) of the beams (the beams were flipped). As the purpose of the pool fire procedure was to create a repeatable damage state, the beams were protected outside their fire exposed regions to inhibit flame spread for a more quantifiable damaged area. This was done by wrapping the beams in aluminum foil in the regions where no char was desired (seen in Figure 6.1). Insulation was also used to protect thermocouple wires running from the data acquisition unit to the pool fire (also seen in Figure 6.1). No water was needed for extinguishment as the beams auto-extinguished once the kerosene fuel was consumed. The fire is to be considered a short period of real fire impingement on a structural element. The fire exposure was designed as non-standard to explicitly induce a controlled and quantified amount of charring on the samples from test to test.

Figure 6.1. Test setup of the heating portion of the experiment for the moment region (left) and the shear region (right).

Of the charred beams, two beams were charred across a 1 m length directly in the center of the beam, and three were charred across a 1 m length on one end, beginning 270 mm from the edge of the beam (Figure 6.1). The purpose of these locations is that in the next phase of testing (mechanical loading through four-point bending), the centre of the beam would be in the region of highest moment, and the side of the beam would be in the regions of constant (highest) shear. This heating configuration had negligible differences in the amount of char observed, even along the top and bottoms of the beams (5 +/- 1 mm at three locations on each beam equally spaced and across the depth). Aluminum foil was wrapped around the beam immediately adjacent to the intended char zone to limit the radiant heat and flame spread to other parts of the beam. When the pool fire burned out, the beams were left to auto-extinguish. Since this happened immediately, no water was used for extinguishment. This test setup allowed for two-sided heat exposure.

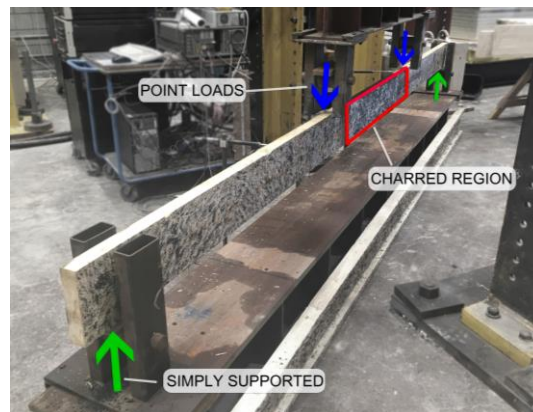
A second set of beams was used to compare strength loss due to degradation beyond the char layer. This set of beams consisted of Beam 3 and Beam 7 (from Table 6.1). Both of these beams had an area of cross section mechanically removed to represent the cross sectional area lost to char in the fire damaged beams. Beam 3 was mechanically carved in the centre, to be compared with the beams damaged in the moment region, while Beam 7 was mechanically carved towards the side, to be compared with the beams damaged in the shear region. The area removed was approximately 5 mm deep on all four exposed sides and 1 m long, consistent with the charred area on the fire damaged beams (see Section 6.4.1 for details). All damaged beams (charred and carved) therefore had the same non-charred cross-sectional area for the mechanical testing. In this manner, any variation in the strength data will be due to factors other than the effective cross section reduction of the damaged beams. The intention on this degree of charring (5 mm) is not to be thought of as information on timber's fire resistance, but rather a controlled set amount of damage that can allow the underlying breakdown mechanisms of timber exposed to fire to be rationally studied. After time for re-acclimatizing to lab moisture conditions (5%) four-point loading was performed to induce constant moment and shear on the specimens. Beams were restrained against lateral torsion at the supports and at the points of load application. The loading setup can be seen in Figure 6.2.

Figure 6.2. Mechanical loading of simply supported beam with four-point loading.

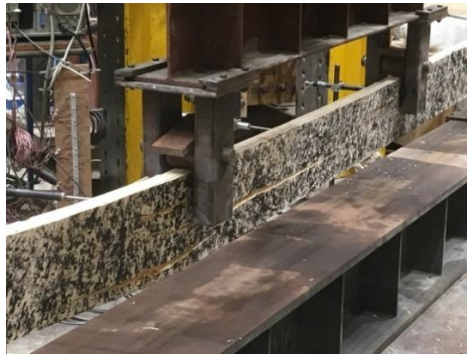
As they were mechanically loaded, the beams primarily failed within the moment region, along both adhesive bond lines and finger joints. The failure mode can be seen in Figure 6.3, where the failure originated along the adhesive bond lines within the moment region.

Figure 6.3. Failure mode of a Glulam undamaged control beam.

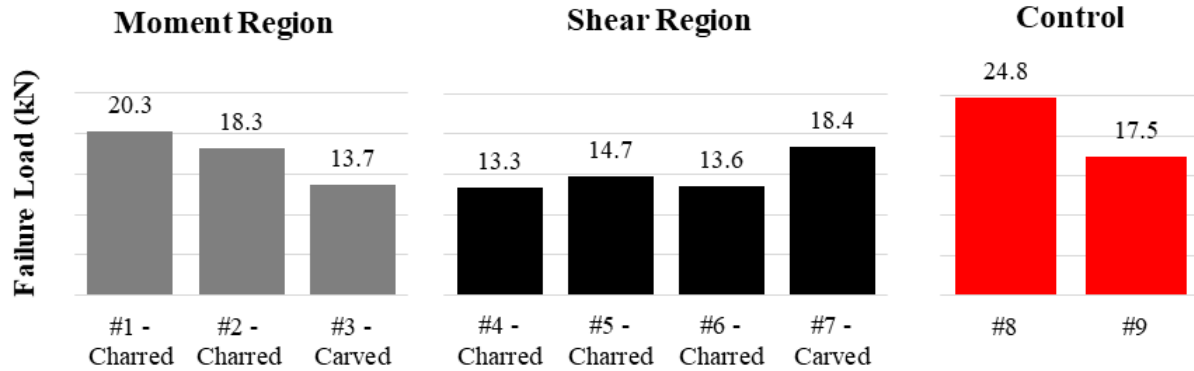
The average failure loads obtained during the mechanical loading are summarized in Figure 6.4. On an average basis, the control beams failed at the highest applied load, with all of the carved and charred beams failing at lower loads. All failure loads were higher than the hand calculated estimated strength, accounting for only the reduction in cross sectional area (predicted as 10.6 kN for the damaged beams). The displacement of the beams is presented in the plots of load versus vertical displacement in Figure 6.5. Displacements were measured by digital image correlation. In all tests lateral movement measured by linear potentiometers (an indication of torsional failure) was negligible.

Figure 6.4. Failure load of all beams damaged in the moment region, shear region, as well as the control beams.

The two control beams failed at relatively high loads with the difference between them possibly due to inherent material variability between the specimens. Amongst beams damaged in the moment region (midspan), the results were quite variable; the beam with mechanically reduced cross section failed at a relatively low load compared to the charred specimens, which withstood relatively high loads, losing only 8.9% (1.9 kN) of their capacity. It is possible that the carved beam had a material defect that was not visibly apparent, causing the low failure load. A large reduction in moment capacity was not expected from the exposure as the depth of the cross-section was largely unaltered, which is the dimension that moment capacity is most dependant on.

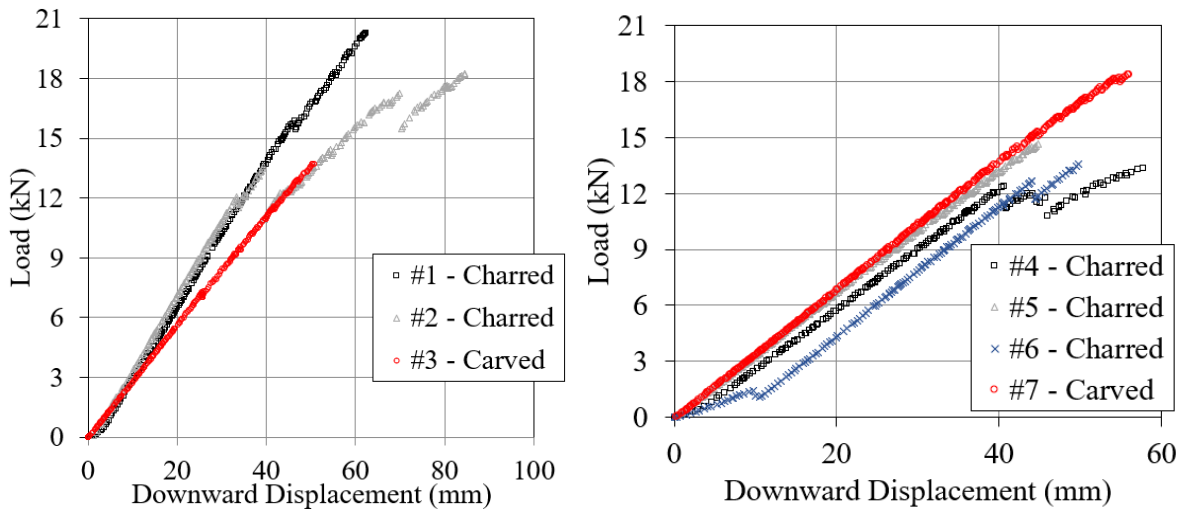
Figure 6.5. Load versus downward displacement beams damaged in the moment region (left) and shear region (right).

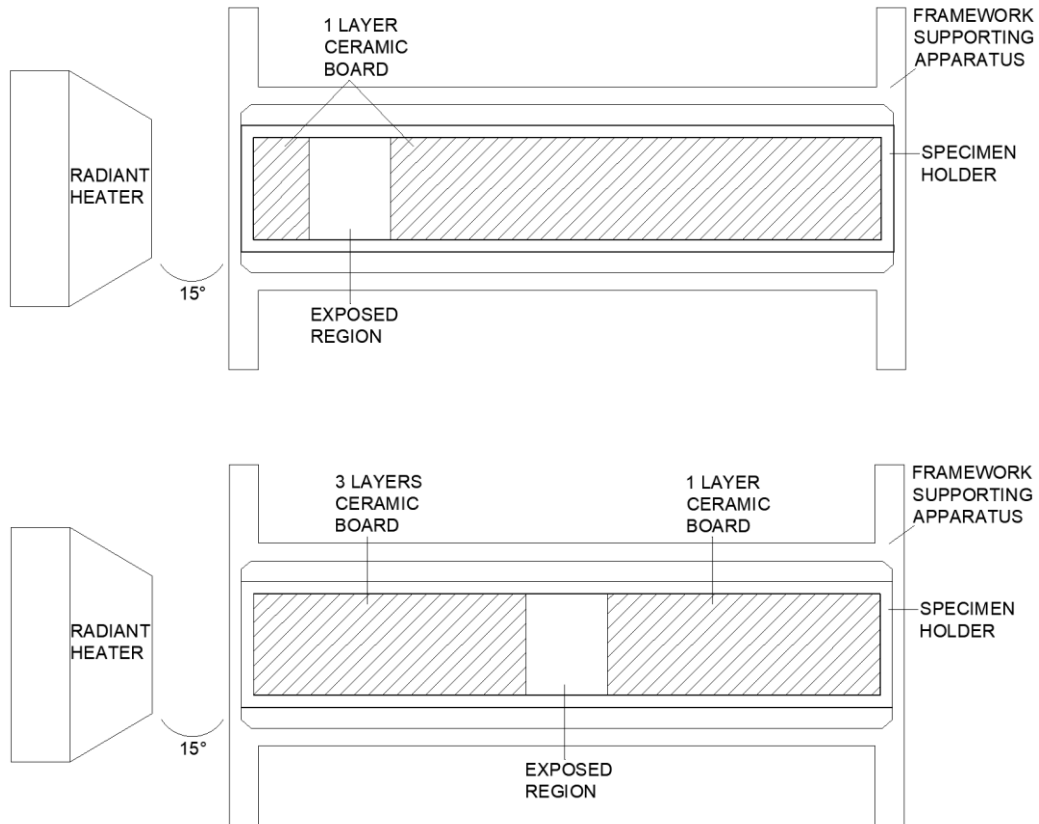
measure or propagate flame spread across the beam, only to use radiant heat to achieve a specific char depth. Additionally, the holder of the beams within the LIFT apparatus was modified so as to only expose specific regions (in the center or the side) of the beam to heat. Multiple ceramic boards designed to prevent heat penetration were placed in front of the engineered timber samples in locations where char depth was not desired. This is seen in Figure 7.1. This configuration ensured that only the exposed portion of the beam would be damaged. The adhesive lines in the Glulam were parallel to the heat flux while the adhesive lines in the LVL were perpendicular to the heat flux (orientation of the specimens was retained from the original beam orientation). The Glulam was only one laminate thick, therefore the Glulam beams did not have any adhesive lines perpendicular to the heat flux. The angle of the radiant heater was left unchanged from ASTM E1321 specifications, where it is placed closest to the member near the side and angled 15 degrees away towards the middle.

Due to the extended exposure duration of the beams exposed in the center, three layers of ceramic board were used for the moment damaged beams instead of the one layer that was otherwise needed, to ensure no damage was created where it was not desired. The extra boards were fastened externally to the holder (using Nickel-Chromium wire).

Figure 7.1 The heating test setup for the beams damaged in the shear region (top) and the moment region (bottom).

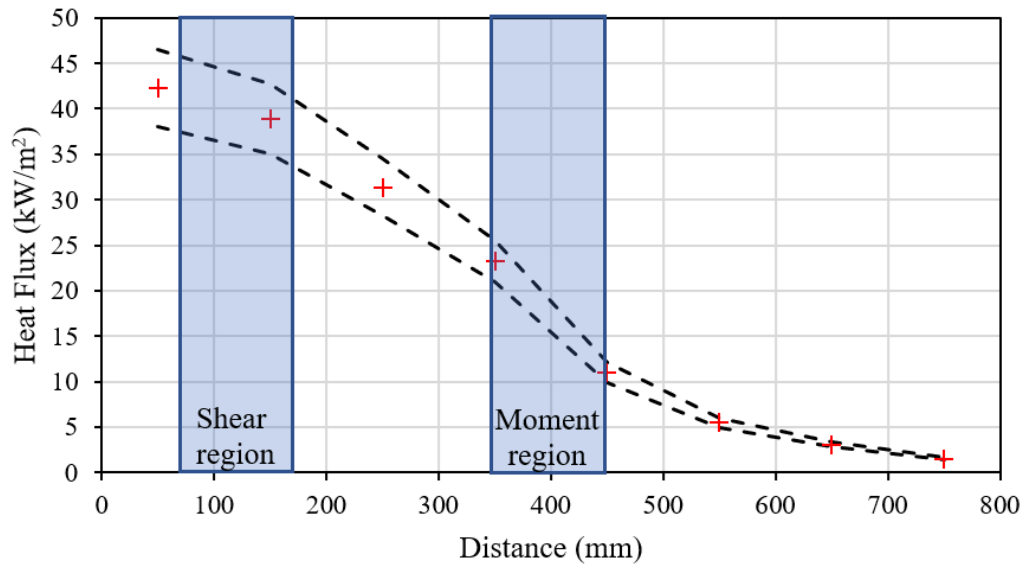
One consequence of placing ceramic boards in front of the engineered timber samples is that the samples were approximately 12 mm (the width of the ceramic board) further away from the radiant heater than typical. This caused the heat flux to vary slightly from its usual capacity. A calibration was performed to determine the heat flux that would result from an offset of 12 mm. The results can be seen in Figure 7.2. This figure also displays the prescribed error of the LIFT apparatus heat flux gauge, which is taken as 10% of the incident heat flux.

Figure 7.2 Heat flux measured by LIFT apparatus after an offset of 12 mm was applied, with the error of the apparatus displayed as contour lines.

The heat flux of the radiant panels reaches a maximum of  $50 \text{ kW/m}^2$  (the heat flux along the entire length of the beam is seen in Figure 7.2). While a real fire will be more severe than  $50 \text{ kW/m}^2$ , these small-scale tests will still give an indication of the adequacy of the values used for the zero-strength layer. Moreover, this test series primarily examines the strength remaining given a particular damage state (char depth) and attempts to assess whether current code procedures are conservative given the damage, not the severity of the heat exposure.

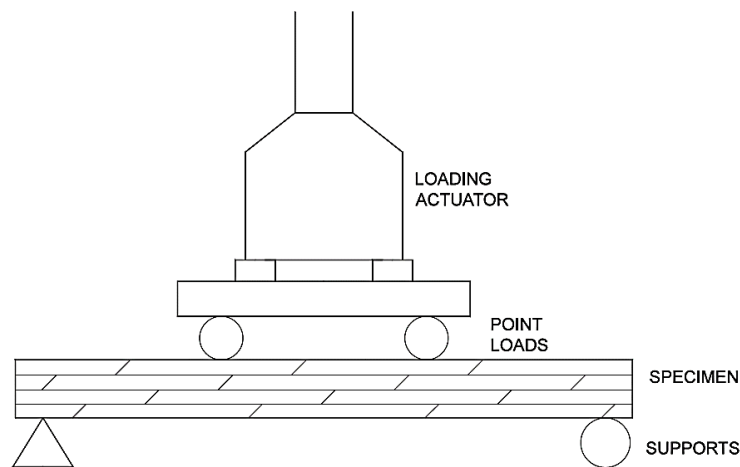
Mechanical loading occurred at a rate of 2.5 mm/min, in line with the loading rate used for ASTM D143 for four-point bending tests [128]. A load actuator applied two-point loads onto the simply supported beams. The total span of the beam was 800 mm. The ends of the beams were aligned with the centre of the supporting rollers, with a small plate that could rotate freely in between the roller and the beam. This setup negated the need for the beam to overhang past the support (such that the beam length and span are both 800 mm). The setup of the mechanical loading procedure can be seen in Figure 7.3 (where Glulam is depicted, and damaged regions would be on the front side and back side of the beams, with the top and bottom being undamaged). All beams were loaded to failure. The damaged areas of the beams were oriented to be on the two sides of the beam, and not on the top and bottom.

Figure 7.3 The four-point bending test setup.
