**THE THERMOMECHANICAL RESPONSE OF STRUCTURAL TIMBER IN REAL  
FIRE EXPOSURES**

A DISSERTATION SUBMITTED TO THE FACULTY OF GRADUATE STUDIES IN  
PARTIAL FULFILLMENT OF THE REQUIREMENTS OF THE DEGREE DOCTOR OF  
PHILOSOPHY

GRADUATE PROGRAM IN CIVIL ENGINEERING  
YORK UNIVERSITY  
TORONTO, CANADA

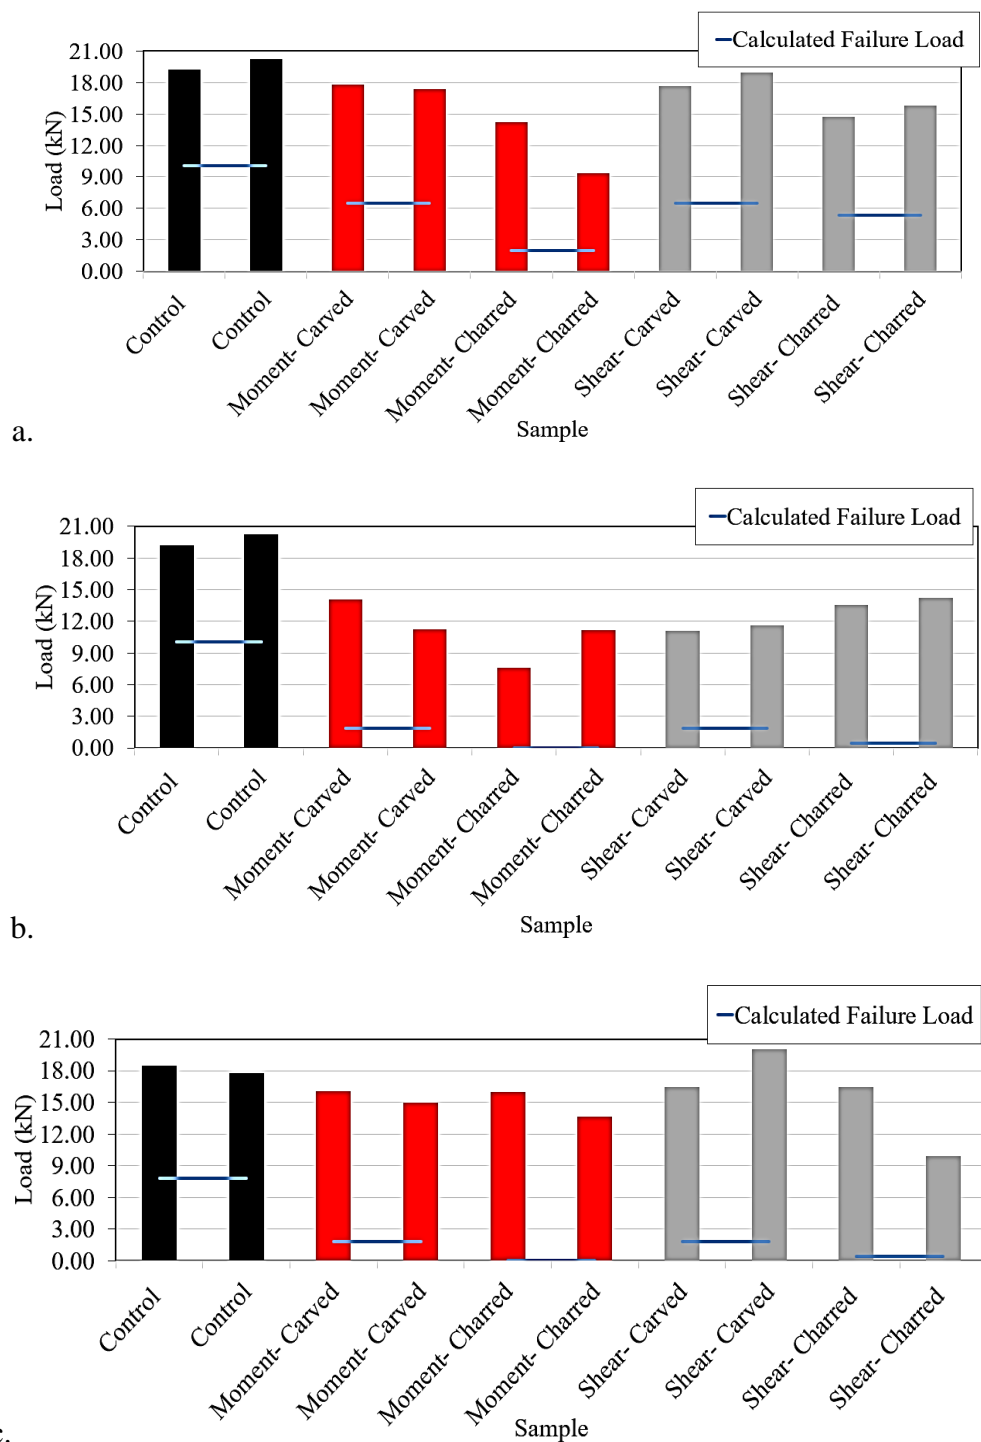
All of the beams failed while they were tested in four-point bending. The average failure loads for each type of damage is seen in Table 7.2. The LVL has been divided into its two damage states (5 mm and 10 mm) for this analysis. The failure loads of both sets of LVL beams and the Glulam can be seen in Figure 7.4. The vast majority of the beams experienced a tension failure within the moment region. The carving process did not reach a very substantial depth, and therefore no significant local stresses were created.

Displayed in Figure 7.4 is the calculated failure load of each beam, as per CSA O86. The beams with 10 mm char have a predicted failure load of approximately 0 kN. This is due to a significant reduction in predicted strength due to lateral stability as the effective width is very small. As the purpose of these tests is not to evaluate the accuracy of the current procedures for calculating char depth, the measured char depth has been used (either 5 mm or 10 mm) in the prediction of the charred beams' failure load. A calculated zero-strength layer has been added to the actual char depth, and the predicted capacity has been calculated based on the remaining cross-section. The zero-strength layer is taken as 7 mm for exposures of 20 minutes or greater in duration, and proportionally less for exposure times of less than 20 minutes [29]. The predicted strength of both the carved beams and the charred beams takes into account the reduction in cross-section,

Figure 7.4 Failure loads for all beams, a. LVL at the 5 mm char depth, b. LVL at 10 mm char depth, and c. Glulam at 10 mm char depth.

For the most part, the LVL 5 mm damage state beams performed as expected. For both the beams damaged in the moment and shear regions, the carved beams carried more load than the charred damaged beams. When compared to the control beams, the charred moment beams had their capacity reduced an average of 40%, while the charred shear beams had their capacity reduced an average of 22%. This indicates that, for LVL, the moment capacity may be more sensitive to thermal degradation of the adhesives than the shear capacity. As the structure of LVL is composed of layers of thin vertical laminates (where the adhesive layers are oriented vertically, parallel to the application of the load), that individually have little moment capacity, it may be more important that the adhesives hold the laminates together to create a single composite unit, which has

The LVL beams carved in the shear region displayed differing results between the 5 mm and 10 mm damage states. For the 5 mm damage in the shear region, the carved beams failed at a higher load than the charred beams. The opposite is true for the 10 mm damage state. The reason the carved beams failed at a lower failure load than anticipated may be that the carving of the beams causes the full width of a number of the laminates to become exposed. As a result, the failure mode that is observed is that the laminates that have become detached fail earlier than the rest of the cross-section. This failure mode can be seen in Figure 7.5 (where the carved area seen on the left-hand side of beam, bound by the split in the wood, and the support). This is less of an issue for the less severely damaged beams, as fewer of the layers of laminates have become exposed during the carving process.

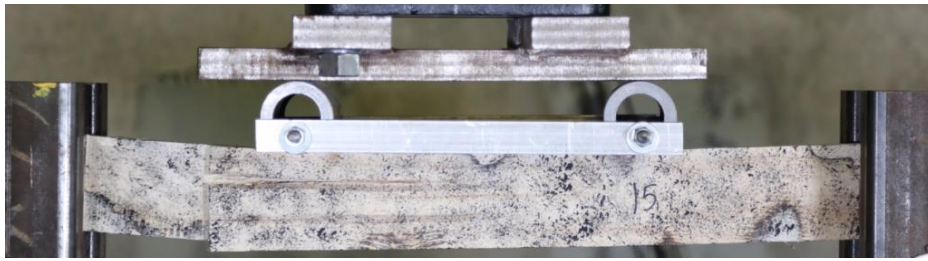
Figure 7.5 Failure of an LVL beam, carved to the 10 mm damage state.

The slope of the load-displacement curves of the LVL beams charred to 10 mm in the shear region (Figure 7.6 b) begin similarly to the charred and controlled beams, but they eventually begin to plateau. This represents the point at which the outer laminates fail (the failure mode seen in Figure 7.5), though the remainder of the beam is still able to carry some load. Also notable is that the load versus displacement curves for the Glulam (Figure 7.6 c) show that one of the beams charred in the shear region (Sample #26 – Charred) experienced a number of drops in its carried load. The initial drop occurs upon initiation of a crack within the shear region. The following drops represent the growth of this crack, which ultimately led to its failure.

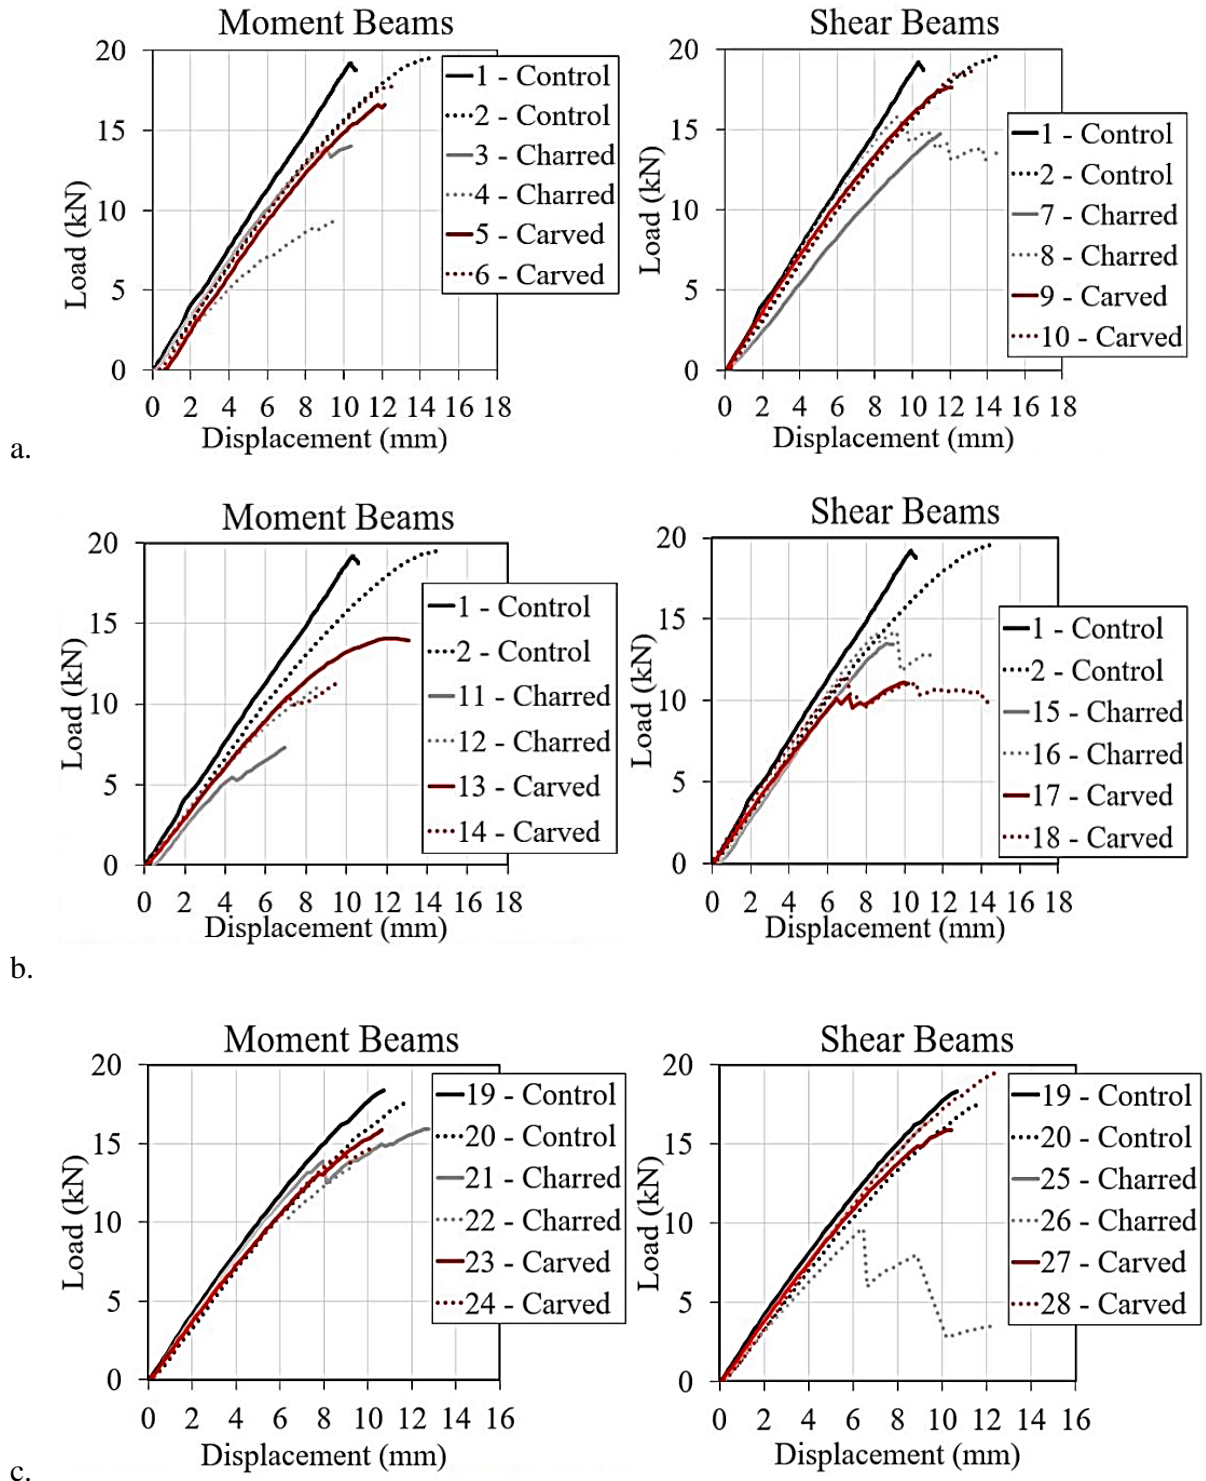
DIC was used to plot the load versus displacement curves for all the beams. These graphs may be seen in Figure 7.6. One of the LVL shear beams charred to 5 mm in the shear region had its capacity drop suddenly a number of times (denoted by Sample #8 – Charred). This beam failed by gradually deflecting, and ultimately cracking in its damaged region. This was also the failure mode for the other charred beam, though they did not exhibit such a sudden failure. This discrepancy may be explained a possible material defect within the LVL, causing it to fail at a lower load than expected.

Figure 7.6 Load versus displacement curves a. LVL at the 5 mm char depth, b. LVL at 10 mm char depth, and c. Glulam at 10 mm char depth.

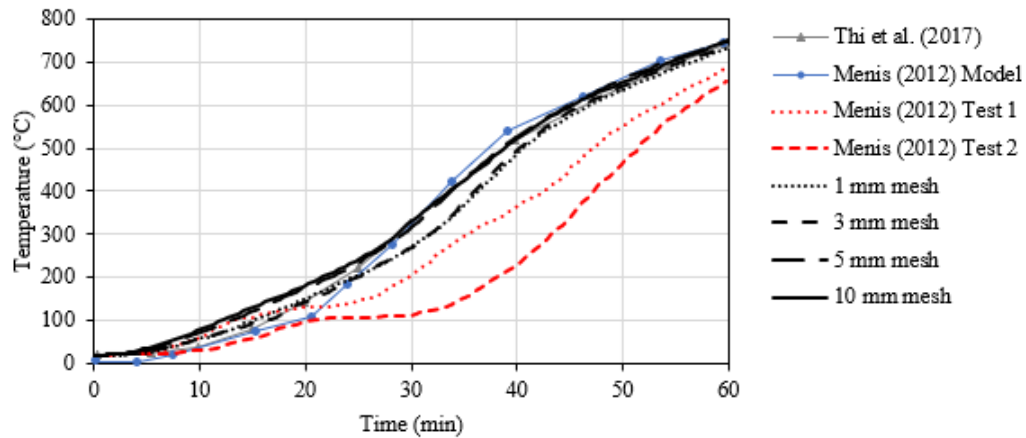
Figure 8.1 shows the results of the mesh analysis, compared to the modelling results of both Thi et al. (2017) and Menis (2012), as well as the data from two experimental tests performed by Menis (2012).

Figure 8.1 Comparison between predicted temperatures of different mesh sizes, with measured temperatures and previous studies by other authors at a) a depth of 21 mm and b) a depth of 52 mm.

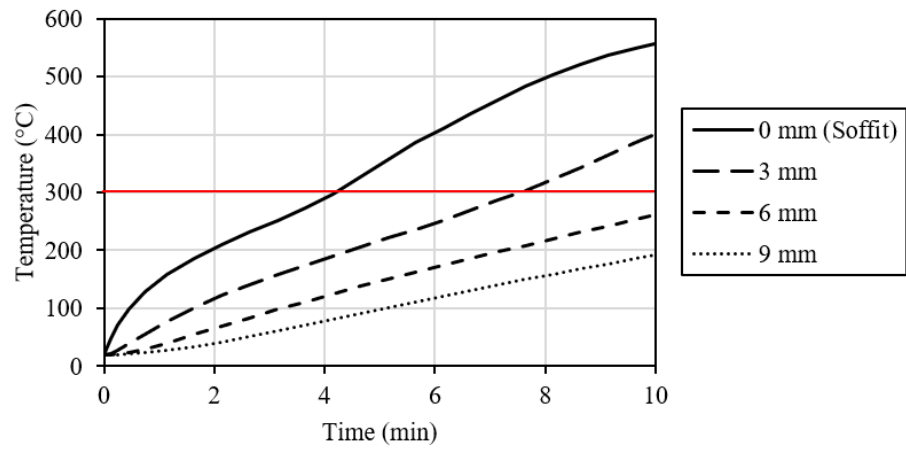
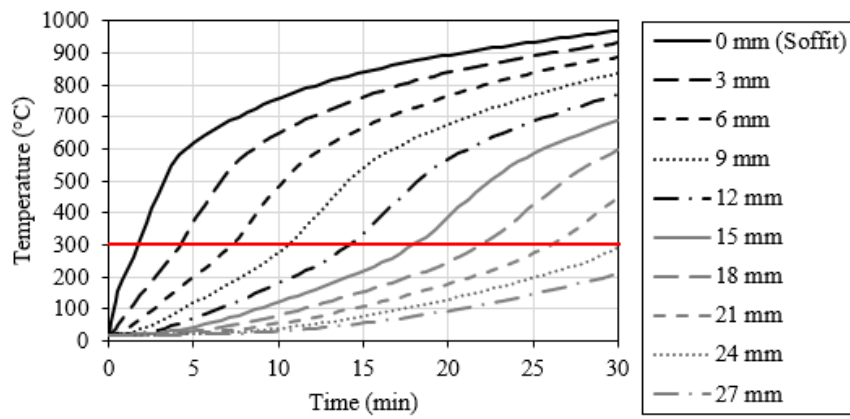
Figure 8.2 Temperature distributions of a) the Glulam members and b) the heritage members. Depths in the legend represent the distance from the soffit of the member, red horizontal line indicates the anticipated charring temperature

The temperature distributions of the Glulam as well as the heritage members used for verification are seen in Figure 8.2. In both figures, the red line at 300°C is used to visualize when a certain depth of timber might char. It can be seen that in Figure 8.2 a) which considers the Glulam

beams, that the beam chars to a depth of 3 mm at approximately 7 minutes and 9 seconds, and the peak temperature at a depth of 6 mm is 262 °C after 10 minutes. From the experiments, it was recorded that the beams charred to a depth of 5 mm +/- 1 mm. Through interpolation, it is expected that after 10 minutes, the timber would be at a temperature of 308 °C at 5 mm from the soffit (and would be considered charred). The percent difference between the modelled char depth and the experimental char depth is 3.5%. The charring rate observed in the model is on average 0.52 mm/min over the 10-minute period. Figure 8.3 shows a comparison of the cross section of the Glulam members post fire, as well as the results of the numerical model. Cracking shown in the photograph was induced by the mechanical loading as described in Chapter 6, and the projected initial areas as outlined in red are adjusted to account for these cracks.

Similarly, in Figure 8.2 b), the heritage members are considered. The experimental tests of these members showed a char depth of 21 mm and 25 mm in the two trials. From the figure, it can be seen that the depth of 24 mm reaches a peak temperature of 292 °C after 30 minutes. Interpolation between 24 mm and 21 mm shows that the depth which would reach 300 °C after 30 minutes and would therefore be considered charred is found at 23.85 mm, well within the range observed in the experimental trials. The percent difference between the modelled char depth and the experimental char depth is 3.7%. The charring rate observed in the model is on average 0.80 mm/min over the 30-minute period. Figure 8.3 shows a visual comparison of the char depths at the end of the heat exposure of the experimental trial that showed a maximum char depth of 25 mm, and the numerical model. Note that in Figure 8.3, a heritage member is shown rather than an engineered member – the initial surface of the member was not perfectly even prior to fire exposure.

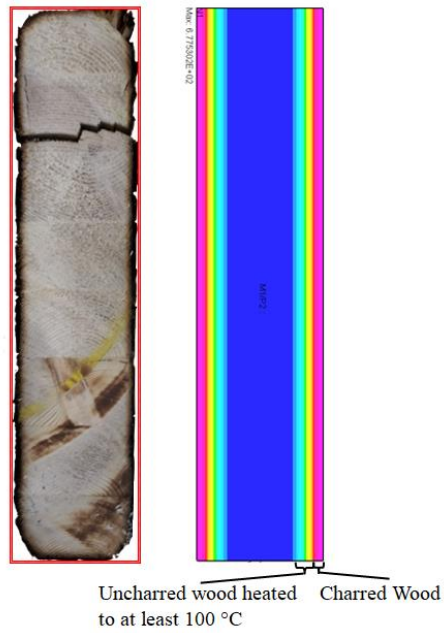
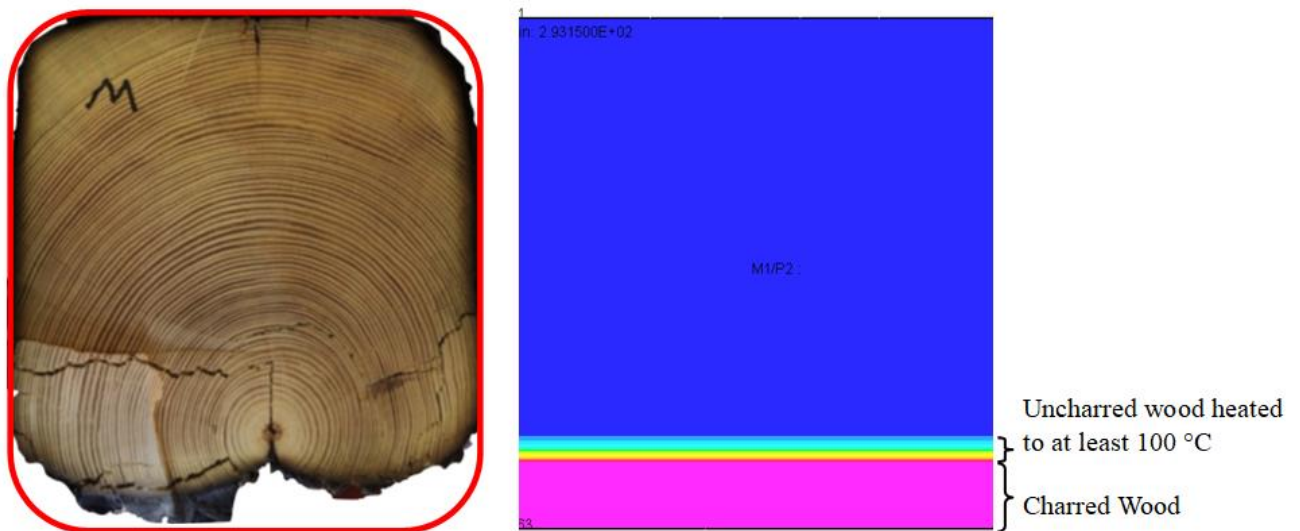
Figure 8.3 Comparison of the charred member and numerical model of a) the Glulam members and b) the heritage members

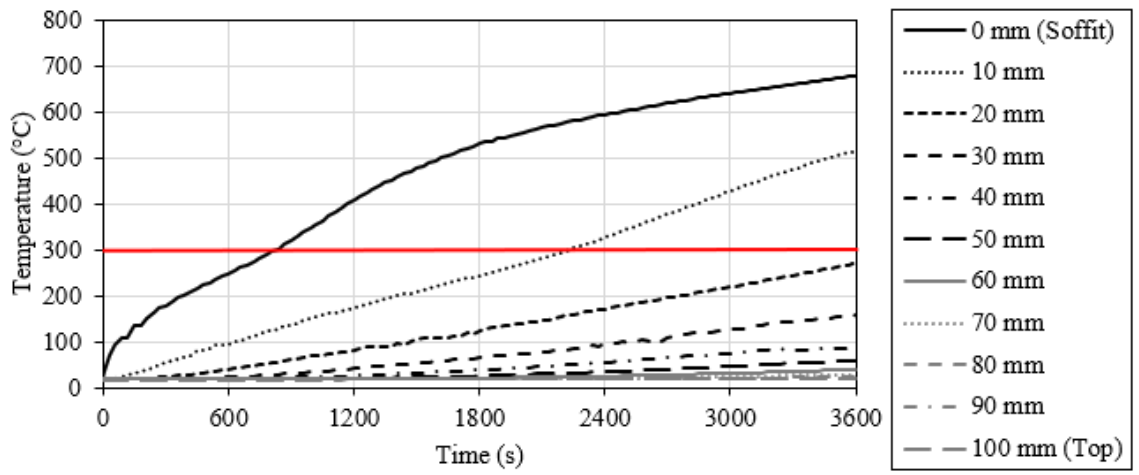
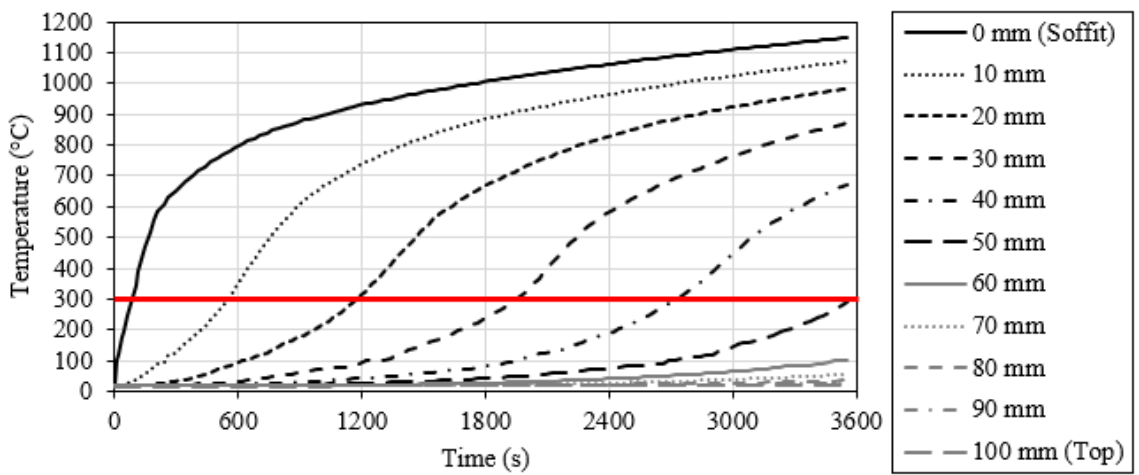
Figure 8.4 Distribution of temperatures based on heat fluxes applied at the soffit of a) 23.9 kW/m<sup>2</sup>, and b) 77.5 kW/m<sup>2</sup>. Depths in the legend represent the distance from the soffit of the member, red horizontal line indicates the anticipated charring temperature

The results of the heat transfer of the two heat flux models are shown in Figure 8.4, where the legend shows the distance from the soffit (the application of the heat flux). Figure 8.5 also shows the temperature distributions within the CLT ceiling at 15, 30 and 60 minutes. Further, the flame spread models were used to highlight needs for data collection. The temperature distribution of the flame spread models is seen in Figure 8.6. It is seen that the temperatures, as expected, are highly dependant on the rate of flame spread and the rate of extinction.

Figures 8.4 and 8.5 highlight the importance of having a clear understanding of incident heat flux of the soffit of the CLT ceiling and its effect on temperature distribution throughout the depth of the ceiling. It was found that the maximum char depth of the models was 2.32 mm for model with a flame spread rate of 19.3 mm/s, and 11.88 mm for the model with the flame spread rate of 1.5 mm/s (assuming that there is no residual smouldering on the member). The slower flame spread rate therefore had a maximum char depth of over 5 times the quicker flame spread rate, emphasizing the importance of flame spread rate in determining the damaged area of a timber member, and resultantly, the residual strength. Figure 8.6 further demonstrates the uncertainty related to flame spread rate and extinction rate, and the impact of these metrics on the temperature distribution of the ceiling, and as a result, the structural capacity of the ceiling.

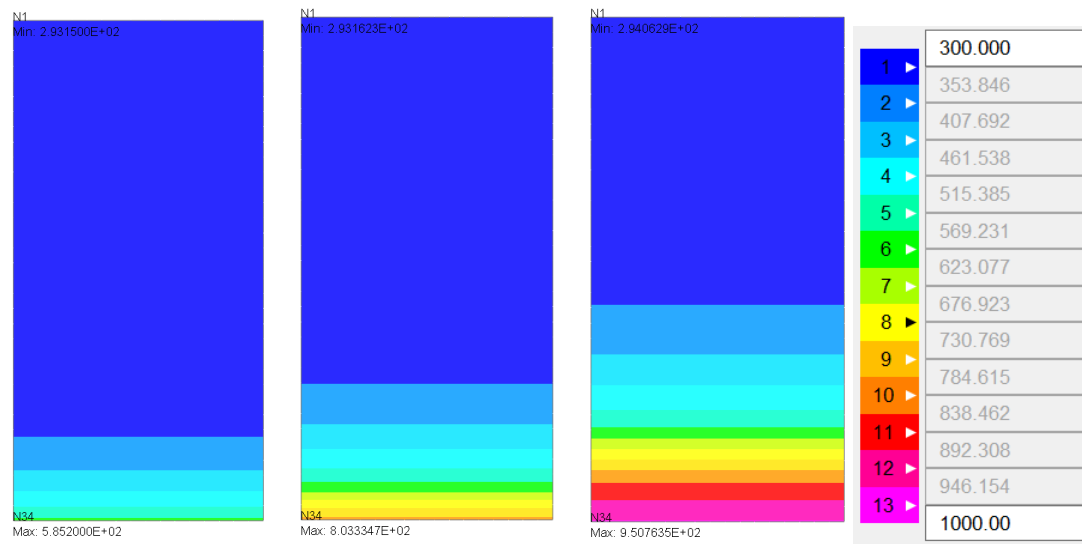
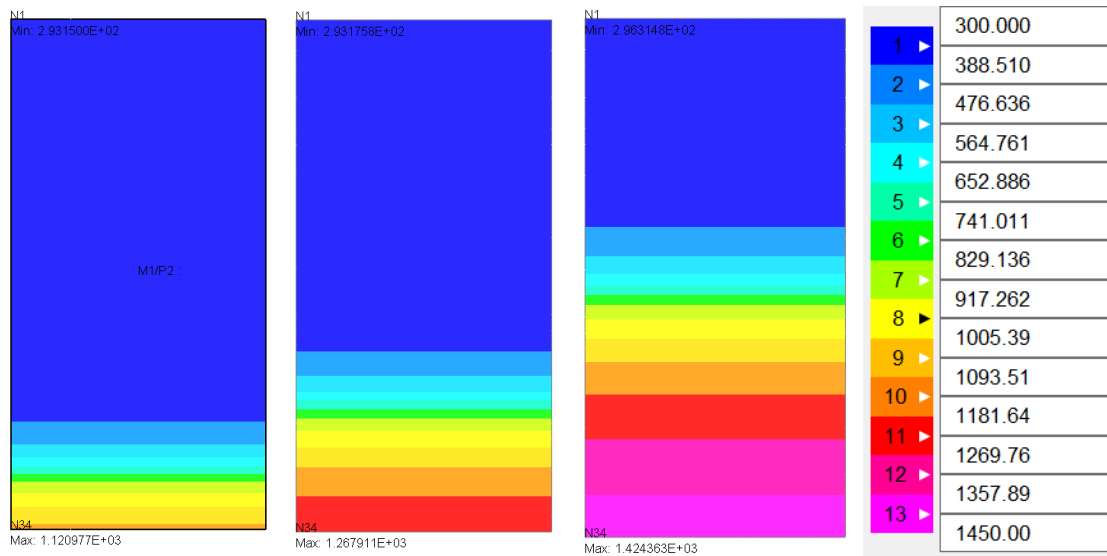
Figure 8.5 Temperature distributions throughout the CLT (from left to right) at 15, 30 and 60 minutes of a) an applied heat flux of 23.9 kW/m<sup>2</sup>, and b) and applied heat flux of 77.5 kW/m<sup>2</sup> (units of temperature are K)

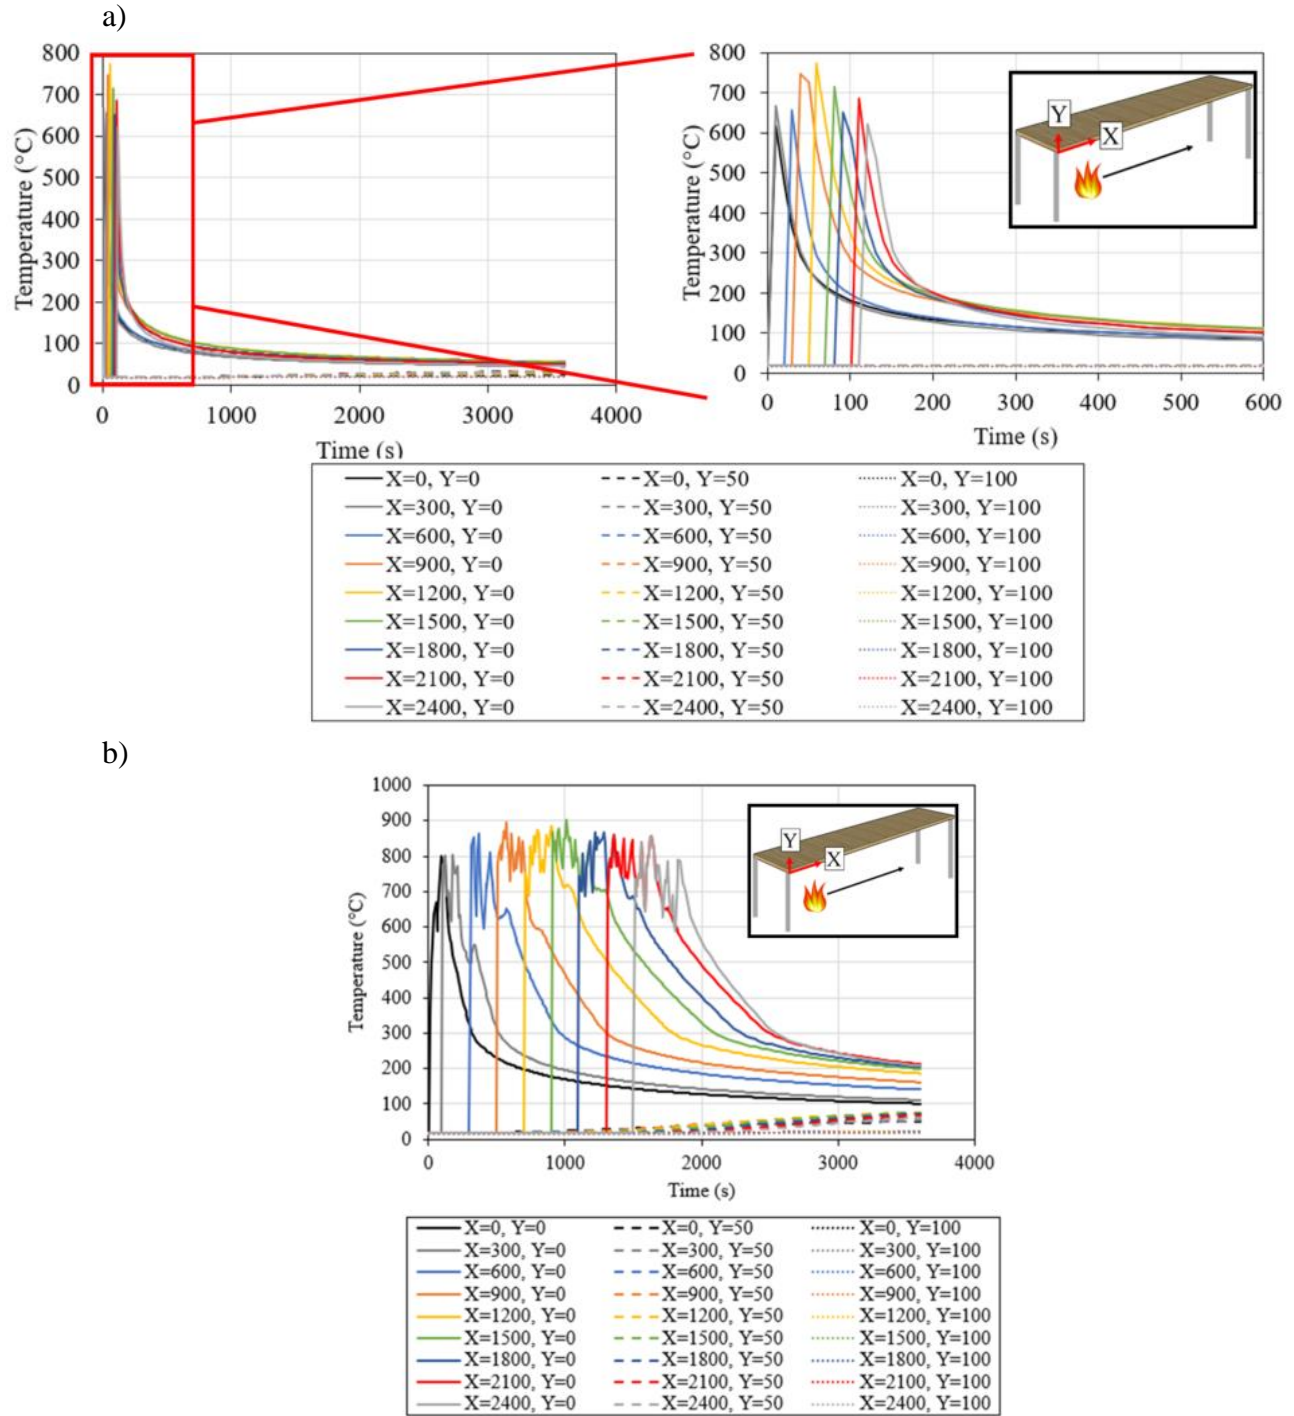
Figure 8.6 Temperatures at varying points along the ceiling considering flame spread rates of a) 19.3 mm/s and b) 1.5 mm/s

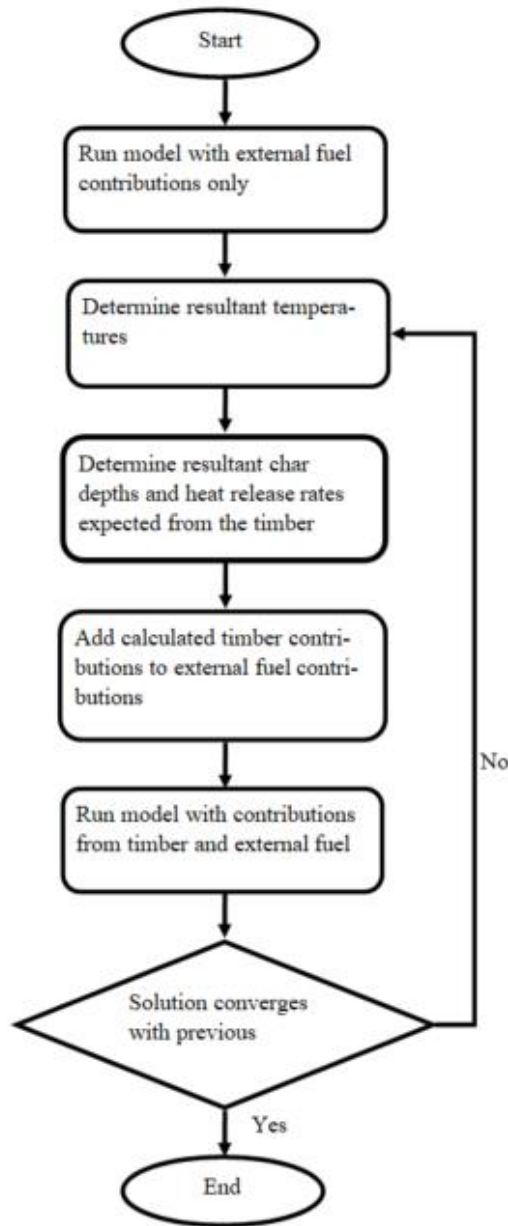
Figure 8.7 Process for incorporating the contributions of timber within the thermal exposure

One aspect that was not considered within the model was the iterative nature of the timber's contributions to the thermal exposure. When timber burns, it creates its own heat, which in turn has the potential to induce additional charring. A flow chart depicting the process that would be needed to incorporate this effect within the model is seen in Figure 8.7.

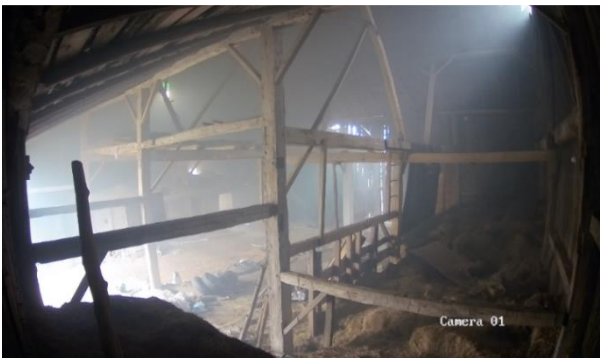
Figure 8.8 15 minutes, 0 seconds

Light is beginning to be obscured from the smoke. Outside, smoke is observed coming from the vents.

A progression of the fire can be seen in Figures 8.8 through 8.14. The times reported are relative to time zero, that is, the time at which the firefighters who were igniting the fire exited the barn structure. A sacrificial GoPro camera was placed inside the barn to monitor the fire, until the camera stopped reporting data 22 minutes and 35 seconds after the firefighters exited the barn.

Figure 8.14 shows the last image after the interior camera was disconnected due to fire damage. As is seen from Figures 8.8 through 8.14, the fire generally progresses by first developing in the location of origin. Smoke begins collecting at the ceiling and can be seen flowing from vents in the ceiling, before beginning to descend inside the structure. The fire begins to spread along the floor, supported by amounts of hay within the barn, at which point embers begin to be emitted. As the fire continues to grow, a ceiling jet is observed. The ceiling begins to fill with flames until the entire ceiling is engulfed. Towards the floor, members at the Southern side of the structure become

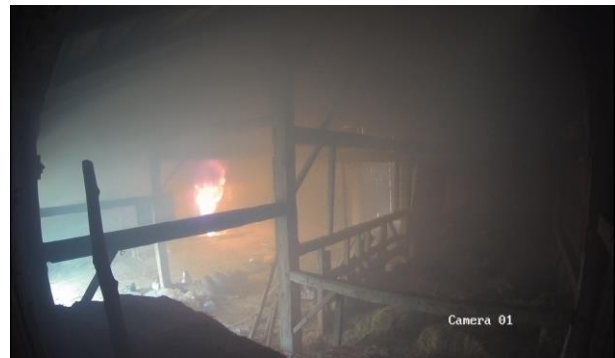
Figure 8.9 17 minutes, 30 seconds

Flames begin flowing from the door of the compartment of origin. Additional smoke is observed, with the smoke layer descending.

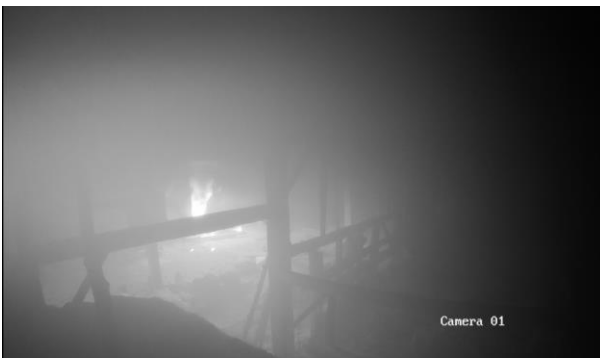
Figure 8.10 19 minutes, 30 seconds

The fire continues to grow, emitting embers. The fire begins spreading on the ground.

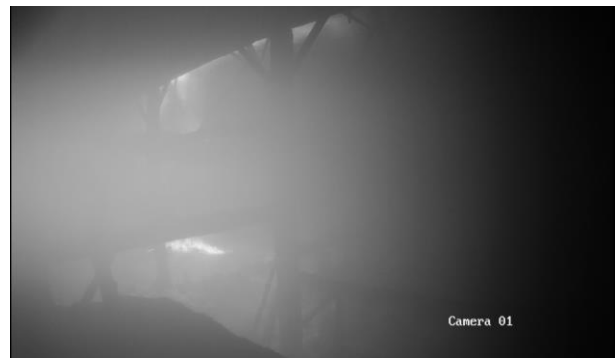
Figure 8.11 20 minutes, 30 seconds

The fire continues to grow, and a ceiling jet is observed.

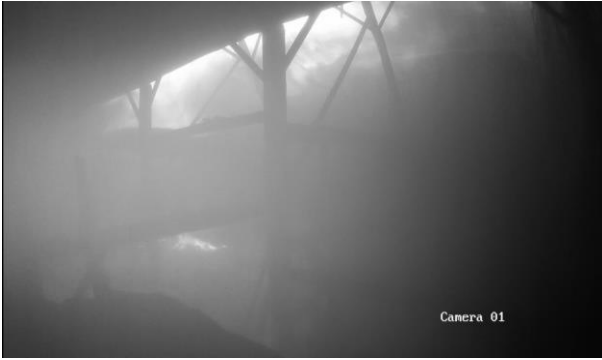
Figure 8.12 21 minutes, 30 seconds

Flames fill the ceiling very quickly until the entire ceiling is engulfed.

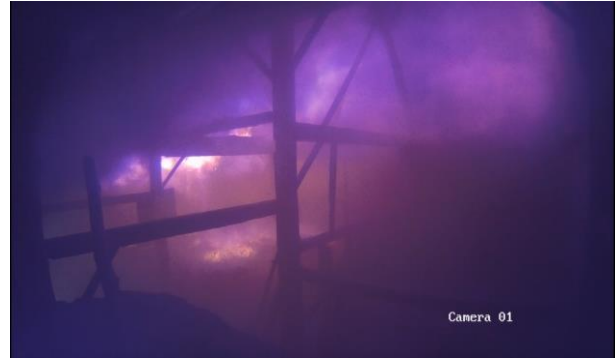
Figure 8.13 22 minutes, 30 seconds

Smoke and flames continue to develop. Members along the southern side of the building are engulfed, while members away from this location show no flaming.

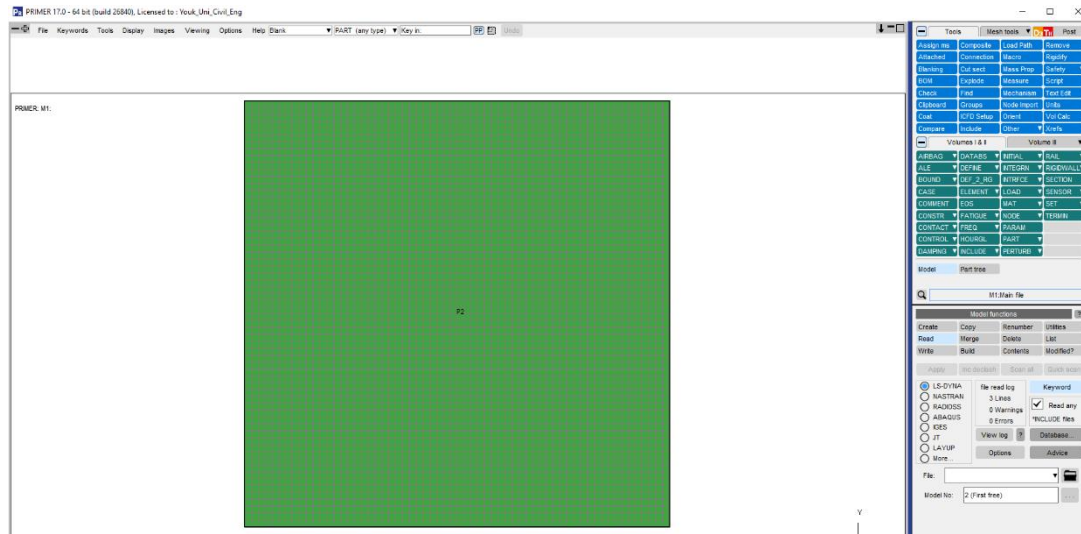
Figure A.1 Overview of Oasys Primer user interface.

Other changes made in Oasys Primer include that the mesh was extruded. This was done by extruding the shells into solids, and specifying the number of shells over the required distance (in this case, 800 shells were extruded a distance of 2.4 m to achieve a consistent 3 mm mesh). Each of the following steps taken in creating the model keyword file was done using Oasys Primer, with an overview of the interface seen in Figure A.1. Figures shown herein are illustrative only, for readers to get an impression of how this modelling was done.

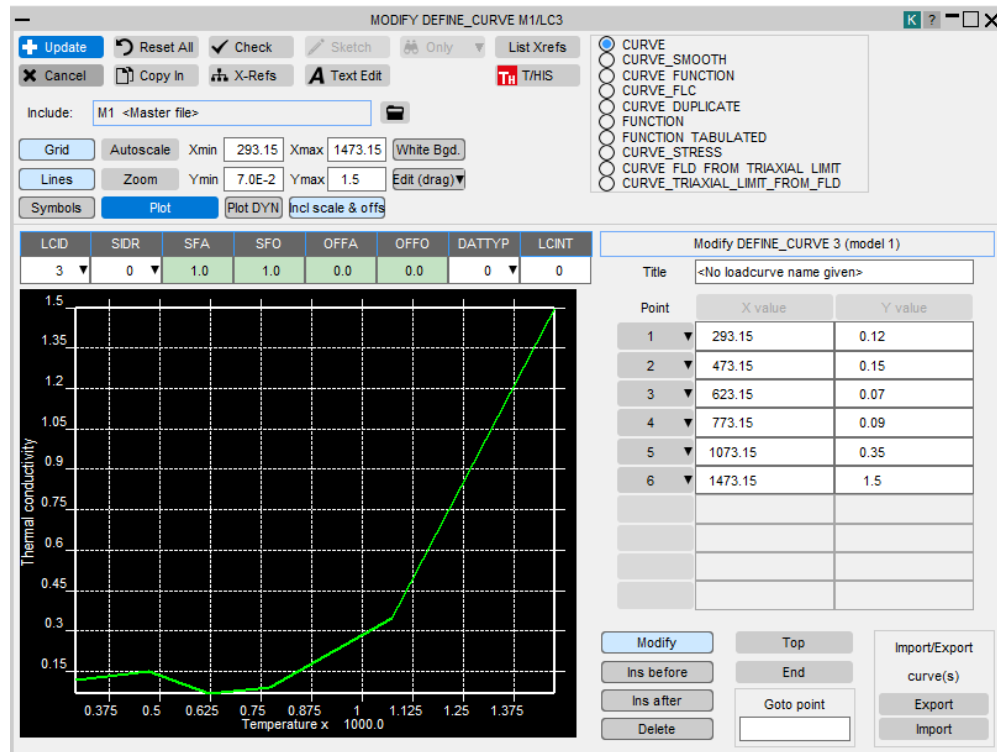
Figure A.3 Defining a curve (thermal conductivity shown here).

The thermal material properties were input into the model, with the specific heat capacity and the thermal conductivity as described in Chapter 8 and as adapted from the Eurocode 5 [5]. Properties were input as Thermal Material Type 10 – which allows for isotropic thermal properties that are temperature dependant and can be specified by load curves. Figure A.3 shows inputting a material property (thermal conductivity) as a load curve. The latent heat was calculated as per Equation 8.1, and the phase change temperature was taken as 373 K (corresponding to the point at which moisture would change phases). The moisture content of the timber is accounted for by the latent heat (the energy absorbed during the phase change of water).

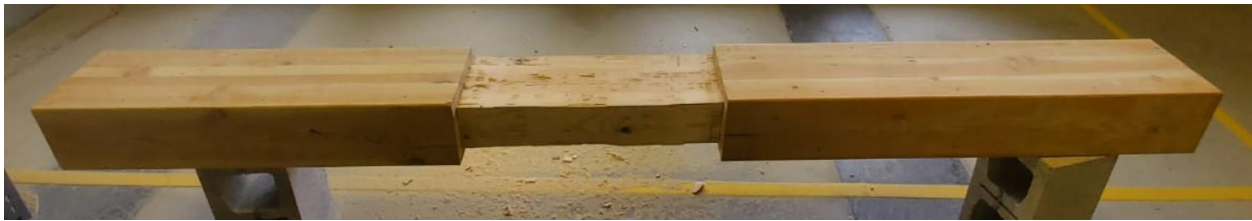
Figure B.1 Carved member before repair.

The carving procedure consisted of using a saw to create guides of a specified depth along the damaged region of the members. The majority of the damaged material was then removed with a chisel. A belt sander was then used to create a smooth and uniform surface, precisely to the desired depth. A carved member before repair is seen in Figure B.1 (where the sides of the member are parallel to the floor, and the bottom is towards the camera).

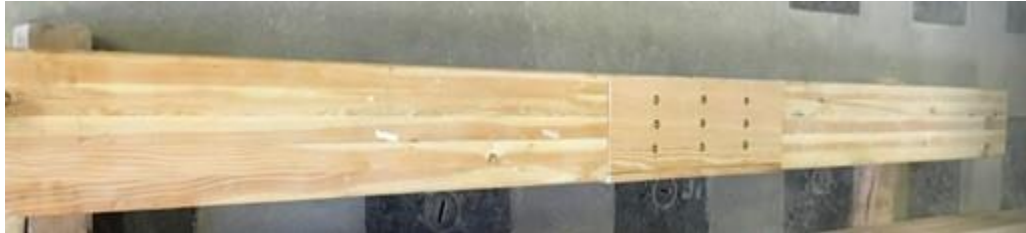
Figure B.2 Side of a repaired member.

The members were repaired using new laminates of timber of the same species and equivalent grade (per NLGA Standard Grading Rules for Canadian Lumber [13]). The panels were cut to the appropriate size and planed to the appropriate depth, such that they would fit in the areas that were previously carved out. The panel along the bottom of the member spanned the entire width of the member (175 mm), while the panels along the sides of the members were in line with the top of the member, and the top of the bottom panel. This configuration was chosen to maximize the potential to recover strength from the contributions of the bottom panel, where the tensile stresses would be highest. A side panel is seen in Figure B.2.

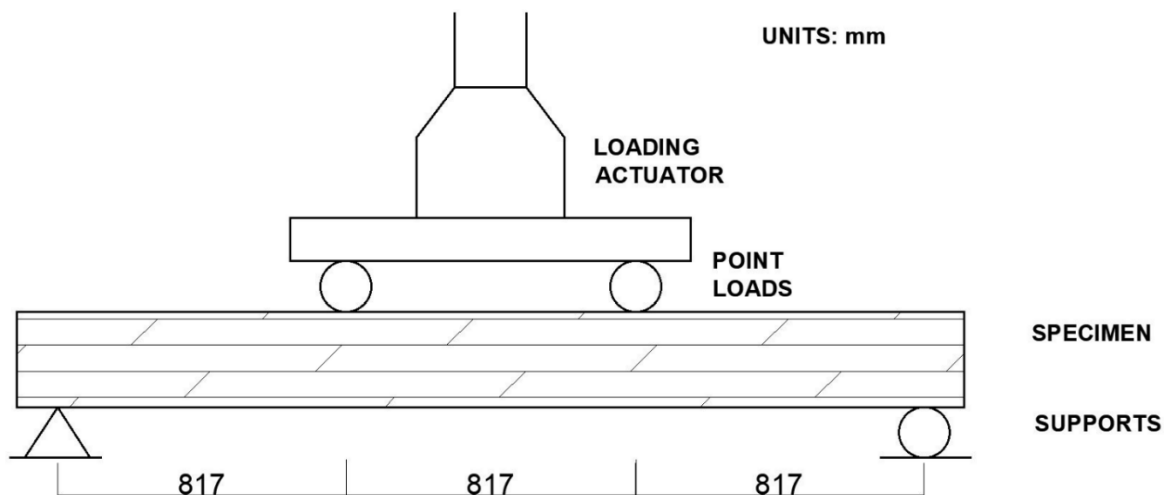
Figure B.3 Mechanical loading test setup.

All six members were loaded in four-point bending at a rate of 2.5 mm/min (following a modified ASTM D143 procedure for small clear specimens of timber) [14]. The test setup is seen in Figure B.3. Each member was loaded six times, three after carving but before repair, and three after repair. Once each member was carved, prior to being repaired, it was loaded and unloaded three times to a load much lower than its ultimate capacity. After repair, the member was again loaded and unloaded three times to the same load, lower than its ultimate capacity. The six loading

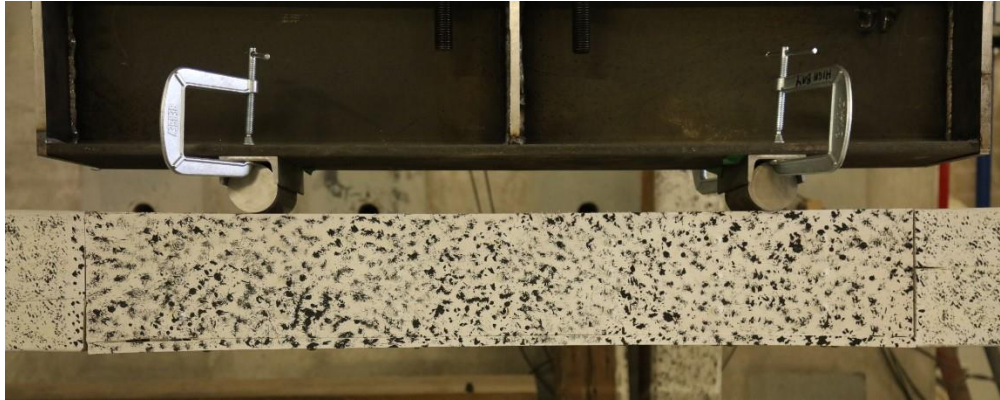
Figure B.4 Photograph that could be used in digital image correlation analysis, showing test setup and speckled pattern paint.

Digital image correlation was used to analyze the displacements of the timber members, a technology that has proven to be accurate for measuring displacement in wood specimens [15]. A Canon EOS 5Ds camera was used to take images at 5 second intervals (Figure B.4). Members were speckled using white and black paint to create high contrast patterns for the GeoPIV RG software to track and analyze the test images [16].

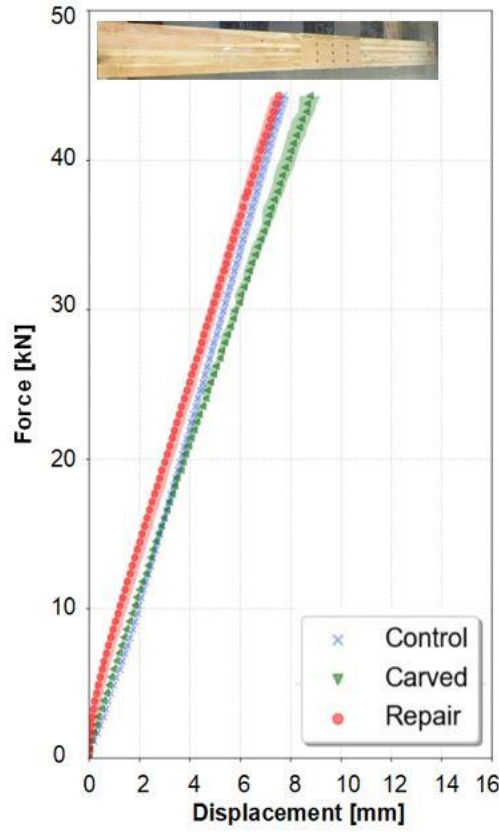
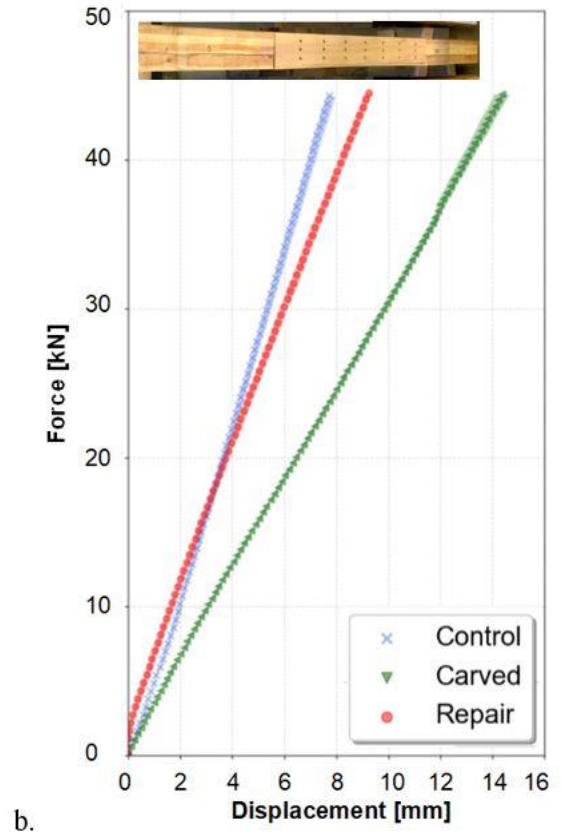
Figure B.5 Loading and unloading of the members of 175 x 190 mm cross section, a. Members 1 (control) and 3 (previously encapsulated), and b. Members 1 and 5 (previously exposed).

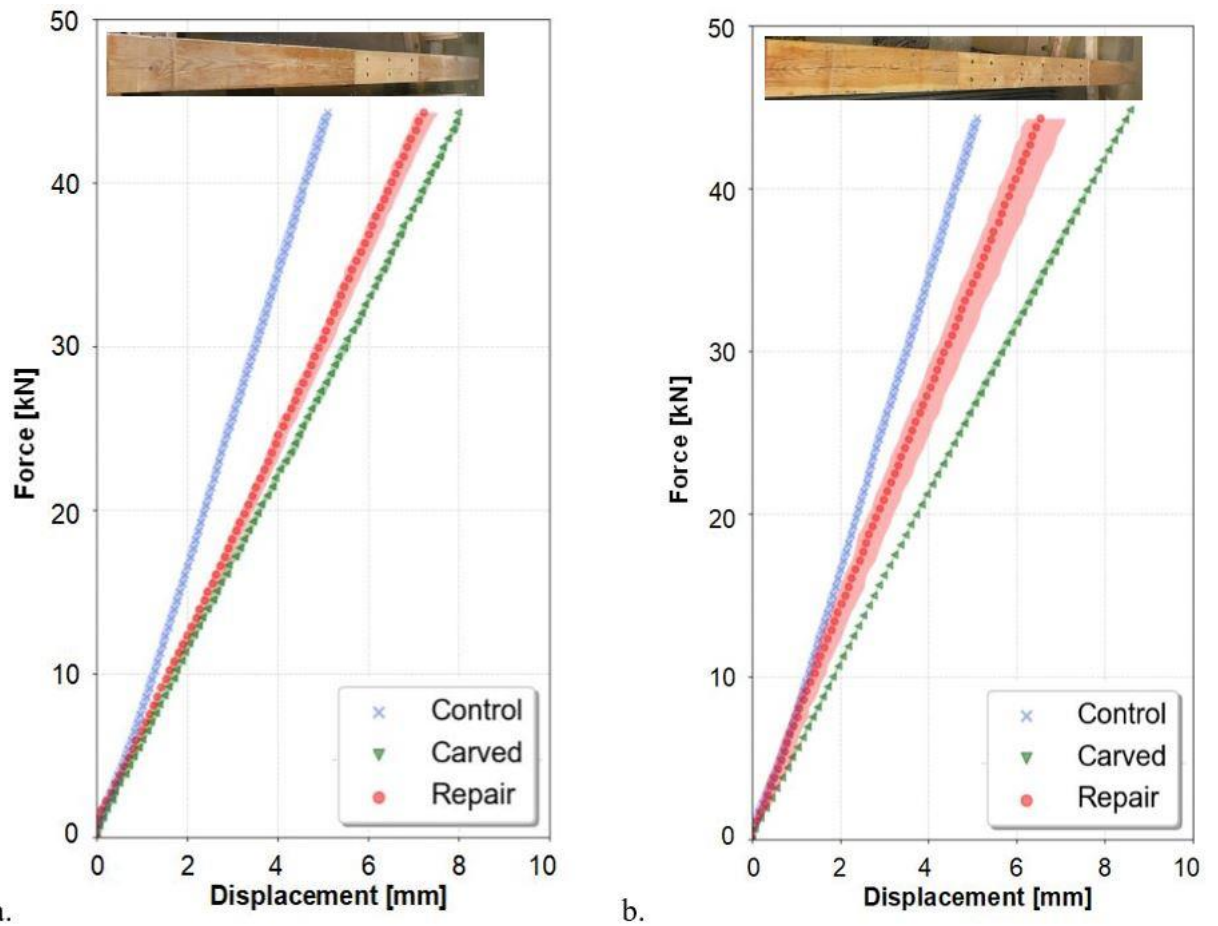
Figure B.6 Loading and unloading of the 175 x 228 mm cross section members, a. Members 2 (control) and 4 (previously encapsulated), and b. Members 2 and 6 (previously exposed).

For both Members 4 and 6, the maximum deflections of the repaired members have been reduced compared to those of the carved members. Member 4 saw a maximum deflection of the repaired member 0.7 mm less than that of the carved member, and Member 6 saw a maximum deflection of the repaired member 2.7 mm less than the maximum deflection of the carved member (about 30% of the total deflection of the carved member). In the cases of both these members, however, the repaired members were not able to return completely to the deflection observed by the control members.

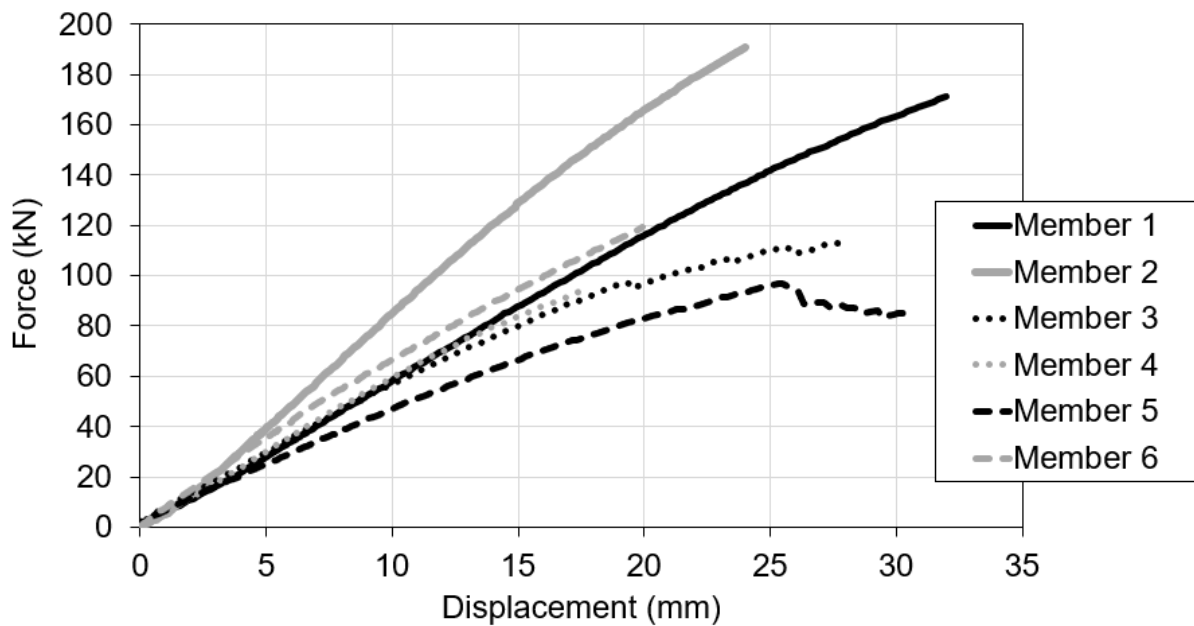
Figure B.7 Each member loaded to failure.

Figure B.7 depicts the force displacement curve of each member loaded to failure (where again, displacement is from digital image correlation and force is the total force from both point loads). This figure shows that the control members were able to achieve a higher force than the repaired members, with all repaired members holding only 49 - 66% of the force that the control members were able to withstand. Members were not loaded prior to carving, however existing work examines the flexural performance of laminated timber members at high temperatures (see Chapter 6, Chapter 7, and [17–19]).
