**THE THERMOMECHANICAL RESPONSE OF STRUCTURAL TIMBER IN REAL  
FIRE EXPOSURES**

A DISSERTATION SUBMITTED TO THE FACULTY OF GRADUATE STUDIES IN  
PARTIAL FULFILLMENT OF THE REQUIREMENTS OF THE DEGREE DOCTOR OF  
PHILOSOPHY

GRADUATE PROGRAM IN CIVIL ENGINEERING  
YORK UNIVERSITY  
TORONTO, CANADA

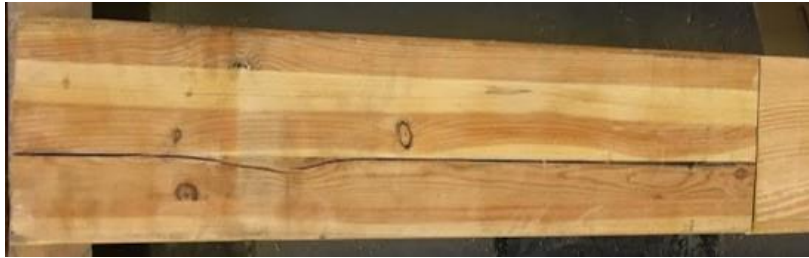
Figure B.8 Side of Member 5.

The failure load of Member 5 was 57% of the control failure load. This is less than the capacity of the other repaired member of the same size (Member 3 that failed at 66% of the control load). One factor that could have played into the low failure load of Member 5 (relative to Member 3) was cracks that were present along the side of the member (primarily along the adhesive lines). These are seen in Figure B.8 and were present after the fire exposure of the member (before any mechanical loading). While this crack or delamination may have a different effect on the structural performance of the member if loaded in compression (as is typically done for Glulam members of 16c-E stress grade, where cracking can impact the moment of inertia reducing buckling capacity of some columns), it will also impact the member tested in bending. The presence of these cracks may have reduced the capacity of the member and made it more difficult to achieve composite action. The effect of cracks and delamination in Glulam members is also something that needs to be considered with regards to repair. Cracks occur in many timber structures, both historic structures as well as structures that were constructed relatively recently. Cracking and delamination in the column of a contemporary timber structure in Toronto, Canada is seen in Figure B.9, where the structure was constructed in 2015, with the photo taken four years later. The column seen in Figure B.9 shows both delamination along the adhesive lines as well as within the timber itself. The presence of cracks and delamination in timber members complicates both the structural and fire performances of the member, as well as the repair procedure. The effect of cracks and delamination in timber should be addressed in future research, with regards to the

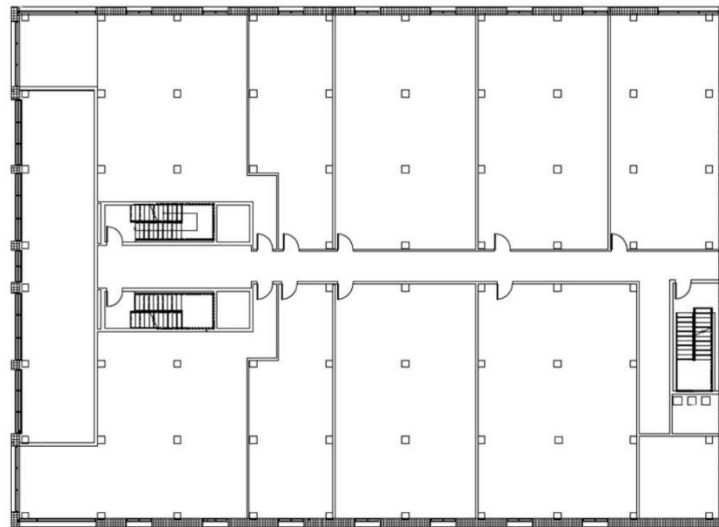
Figure B.10 Hypothetical building floor plan (for illustrative purposes only).

While some columns will be corner and perimeter columns and are therefore likely to have one or more sides not exposed directly to fire, it will be assumed that charring occurs on all four sides of the column. This will be done to be conservative, as previous studies have shown that gypsum board is not always effective at protecting timber from fire (see Chapter 4, [25–27]).

Furthermore, all interior columns are assumed to be unencapsulated and exposed to the fire. This setup is not meant to necessarily reflect what is currently permissible by current code allowances, but to reflect the architectural desire to have exposed timber within tall structures.

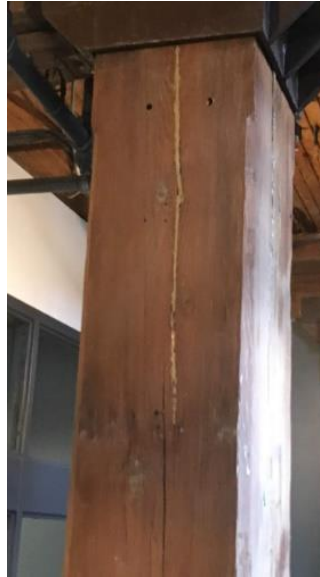
Figure C.1 Partial attempted sealant repair on a radial crack present on a column (author's photo).

fire performance. Often one fills the crack in-situ to negate any potential reductions in fire resistance, as seen in Figure C.1. Products known as wood filler and wood putty are readily available and advertise the ability to repair cracks and surface defects on wood. These attempted repair practices have insufficient evidence to support their use for fire performance purposes and can unduly compromise the architectural appearance of a timber structure.

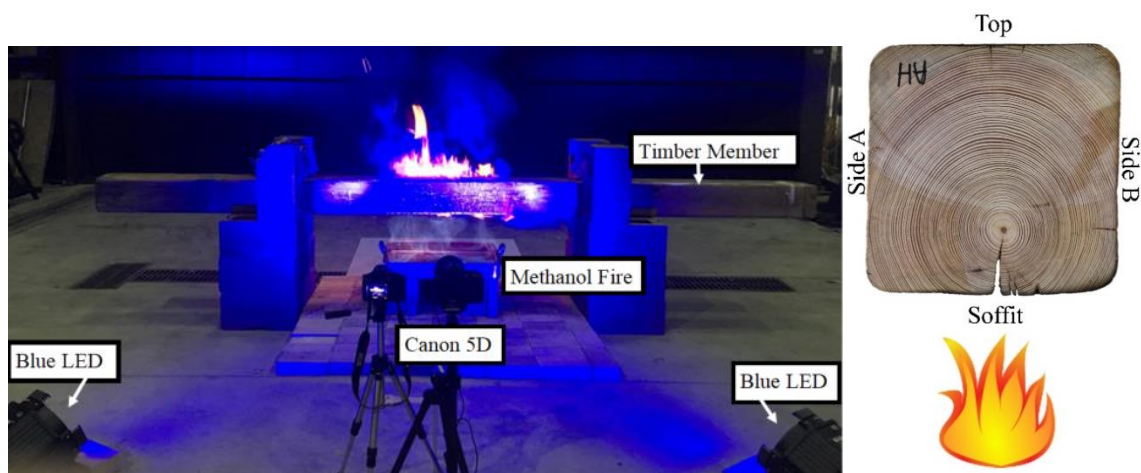
Figure C.4 Experimental test setup for pool fire, view of beam Side B.

Heritage 1 and 2 were tested in a 30-minute methanol pool fire with soffit temperature in excess of  $800^\circ\text{C}$  and allowed to cool for another 30 minutes. The test setup is seen in Figure C.4. Narrow spectral illumination (as described in [25,26]) was used to filter out the flame in photographs that were taken throughout the test so that visual observations regarding changes in

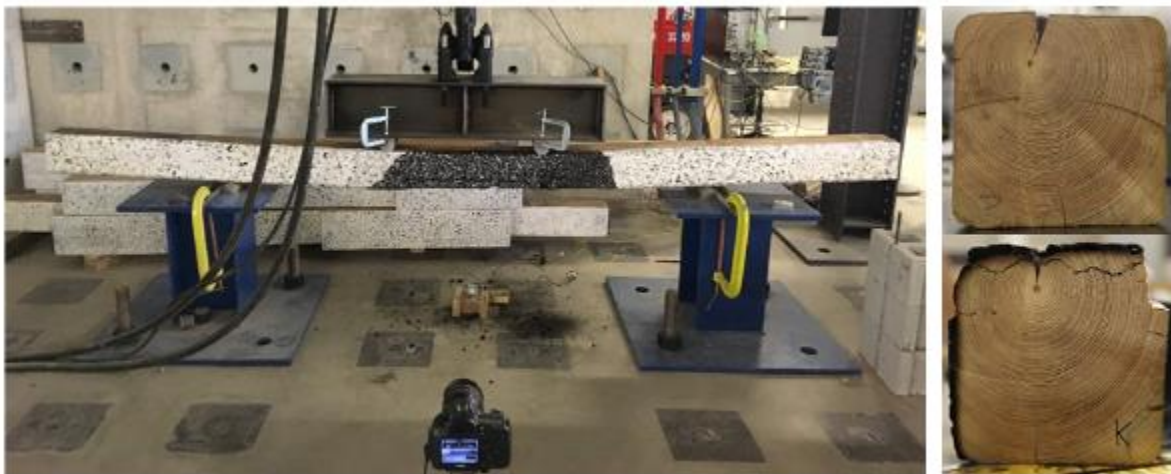
Figure C.5 Loading test setup (left) and member cross section slices (right, top- towards the end of the member, bottom- towards the centre of the member).

The test setup and char depth on the member at different points can be seen in Figure C.5. In addition to the members tested in fire (Heritage 1 and 2), one uncharred heritage member (Heritage 3) was included in the test program as a control member. From Figure C.5, it can be seen that the charred portion of the member is not always centred within the loading apparatus. This is because the charred portion was not always centred along the length of the member, even though

the pool fire was centred. During the heating of Heritage 1, the center of the ignited portion of the beam deviated from the center of the pool fire by 194 mm. Figure C.5 also shows the camera set up and black and white speckled pattern along the member, used for monitoring deflection through digital image correlation. A Canon EOS 5Ds camera was used to take photos at five second intervals throughout the loading of the members, and the black and white pattern provided high-contrast points. Deflection was then computed using digital image correlation software (GeoPIV RG) [31], a technique shown to be accurate for monitoring displacement in wood specimens [32].

After the timber members were loaded until failure, they were cut into 50 mm segments along the length of the member, so that the char depth could be measured along the length of the member. Char depth was determined by measuring the portions of the cross section that were not visually black by colour and subtracting those dimensions from the initial dimensions of the member. Two of these slices, showing the cross-sectional area of the heritage timber including a radial crack propagating from the top of the member towards the pith, are shown in Figure C.5.

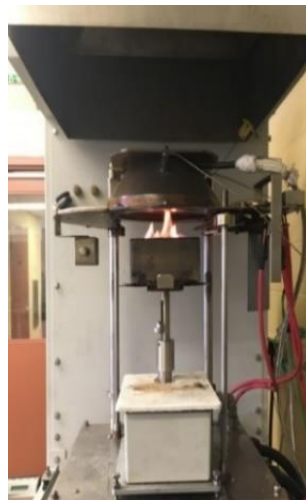
Figure C.6 Cone calorimeter test setup.

what would be found in practice as opposed to mechanically creating a crack within solid timber. The specimens were exposed to heat using a Cone Calorimeter apparatus, according to a modified ASTM E1354 procedure [33] shown in Figure C.6. The ASTM E1354 procedure was modified in that no pilot burner was used, and that the samples were removed from the apparatus after the desired heat duration and extinguished with light amounts of water. All samples were exposed to a heat flux of  $50 \text{ kW/m}^2$ , for varying exposure durations. The cracked and solid samples were exposed to the heat flux for 6, 15, and 30 minutes respectively (with duplicates of the 6-minute tests to confirm test repeatability). The primary purpose of the Cone Calorimeter tests was to induce a repeatable thermal exposure on the timber, such that the effect of the crack on the fire performance of the samples could be assessed. As such,  $50 \text{ kW/m}^2$  was therefore chosen as a heat flux that was great enough to induce significant char depths, but not so high as to run the risk of charring through any specimens completely at 30 minutes [34]. Test times were selected as 30 minutes to induce a reasonably deep char depth that would be certain not to char through (considering the sample height, crack depth, and charring seen in similar tests [35]). 15 minutes was selected as half of 30 minutes to provide a moderate point of comparison, and 6 minutes was selected as an even milder point of comparison, in line with the methodology of Chapter 5, as to be able to compare data from both studies.

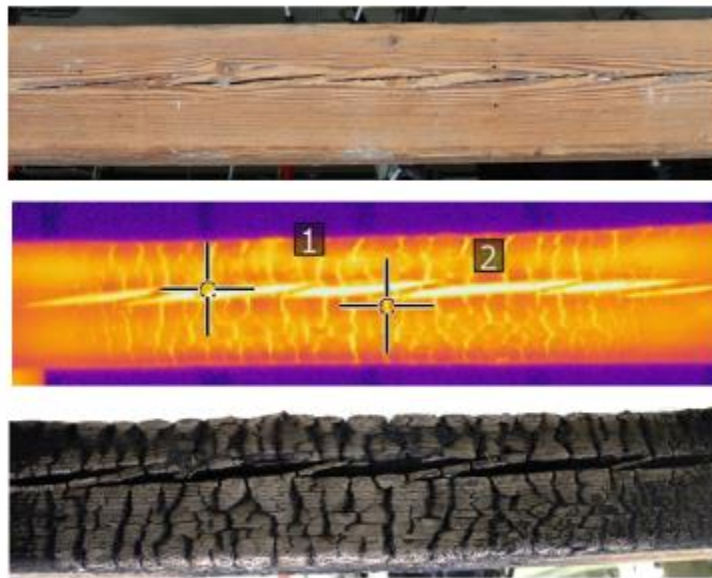
Figure C.7 Side A crack progression before (top) and after fire (middle and bottom) on Heritage 2 (identifiable markings were recorded temperature markers).

The largest existing cracks on each of the timber members were measured before and after exposure to the pool fire and presented in Table C.3. The table also presents the average char depth excluding the crack region, and the maximum char depth (at the crack region) of each member on the side with an existing crack larger than 2 mm. The char depth was calculated by subtracting the dimensions of the residual undamaged timber from the initial dimensions of the member. The average char depth away from the crack was determined as the average of four measurements equally spaced away from the crack region, cracks included in consideration of Table C.3 include the existing cracks on the soffit for member Heritage 1 and side A for Heritage 2. Figure C.7 shows the 5.4 mm cracks on side A of member Heritage 2 before exposure to the pool fire, and then after with a thermal camera and regular camera where the maximum crack width is 10.4 mm.

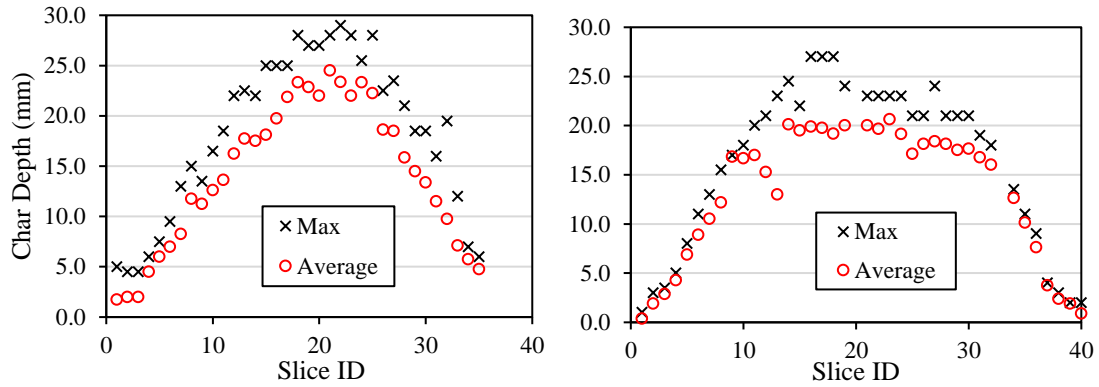
Figure C.8 Char depths after loading on soffit of Heritage 1 (left) and Heritage 2 (right), where Max is the maximum char depth around the crack, and Average is average char depth away from the crack.

The char depth measured at each 25 mm slice for the soffit of Heritage 1 and 2 were recorded and presented in Figure C.8, note that for Heritage 1 there was a pre-existing crack, and for Heritage 2 there was no crack present on the soffit. The existing radial crack on Heritage 2 was present on the side of the member with respect to the pool fire, and those char measurements are

shown in Figure C.9. It should be noted that the members charred primarily on the soffit and two sides, with little to no char on the top of the members. Therefore Figure C.8 represents the char measured on the soffit of the member, while Figure C.9 represents the sum of the char depths measured on both of the sides. The char depth represented in these figures was determined by subtracting the measured undamaged depth of timber post testing from the initial dimensions.

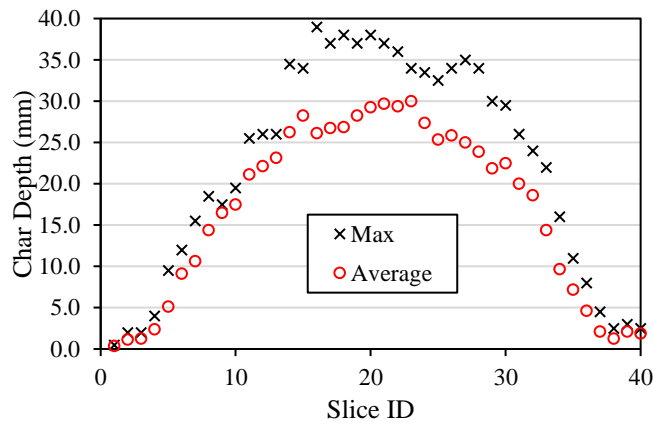
Figure C.9 Char depths after loading on the sides of Heritage 2, where Max is the maximum char depth around the crack, and Average is average char depth away from the crack.

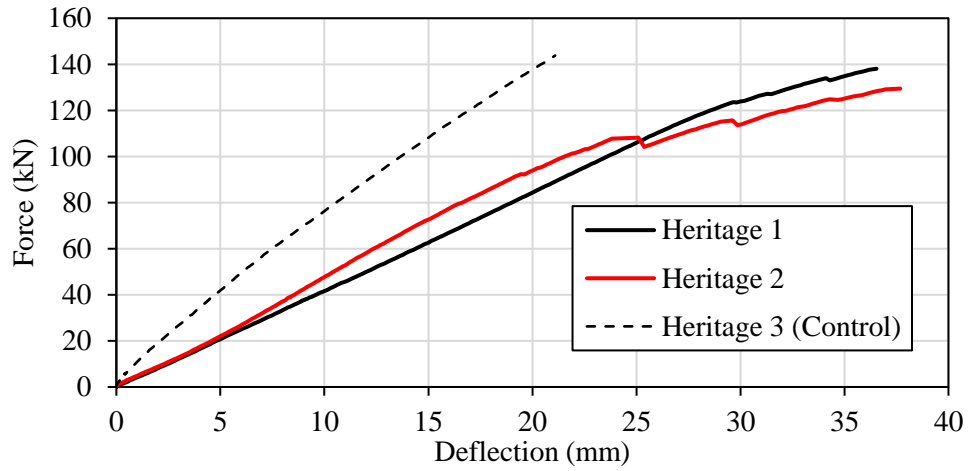
Figure C.10 Force vs deflection for the charred heritage and control members.

The deflections computed during the loading tests for the two heated members, Heritage 1 and 2, and the control member, Heritage 3, are presented in Figure C.10. The deflections measured in millimeters are plotted in relation to the force applied in kilonewtons, until failure.

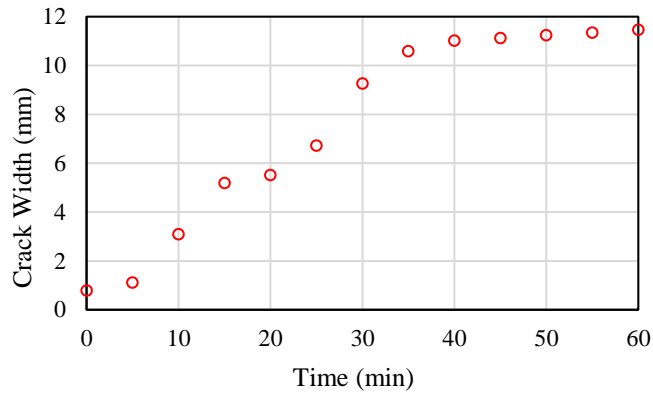
Figure C.11 Crack expansion over time during the 30 minute pool fire and 30 minute cooling phase on Side B of Heritage 2.

Figures C.11 and C.12 show that the crack did continue to increase in width after the heating phase was complete. Figure C.11 shows that during the heating phase (the first 30 minutes of testing), the crack width increased by 8.5 mm, while during the cooling phase (the second 30 minutes of testing), the crack width increased by 2.2 mm. The continued increase in crack width

during the cooling phase of testing could be attributed to continued heating and moisture evaporation of the timber even after the pool fire had been consumed.

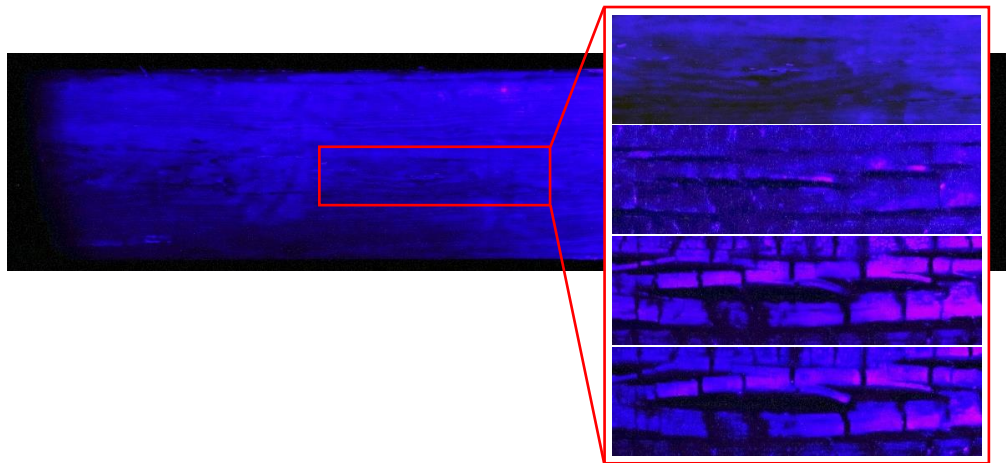
Figure C.12 Crack expansion during heating at 0, 15, 30, and 60 minutes on Side B of Heritage 2.

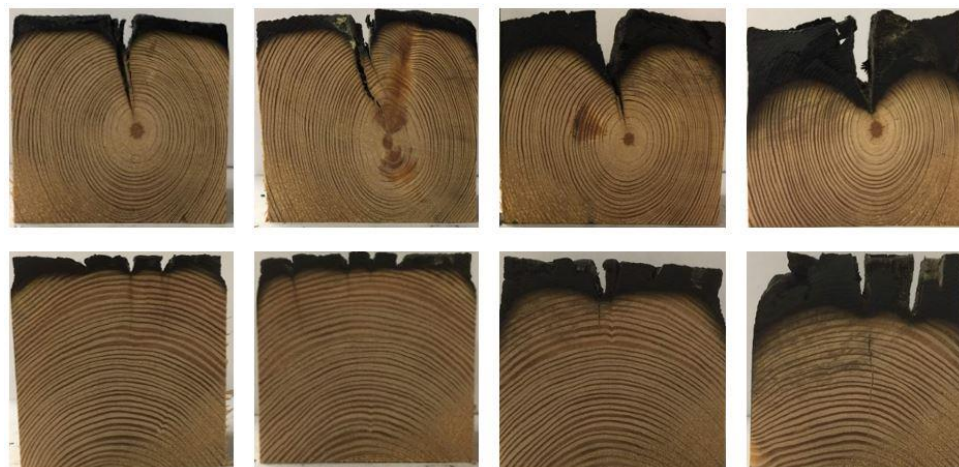
Figure C.13 Char depth of cracked (top) and solid (bottom) timber samples at various exposure durations.

Figure C.13 shows the cross section of each of the samples tested, showing the char depth at the center of the cracked samples at the top, and solid samples at the bottom in order of exposure duration. Samples labelled “solid” were characterized to have no crack exceeding 2 mm in width before exposure. The char depth of each sample, both cracked and solid, is shown in Figure C.14 at the three exposure durations tested. The value at 6 minutes is an average of the two samples tested at that exposure duration for the cracked and solid samples. The second graph shows the heat release rates from the 30-minute exposure test of the cracked and solid samples.

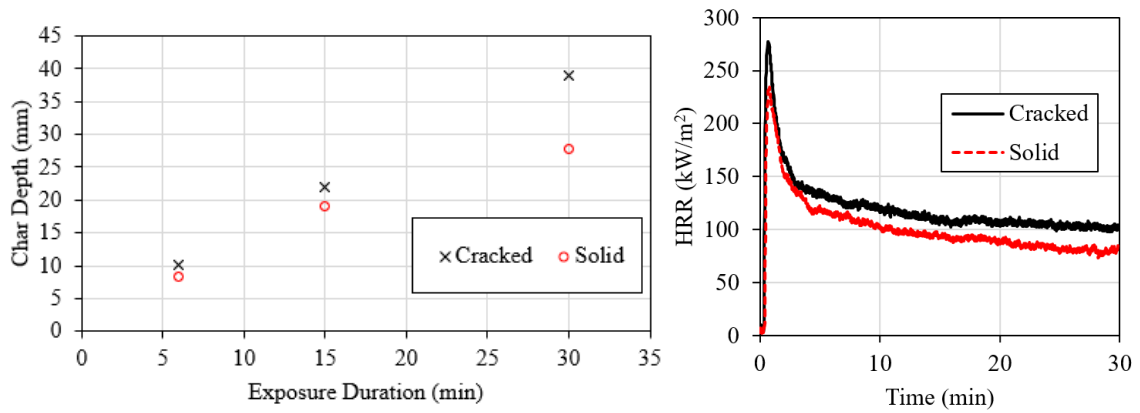
Figure C.14 Maximum char depth of cracked and solid specimens, and heat release rates of cracked and solid samples tested to 30 minutes.
