The Effects of Radial Cracks on the Fire Performance of Heritage Timber

As published Fire and Materials, issue 47(3), 386-399

Heritage timber buildings are found worldwide, and their irreplaceable nature makes them of high value. A common occurrence on heritage timber members is radial shrinkage cracks resulting from changing moisture contents over time. There is little information available that can be used to assess the fire performance of heritage timber members (which has unique differences from contemporary timber), and, to the author's awareness, no information regarding how the presence of radial cracks affects the fire performance and char depth of a timber member. The purpose of this study is to provide an evaluation of the effects of radial cracking on the fire performance of timber members, including its effect on char depth, time to ignition, and residual strength. Full-scale heritage Pine timber members were procured from a 115-year-old building undergoing demolition and then subjected to a pool fire. Cracked samples were also extracted from the members and tested in a Cone Calorimeter apparatus relative to solid samples. It was found that the presence of cracks did

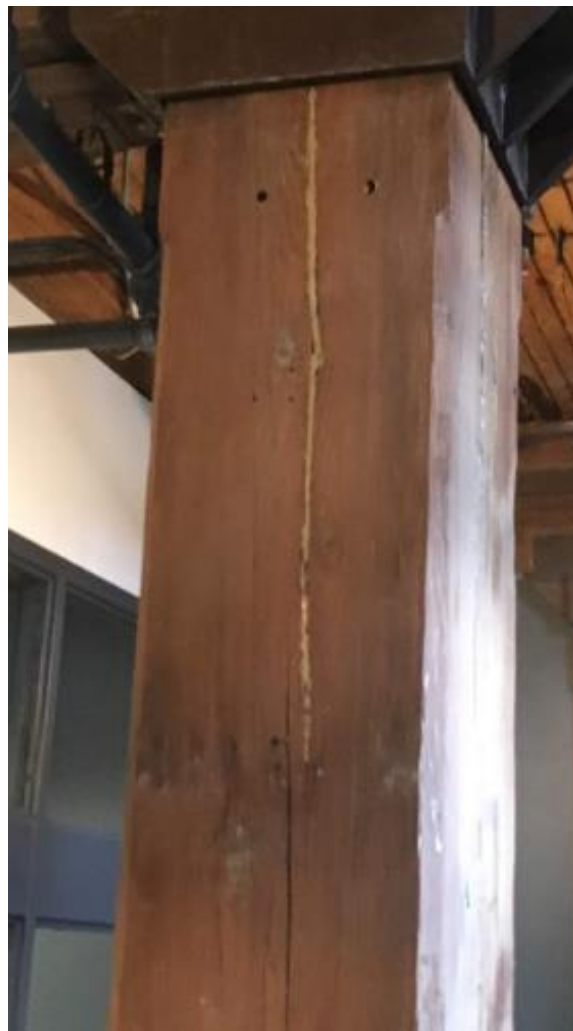
Figure 1. Partial attempted sealant repair on a radial crack present on a column.

Radial cracking from shrinkage (checking) occurs with significant reductions in the moisture content of timber. These cracks can penetrate deep within the cross-section of the timber member. Significant changes in moisture content usually occur when there are changes in use or occupancy of the building, or during renovations when the building is not conditioned as usual. There is little information currently available regarding how these radial cracks within timber will affect a timber structural element's fire performance. Often one fills the crack in-situ to negate any potential reductions in fire resistance, as seen in Figure 1. Products known as wood filler and wood putty are readily available and advertise the ability to repair cracks and surface defects on wood. These attempted repair practices have insufficient evidence to support their use for fire performance purposes and can unduly compromise the architectural appearance of a timber structure.

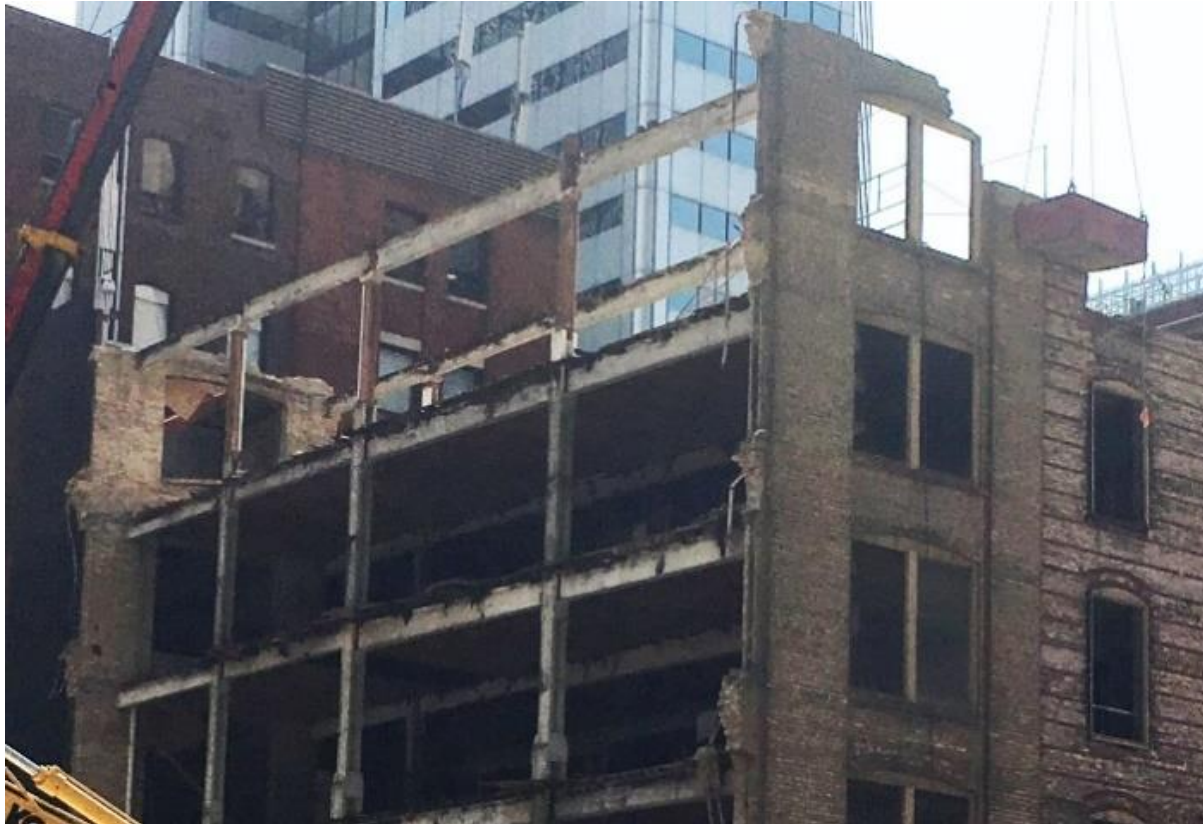
Figure 2. Material acquisition from an industrial building in Toronto, Canada.

The timber material was collected from a former industrial building in Toronto, Canada, built in 1905. The material acquisition occurred during the partial deconstruction of the building to accommodate a new high rise on the site that will incorporate a small portion of the original façade. The building was a 6-storey brick masonry structure with interior elements made of timber and steel, the timber elements tested herein were found on the upper (5th and 6th) floors as seen in Figure 2. Its original use was industrial but had been converted to commercial office space for contemporary use. The timber members were encapsulated at the time of deconstruction, as observed by the authors, which is common with heritage timbers. The first National Building Code in Canada, published in 1941, limited combustible construction to 4 storeys which terminated the construction of high rise timber structures [26]. For the 6-storey building, it can be assumed that the timber on the upper levels was encapsulated sometime after 1941 to comply with building codes of the time, hypothesized by the authors after the change from industrial to commercial use.

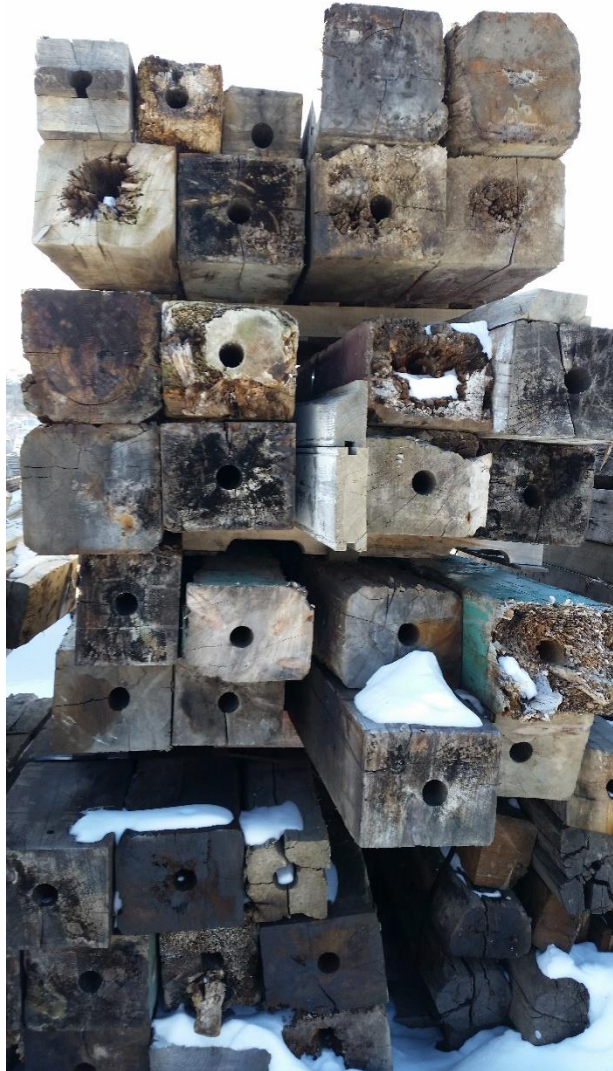
Figure 3. Improper storage of heritage timber materials.

Collecting viable heritage materials for destructive testing presents unique challenges concerning limited access to materials and their conditions. The larger timber members used in high rise construction (between 5-8 storeys) can only be found in buildings built before 1941 in Canada, which contributes to their rarity. Additionally, they are often found in designated heritage buildings that are protected from removal or demolition. The heritage materials must also be in serviceable condition, so any materials from buildings being demolished due to deterioration are not representative of heritage timbers in use, and therefore cannot be used. Members that have been stored outside during renovation or deconstruction projects can also be subjected to damage from moisture and/or pests and become structurally compromised after removal. Figure 3 shows unsuitable storage of materials of a different site found in Canada where the authors rejected other samples. These considerations exemplify the difficult to study nature of procuring in-situ testing of older material specimens and the need to provide guidance on material collection for other practitioners.

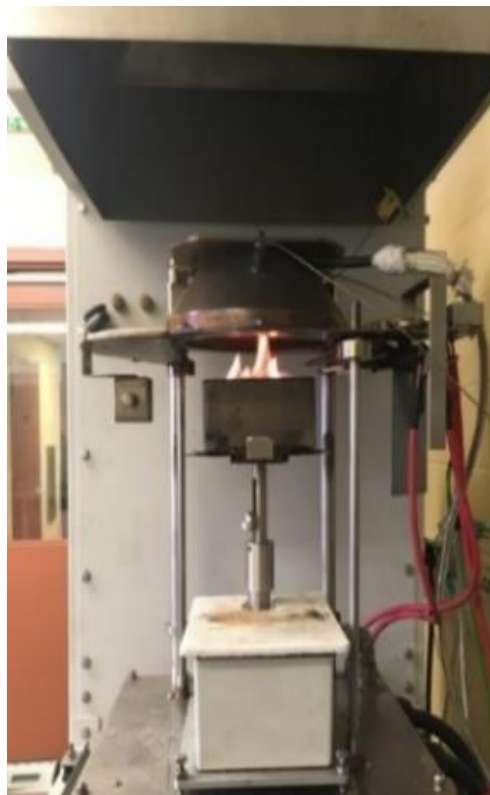
Figure 7. Cone calorimeter test setup.

Using the same heritage timber from the testing program described above, Cone Calorimeter tests were conducted to further study the effect of radial cracks present in heritage timber. The Cone Calorimeter utilizes a coiled radiant heater for thermal exposure. As previously mentioned, in larger members, using radiant heaters to create a radiant heat flux along one face of a timber member can create an upwards bowing effect through de-hydration of the material. The sample holder and small size of the Cone Calorimeter minimizes this effect, and thus the Cone Calorimeter offers an opportunity to consider radiant heat only where the bowing effect will not significantly affect the results.

Following heat exposure in the Cone Calorimeter apparatus, each of the eight samples was cut in half, perpendicular to the direction of the crack. Char depth was then determined by measuring the depth of undamaged timber, determined visually by colour as the region that had not turned black or brown, and subtracting the undamaged depth from the initial depth of the sample. Char depth was measured at quarter and mid spans of the samples.

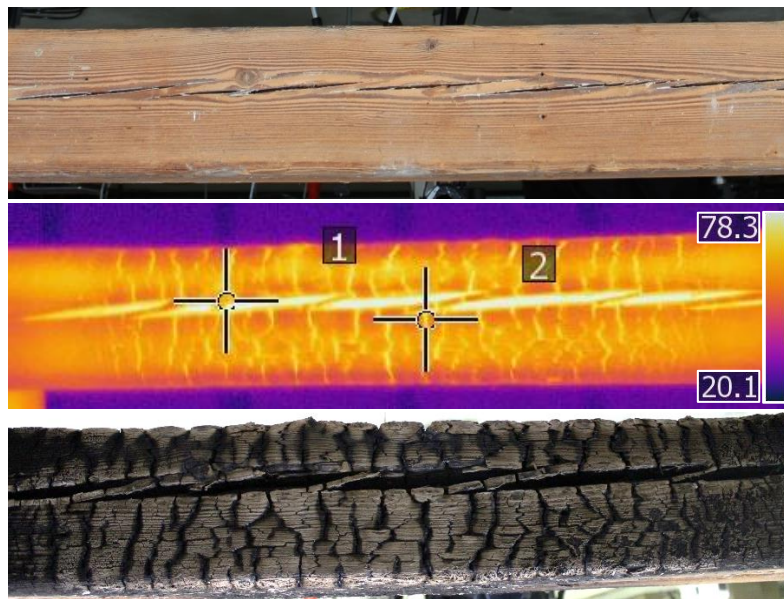
Figure 8. Side A crack progression before (top) and after fire (middle and bottom) on Heritage 2 (identifiable markings were recorded temperature markers and scale is in °C).

The largest existing cracks on each of the timber members were measured before and after exposure to the pool fire and presented in Table 3. The table also presents the average char depth excluding the crack region, and the maximum char depth (at the crack region) of each member on the side with an existing crack larger than 2 mm. The char depth was calculated by subtracting the dimensions of the residual undamaged timber from the initial dimensions of the member. The average char depth was taken as the average of 4 measurements, taken at 1/5 points on the width of the beam (excluding the center measurement, which represents the maximum char depth due to the crack). Cracks included in consideration of Table 3 include the existing cracks on the soffit for member Heritage 1 and side A for Heritage 2. Figure 8 shows the 5.4 mm cracks on side A of member Heritage 2 before exposure to the pool fire, and then after with a thermal camera and regular camera where the maximum crack width is 10.4 mm. The thermal image serves as a confirmation that the narrow spectrum illumination technology indeed shows the development of the crack, as the heat in the cavity is captured in the thermal imaging.

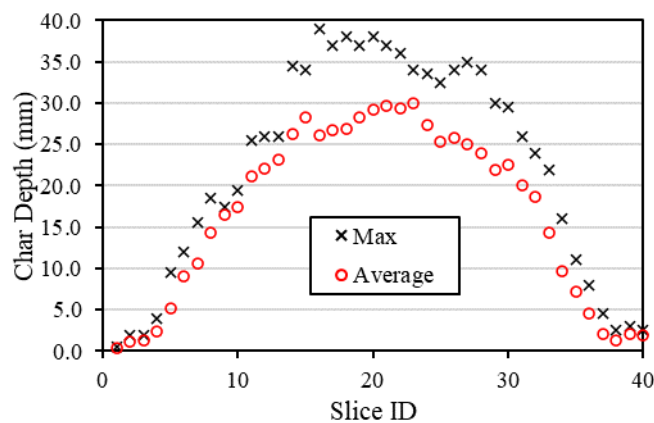
Figure 10. Char depths after loading on the sides of Heritage 2, where Max is the maximum char depth around the crack, and Average is average char depth away from the crack.

Figures 9 and 10 therefore give an idea of the location of the 300 °C isotherm along the length of the member.

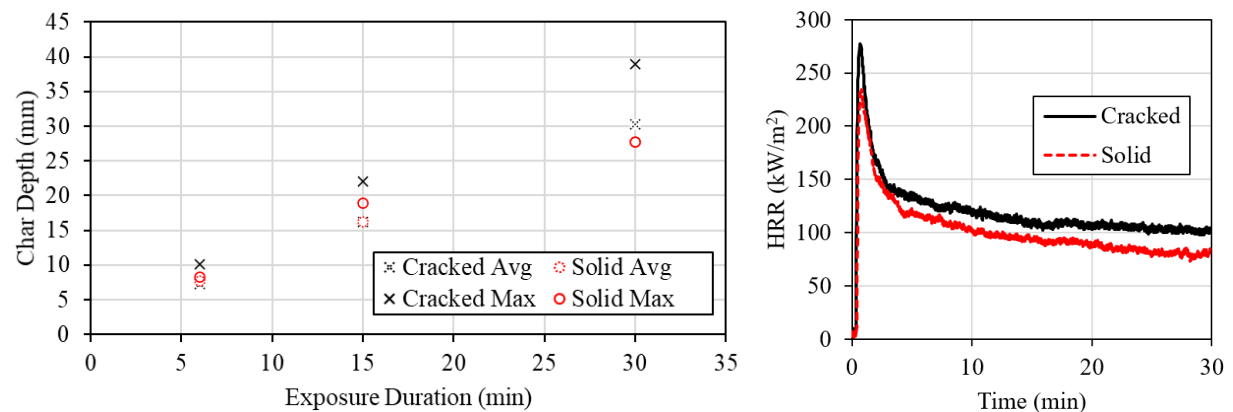
Figure 15. Average and maximum char depth of cracked and solid specimens, and heat release rates of cracked and solid samples tested to 30 minutes.

Figure 14 shows the cross section of each of the samples tested, showing the char depth at the center of the cracked samples at the top, and solid samples at the bottom in order of exposure duration. Samples labelled “solid” were characterised to have no crack exceeding 2 mm in width before exposure. The char depth of each sample, both cracked and solid, is shown in Figure 15 at the three exposure durations tested. The value at 6 minutes is an average of the two samples tested at that exposure duration for the cracked and solid samples. The second graph shows the heat release rates from the 30-minute exposure test of the cracked and solid samples.

The results of the Cone Calorimeter tests showed some notable differences between the cracked and solid samples. First, the presence of the crack did seem to affect char depth and heat release rate. The maximum char depth was 29% greater for the cracked samples than the solid samples after 30 minutes. Similarly, for the heat release rate, the peak heat release rate of the cracked samples was 16 kW/m² (6 %) higher than the average peak heat release rate of the solid samples. The average heat release rate over 30 minutes was also higher (118 kW/m²) than the solid samples (100 kW/m²). Despite the differences, the small sample size of the cracked and solid samples makes it difficult to draw firm conclusions regarding the heat release rates, re-emphasizing challenges in obtaining heritage materials suitable for testing. Although the peak heat release rates do not appear to be statistically different, more comparative test data for cracked and non-cracked specimens and further study are needed to draw substantiated conclusions regarding the effect of cracks on heat release rate.
